BULLETIN NUMBER:
SB12-11-S001

Regional Safety Recall 12V-306

Corrosion Affecting the Forward Mounting Point for Rear Suspension Lower Link Brackets

- 1998-1999 Model Year Isuzu Amigo (UA)
- 2000-2002 Model Year Isuzu Rodeo Sport (UA)

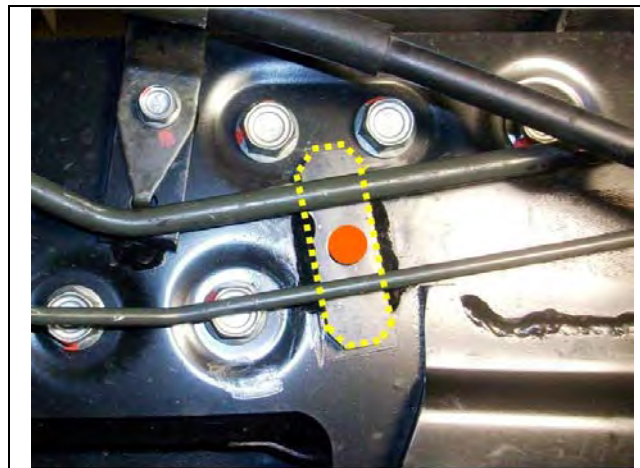
Figure 53

20. Using a ¼” drill bit, drill a hole in the frame through the passenger side reinforcement bracket brake clip mounting hole. See Figure 53.

22. Locate the ¼” hole drilled in Step 20. Use the 33/64” drill bit and finish drilling this location. Mark this location with tape or chalk. This hole is required to provide clearance for the passenger side brake pipe clip. See Figure 53.

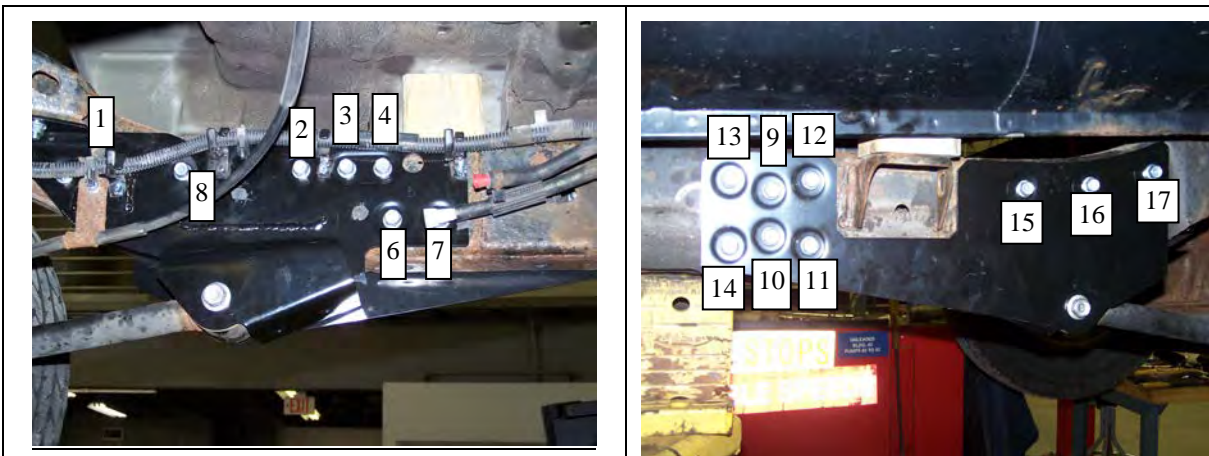
Figure 60
 1. Upper link stud and nut; Torque to 50-55 Nm (37-40 lb ft)
 2.-17. Bracket bolts; Torque to 25-30 Nm (18-22 lb ft)

35. Torque bolts according to the sequence and specifications shown in Figure 60.

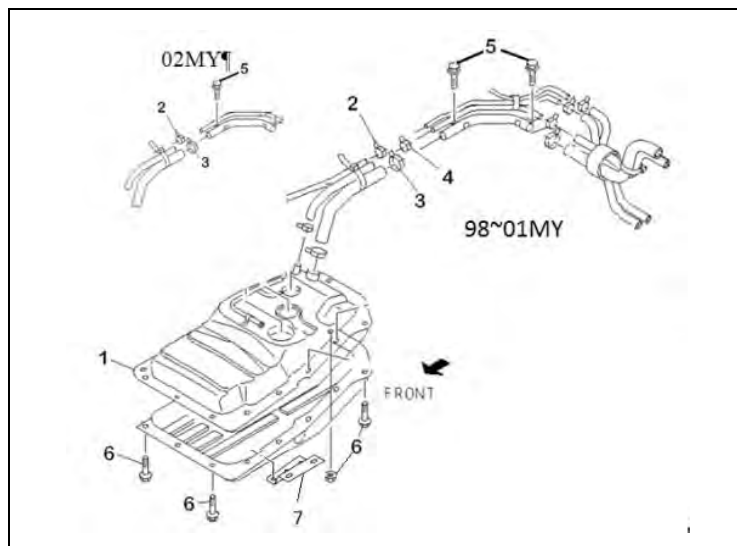
Figure 61

1. Fuel Tank
2. Fuel Line Clip
'98/'00MY 8-97138-011-0
'01/'02MY 8-94242-034-0
3. Fuel Line Clip
'98/'00MY 8-97139-975-0
'01/'02MY 8-97237-146-0
4. Fuel Line Clip
All 8-94242-034-0
5. Fuel Pipe Mounting Bolts
6. Fuel Tank Mounting Bolts and Nut
Nut 8-97142-595-0
Bolt 8-97174-300-1
7. Fuel Tank Protector Bolts and Washers
Bolts: 8-98174-544-0
Washers: 0-9161-4810-0

- d. Install fuel tank. Install new parts at locations 2, 3, 4 and 6 shown in Figure 61.
