Technical Bulletin

Section Title: Body, Cab and Accessories
 TSB No. TS 13 09212

- SUBJECT:** SAFETY RECALL CAMPAIGN “NU”; INOPERABLE LOW AND HIGH BEAM HEADLIGHT FUNCTION.
- MODEL(S):** FORENZA SEDAN/WAGON, RENO (RQ420)
- YEAR:** ALL 2004~2005 MY, AND CERTAIN 2006 MY THROUGH PRODUCTION DATE OF MARCH 27, 2006
- CONDITION:** Some vehicles may experience an intermittent or total loss of high/low beam headlight function.
- CAUSE:** Affected vehicles were produced with an instrument panel wire harness which included a splice pack (S201) that may have high resistance at the headlamp splice.
- CORRECTION:** Suzuki dealers are requested to remove the S201 splice pack and then re-join related wiring with the special crimp/solder style splice connectors (part # 99963-85ZSC).

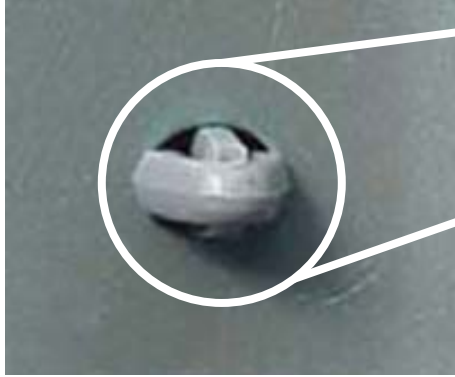
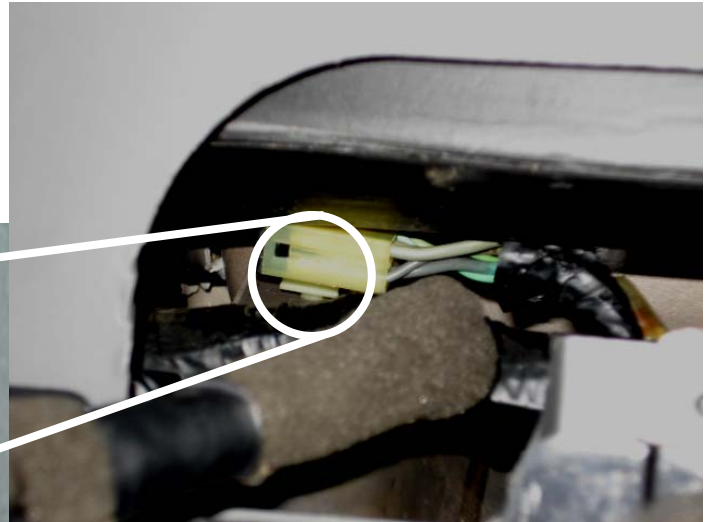
7. Pull the splice pack out from in between the A/C duct and dash support structure. Inspect the splice pack for the three violet wires shown. If they have been cut off, a repair attempt has been made. If the violet wires are showing signs of a poor repair (loose, improperly soldered, poorly crimped, burnt etc...) the violet wires will have to be included in this repair as follows beginning with step 8.

8. Cut the two (2) sky blue wires and five (5) light green wires as close to the splice pack connector as possible. Also cut the three (3) violet wires if they have not previously been removed. If any heat damage exists, cut the wires just behind the damaged area. Discard the removed splice pack connector (S201).

If an inadequate repair has already been made to the violet wires, remove the repair by cutting the wires as close to the repair as possible and just behind any damaged area, then make the repair.
