1199 Panigale Safety Upgrades
Models: MY 2012 and MY 2013 Panigale (All Versions)
Recall Bulletin RCL-12-006

Date: Tuesday, August 7th, 2012
To: Dealer Principal, Service Manager, North American Dealer Network
From: Austin Gray, Technical Director; Jonathan LaForte, Technical Manager

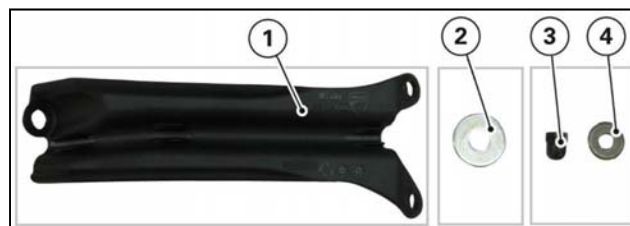
On the involved bikes a comprehensive parts kit has been created (part no.69926601A) containing the spare parts you will need to perform these upgrades. The kit includes the following:

<i>KIT part no. 69926601A</i>		
<i>Ref.</i>	<i>DESCRIPTION</i>	<i>Q.ty</i>
1	Exhaust Valve Cable Heat Shield	1
2	Washer P.6.4X18X1.6 ISO7093	1
3	Cap Nut M5 DIN1587-KL6 Galvanized Black	1
4	Washer P.5X15X1.5 UNI6593SS	1

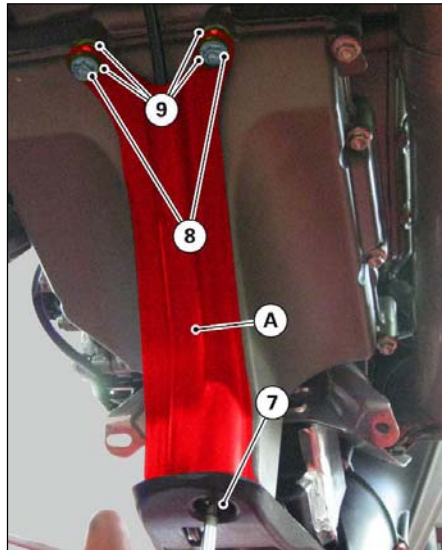
- A) **EXHAUST BUTTERFLY VALVE BOWDEN CABLE SUPPORT** (all versions): In some rare conditions of engine faulty operation (for instance when the bike is operated while running on one cylinder due to a fouled spark plug) it is possible that the excess heat built up in the catalytic converter can overheat the lower engine area. This could cause the exhaust butterfly valve Bowden cable support, installed to the oil sump, to melt or burn. This part must be replaced with the new one having a higher heat rating. During this procedure it is also required that the technician re-tighten the screws retaining the silencer central brackets. (Even if this has previously been performed during the OIL SERVICE 1000 pursuant to Tips&Tricks no. 54).

7) Remove the *exhaust butterfly valve Bowden cable support (A)*, by loosening the *bottom screw (7)* and the *two top nuts (8)*, keeping the four *spacers (9)*.

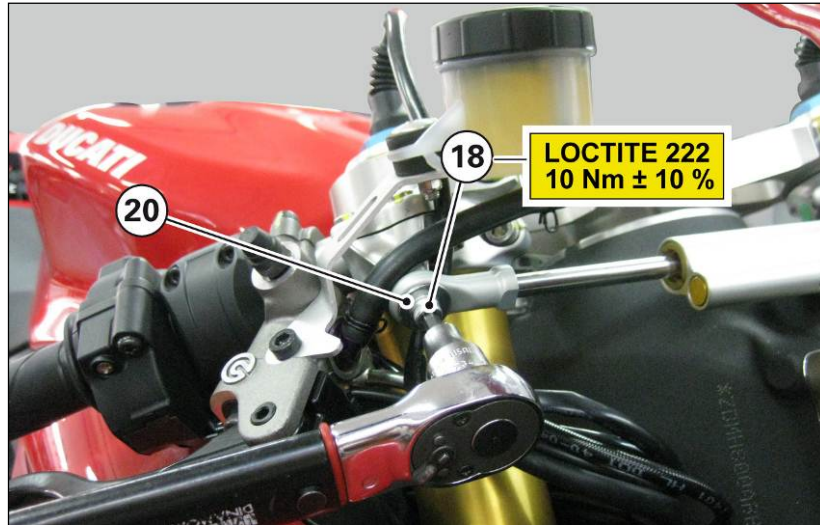
- C) **STEERING DAMPER RETAINING SCREWS** (all versions): The two steering damper retaining screws might loosen from their original tightening torque. It is necessary to re-tighten the screws and properly apply the specified threadlocker.

5) Tighten the **screw (18)** with **LOCTITE 222** to **10 Nm \pm 10%**.

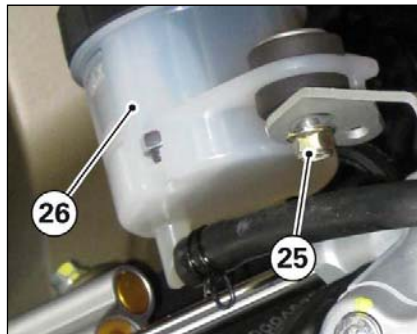
- E) ***FRONT BRAKE MASTER CYLINDER FLUID RESERVOIR CONNECTION TUBE*** (all versions): The front brake master cylinder fluid reservoir connection tube might interfere with the threading end of the reservoir retaining screw. In order to avoid this potential damage it is necessary to install a nut and washer.

- 1) Remove **nut (25)** retaining the front brake fluid **reservoir (26)**.
