Re: Toyota Safety Recall 12V-537 – Dealer Notification Remedy Phase 2

Subject: **Safety Recall - C0T Remedy Notification**
2004 to certain 2009 Model Year Prius Vehicles
Steering Intermediate Extension Shaft

TECHNICAL INSTRUCTIONS
FOR
SAFETY RECALL C0T
STEERING INTERMEDIATE EXTENSION SHAFT
2004 – CERTAIN 2009 MODEL YEAR PRIUS

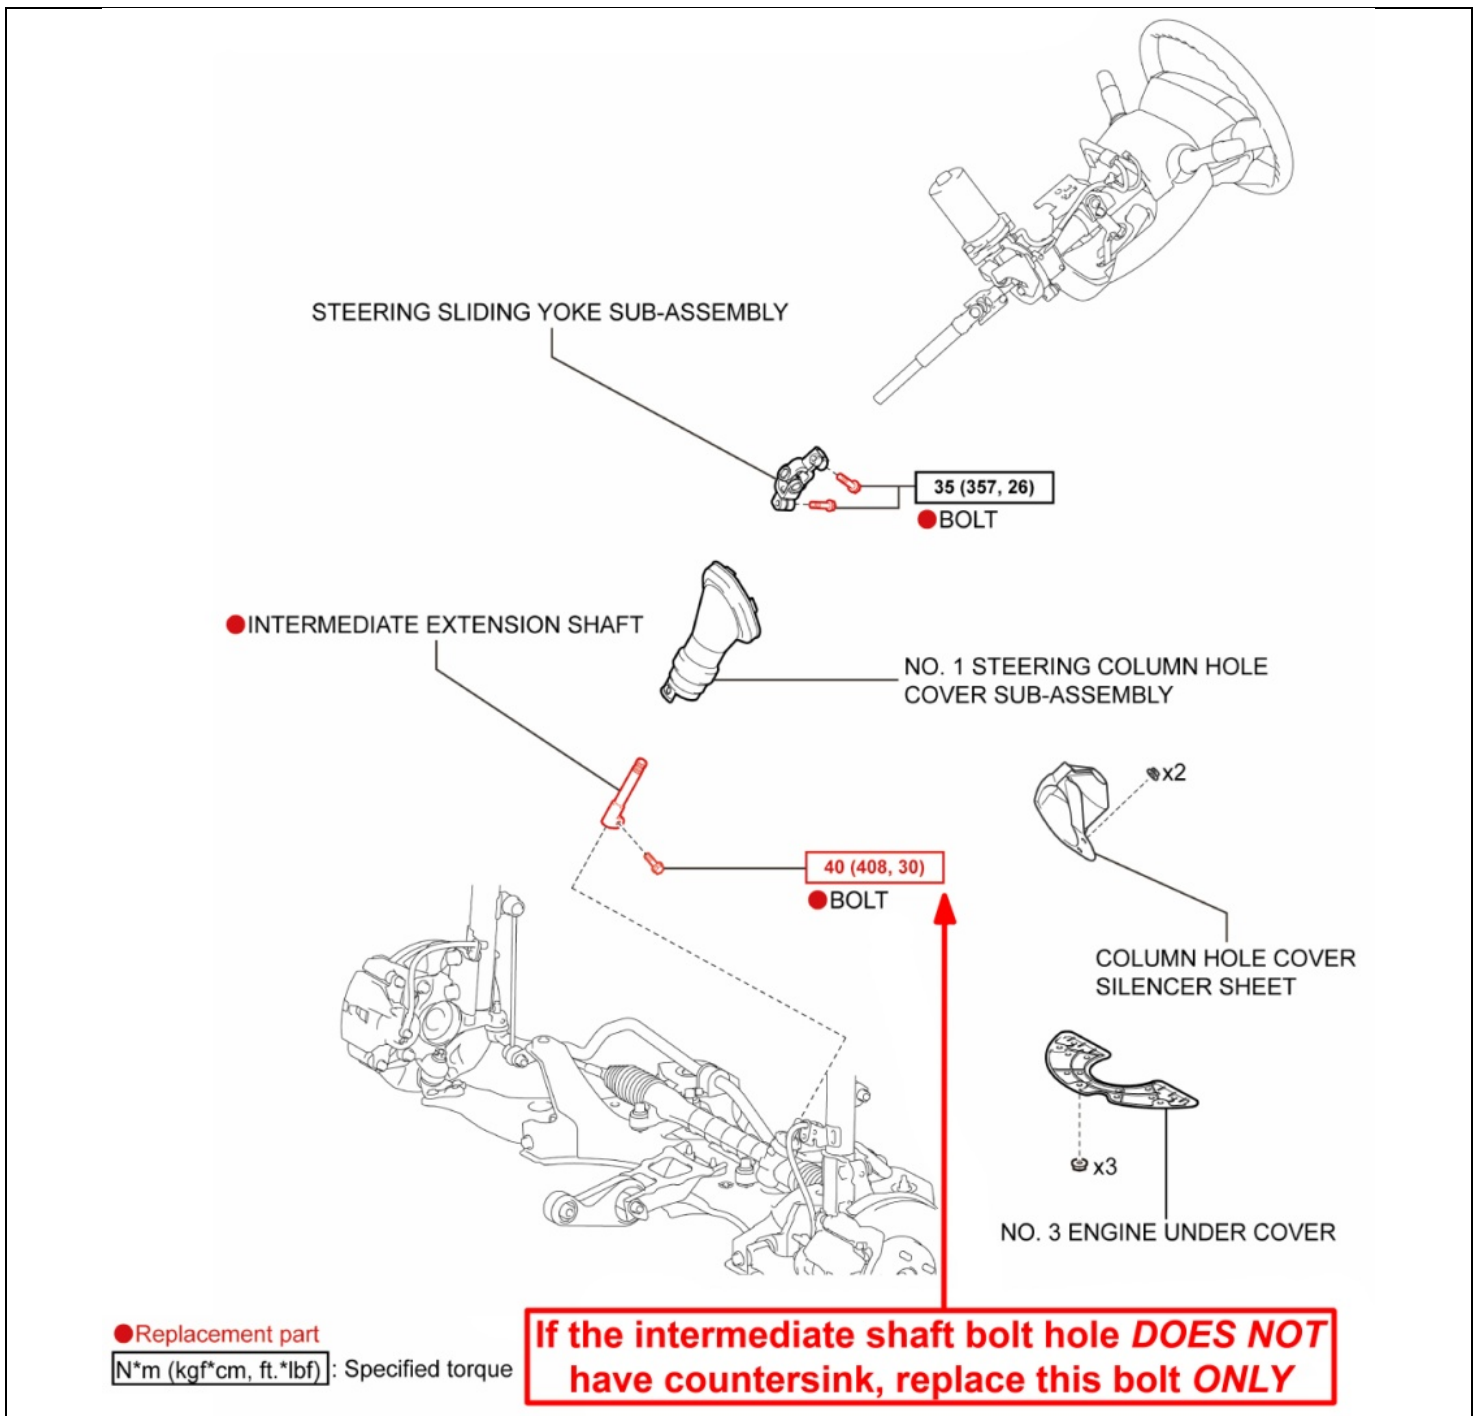
V. COMPONENTS

The steering shaft system of the subject vehicles consists of a steering intermediate shaft assembly, steering sliding yoke sub assembly, and steering intermediate extension shaft assembly. Due to insufficient hardness of the extension shaft supplied by a specific supplier, the splines which connect the extension shaft to the steering gear box may deform if the steering wheel is frequently and forcefully turned to the full-lock position while driving at a slow speed. This may create an increased backlash, and splines may eventually wear out over time, which could result in loss of steering ability.

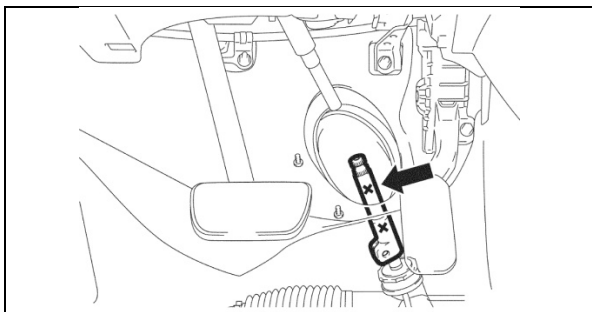
STOP The new shaft in the kit (04001-41212) is manufactured with a countersink, mark the NG shaft to confirm it is not reused.

18. REMOVE THE EXTENSION SHAFT

a) Remove the extension shaft.

b) Mark the shaft so it is not reused.
