WQE-41

February 2013

PRODUCT CAMPAIGN BULLETIN

SUBJECT: Optional Genuine Subaru Puddle Lights

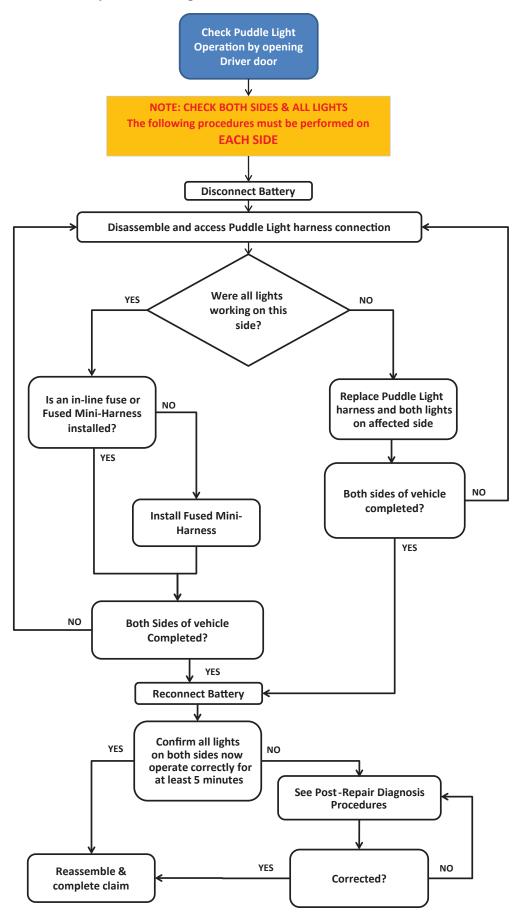
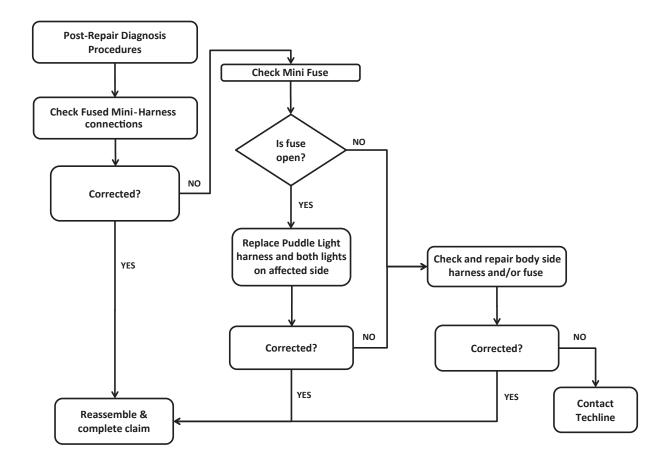
Appendix C - Summary and Post-Repair Flow Charts

- 4. After completing installation of the Fused Mini-Harness on both sides of the vehicle, reconnect the battery and confirm that all the puddle lights operate normally by leaving the driver's door open with the puddle lights on for at least 5 minutes.
 - a. If any of the lights fail to operate as designed, review all connections to ensure they are secure.
 - b. If the mini-fuse in the Fused Mini-Harness or puddle light harness has become open, replace the puddle light harness and both lights on that side of the vehicle. Refer to applicable accessory installation guide for detailed instructions for harness and light installation. NOTE: All current replacement puddle light harnesses include an in-line fuse. In this case, installation of the Fused Mini-Harness would not be required.
 - c. If not resolved, by a and / or b, see the Post-Repair Diagnostic Flow Chart in **Appendix C**.
