Re: Toyota Safety Recall 12V-373 – Dealer Re-Notification

Subject: Safety Recall CSE - *(Supplement to CLE) - Interim Notice (C3E)*  
2010 Model HS 250h Vehicles  
**REINSPECTOR REQUIRED** - Rear Lower Suspension Arm No. 1

**INTERIM TECHNICAL INSTRUCTIONS**  
**FOR**  
**SAFETY RECALL CLE INTERIM C3E**  
**REAR LOWER SUSPENSION ARM No.1**  
**CERTAIN 2010 MODEL YEAR HS250h**

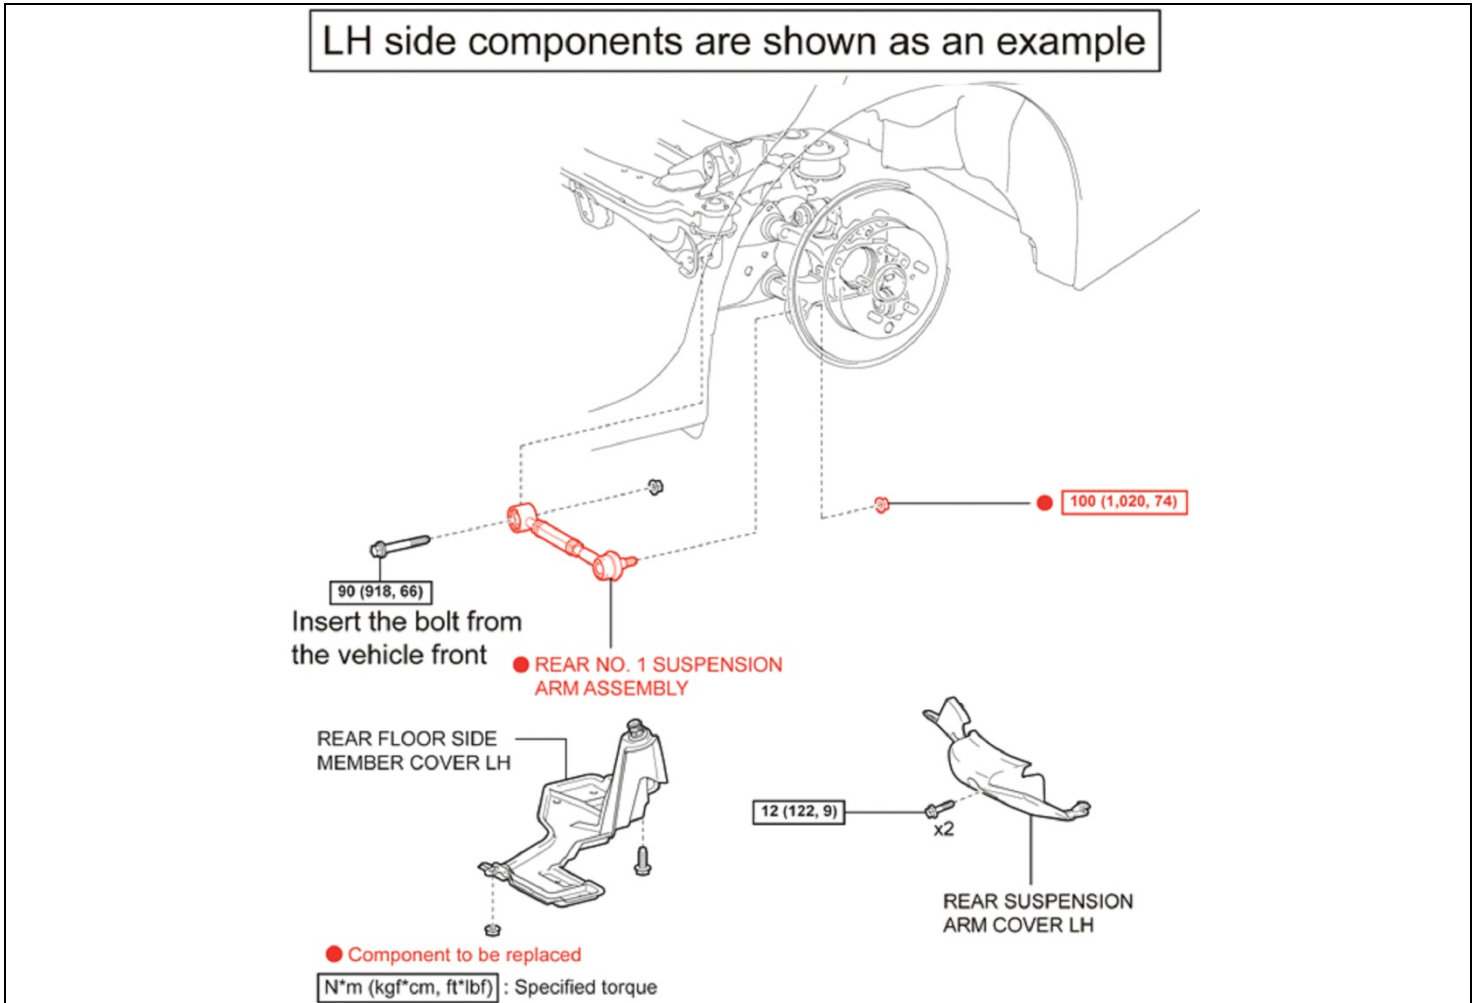
### V. COMPONENTS

Safety Recall CLE involved inspecting the right and left Rear Suspension Lower Arm No. 1 (“arm”) for looseness. Based upon this inspection, it may have been necessary to replace the arm(s).

- Replace the suspension arm(s) if:
  - Looseness is found.
  - A gap is visible between the lock nut(s) and adjusting tube.
