Recall Bulletin

PRODUCT SAFETY RECALL

SUBJECT: Supplemental Restraint System (SRS) Electronic Control Module (ECM)

MODELS: 2003-2004 Pontiac Vibe

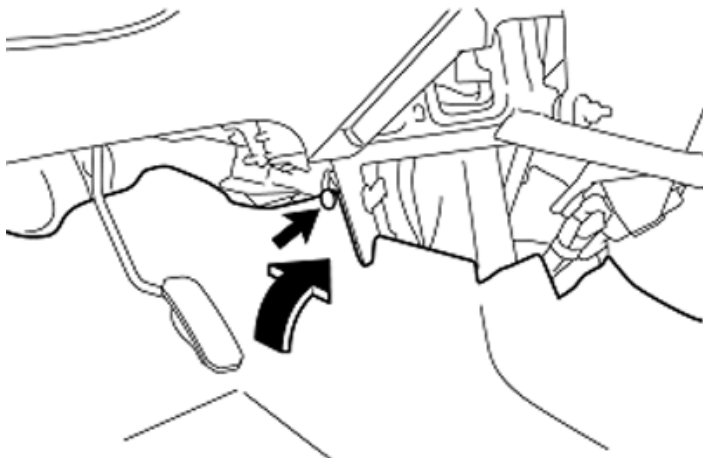
3352719

Warning: Confirm the floor carpet is secure and the clip is not damaged. Failure to secure the carpet could result in pedal interference.

18. REINSTALL THE FLOOR CARPET LH

- a) Reposition the carpet and engage the clip.
- b) Fasten the Velcro fastener.
