Re: Toyota Safety Recall 13V-030 Dealer Notification - Remedy

Subject: Safety Recall DLA - **Remedy Available**
2006 Through Early 2012 Model Year IS 250 and IS 350,
2010 Through Early 2012 Model Year IS250C and IS 350C, and
2008 Through 2011 Model Year IS-F
Front Wiper Arm Nut

SAFETY RECALL DLA

FRONT WIPER ARM NUTS

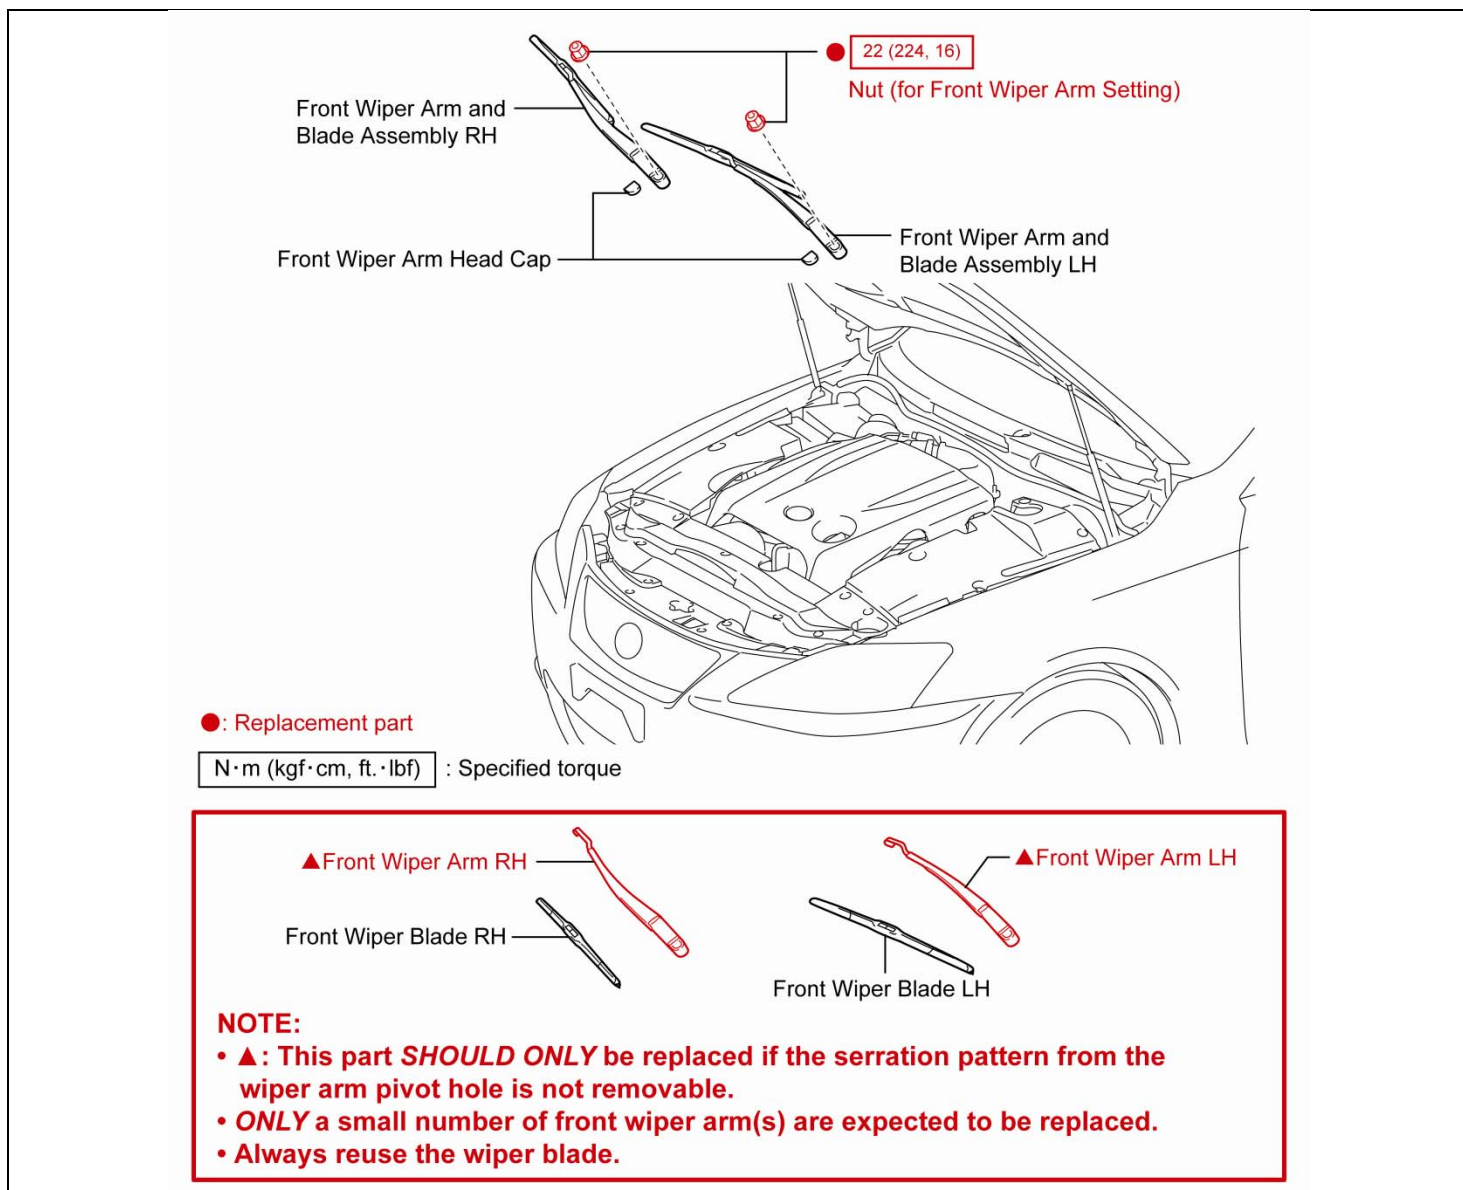
V. COMPONENTS

Each wiper arm is installed onto a pivot shaft, which is linked to the wiper motor mechanism, by an installation nut (wiper arm nut). The wiper arm nut may not have been tightened sufficiently due to high friction between the nut and the wiper arm. Under certain usage conditions, such as a buildup of heavy snow on the windshield, one or both of the wipers could become inoperative. Inoperative wiper arms could reduce driver visibility and increase the risk of a crash.
