RECALL CAMPAIGN BULLETIN

NTB13-032a

VOLUNTARY SAFETY RECALL CAMPAIGN 2013 SENTRA OCS SENSORS

CAMPAIGN ID #: PC213

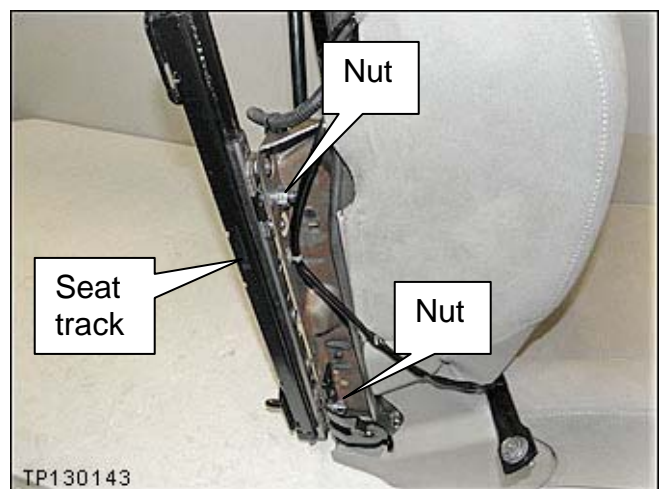
Figure 19

22. Remove the inboard seat track.

- Remove both 14 mm nuts shown in Figure 19.

NOTE: These nuts will not be reused.

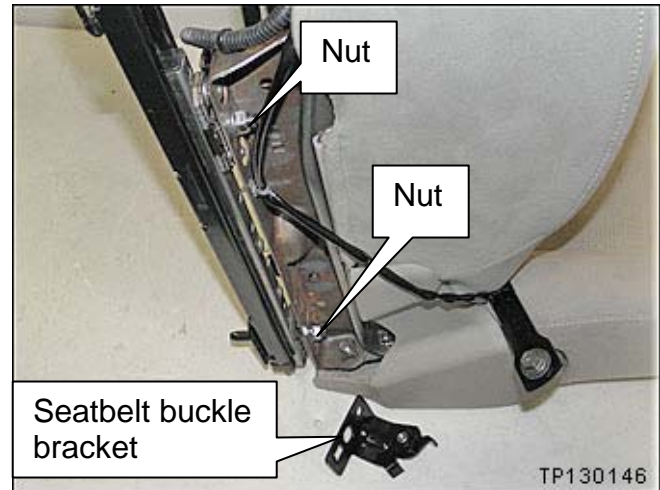
Figure 21

25. Reinstall the inboard seat track.

- **Use new 14 mm nuts.**
- Install the 14 mm nuts **finger tight only.**
- **Do not** install the seatbelt buckle bracket at this time.

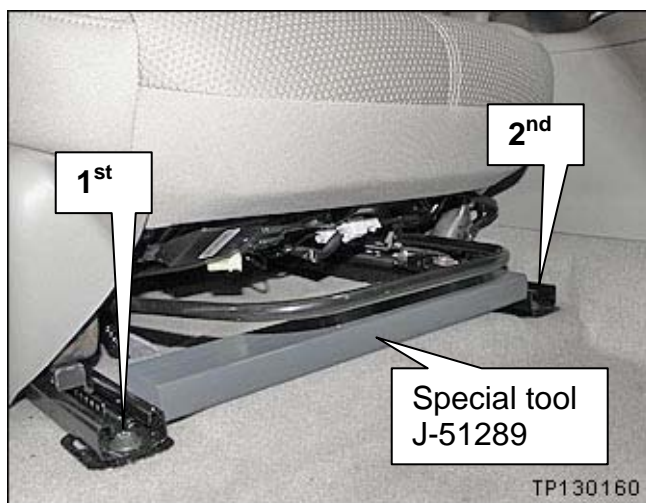
Figure 27

- d. At the front of the seat, place the Seat Track Alignment Gauge (special tool J-51289) between the seat tracks as shown.

- e. Torque the front seat track bolts.

- Torque in the order shown.
- Torque to:
40 N•m (4.1 kg-m, **30 ft-lb**)

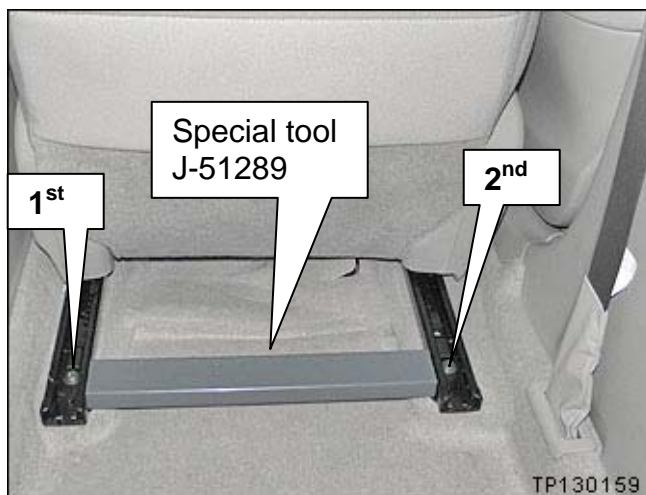
Figure 28

- g. At the rear of the seat, place the Seat Track Alignment Gauge (special tool J-51289) between the seat tracks as shown.

- h. Torque the rear seat track bolts.

- Torque in the order shown.
- Torque to:
40 N•m (4.1 kg-m, **30 ft-lb**)

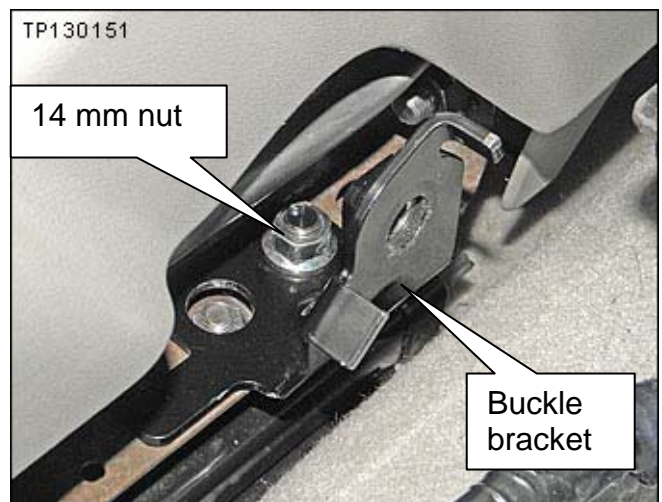
Figure 30

- The torque specification for the 14 mm nuts in steps 29 and 30 is critical.
- Make sure your torque wrench is properly calibrated.
- Make sure to torque these nuts as indicated.

- c. Use special tool J-49752 to torque the 14 mm nut.
 - Torque 14 mm nut to:
39.3 N•m (4.0 kg-m, **29 ft-lb**)*

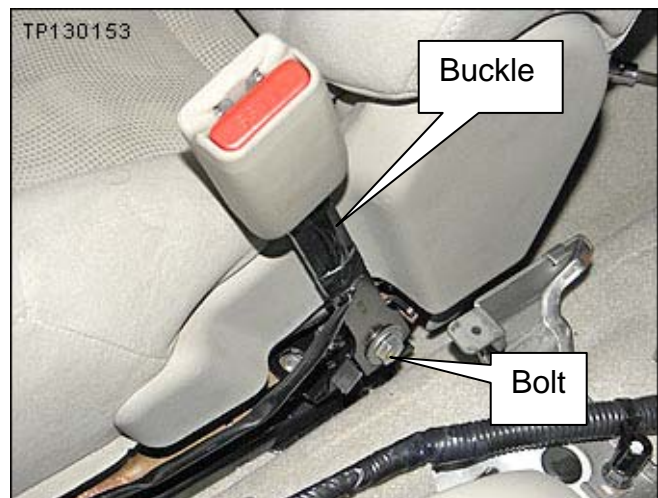
Figure 33

31. Reinstall the seatbelt buckle.

- Torque bolt to:
49 N•m (5.0 kg-m, **36 ft-lb**)

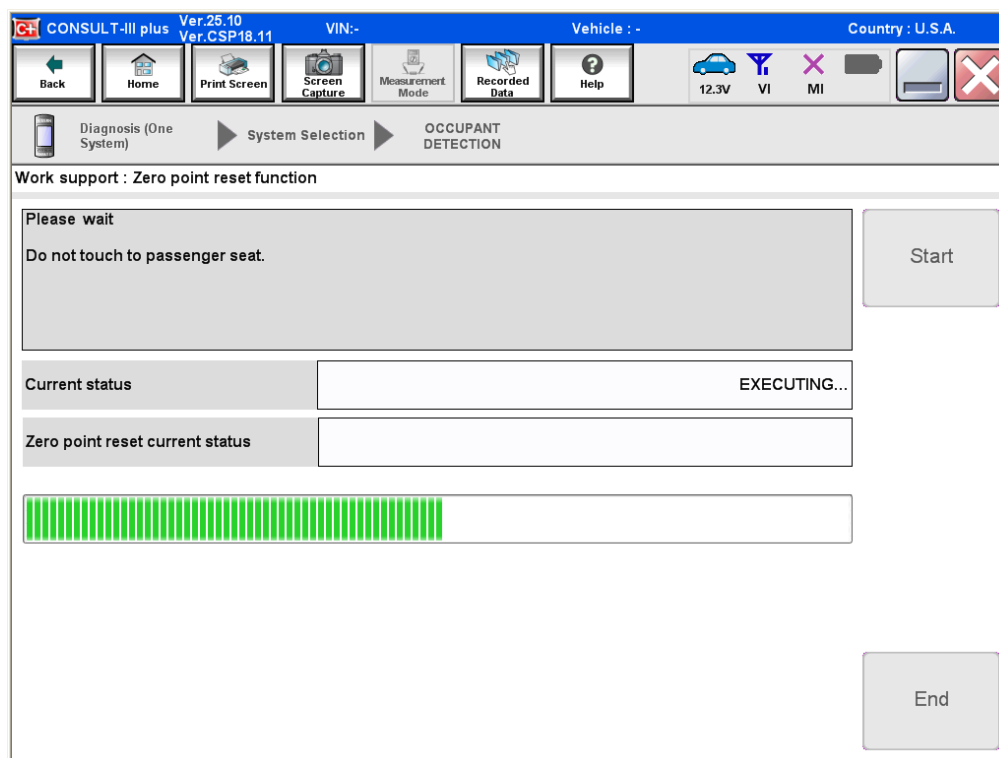
Figure Z6

13. Wait for Zero Point Function to complete.

If Zero Point Reset will not complete:

- a. Turn the ignition OFF.
- b. Make sure all electrical connectors under the seat are **securely connected**.
 - Body harness to seat harness.
 - OCS sensors
 - OCS Control Unit.
- c. Try Zero Point Rest again.
- b. If it still will not complete, an installation process or step was not followed exactly as specified.
 - Recheck / re-perform the OCS sensor installation process.
 - **Pay special attention to the 14 mm nut torque (steps 29 & 30 on pages 19 & 20).**
