# RECALL CAMPAIGN BULLETIN

NTB13-035a

## VOLUNTARY SAFETY RECALL CAMPAIGN 2013 PATHFINDER OCS SENSORS

**APPLIED VEHICLES:** 2013 Pathfinder (R52)

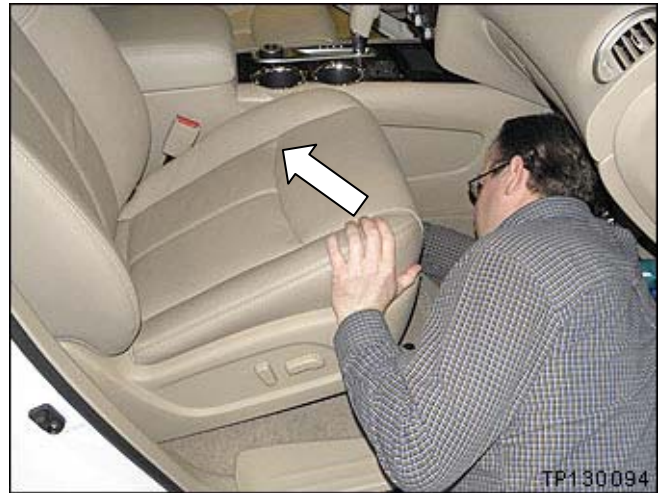
Figure 14

10. Check the lot code on the front OCS sensor as follows.

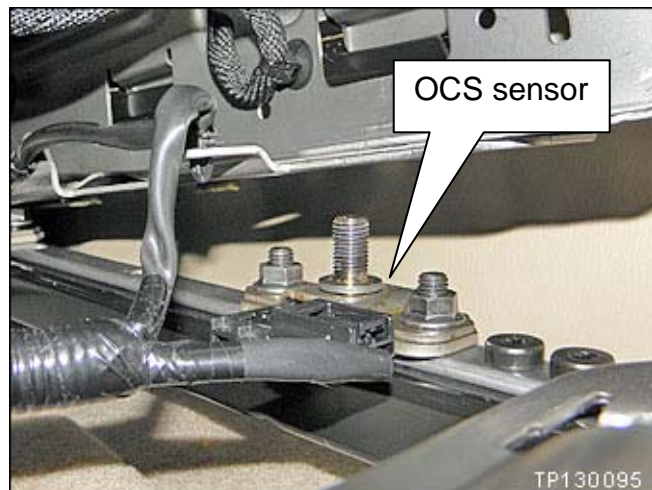
Figure 15

d. Check the lot code.

**NG: Lot code is in this range - 2472 to 3102; replace the sensor**

- If the first four digits of the lot code are 2472 to 3102, replace the sensor.

**OK: Lot code is not in the above range - reinstall the original sensor.**

- If the first four digits of the lot code are not in the range above, reinstall the original sensor.

11. Install the front OCS sensor (new or original).

a. **Use new 12 mm nuts.**

- Torque nuts to:  
22 N•m (3.04 kg-m, **16 ft-lb**)

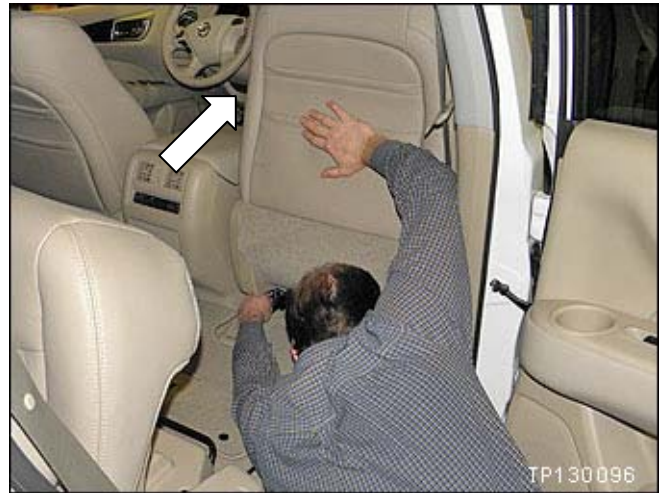
Figure 18

12. Check the lot code on the rear OCS sensor as follows.

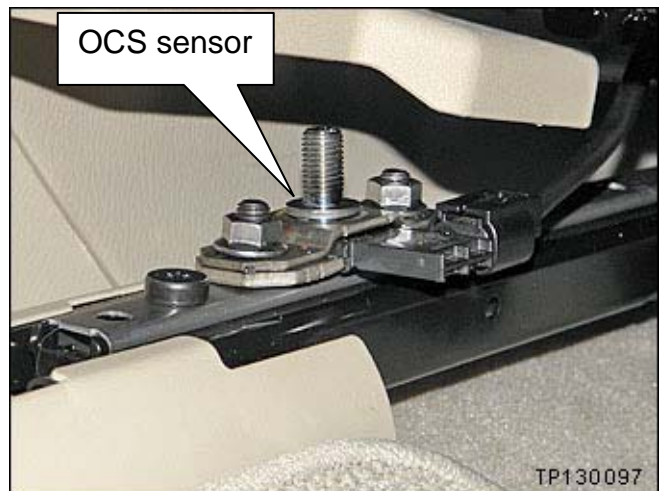
Figure 19

d. Check the lot code.

**NG: Lot code is in this range - 2472 to 3102; replace the sensor**

- If the first four digits of the lot code are 2472 to 3102, replace the sensor.

**OK: Lot code is not in the above range - reinstall the original sensor.**

- If the first four digits of the lot code are not in the range above, reinstall the original sensor.

13. Install the rear OCS sensor (new or original).

**a. Use new 12 mm nuts.**

- Torque nuts to:  
22 N•m (3.04 kg-m, **16 ft-lb**)
