TMS-NTC-13112
May 13, 2013

Re: Toyota Safety Recall 13V-098 – Dealer Notification Remedy

Subject: Safety Recall – **Remedy Available**
2007 through Late 2013 Model Year FJ Cruiser Vehicles
Access Door Inner Panel

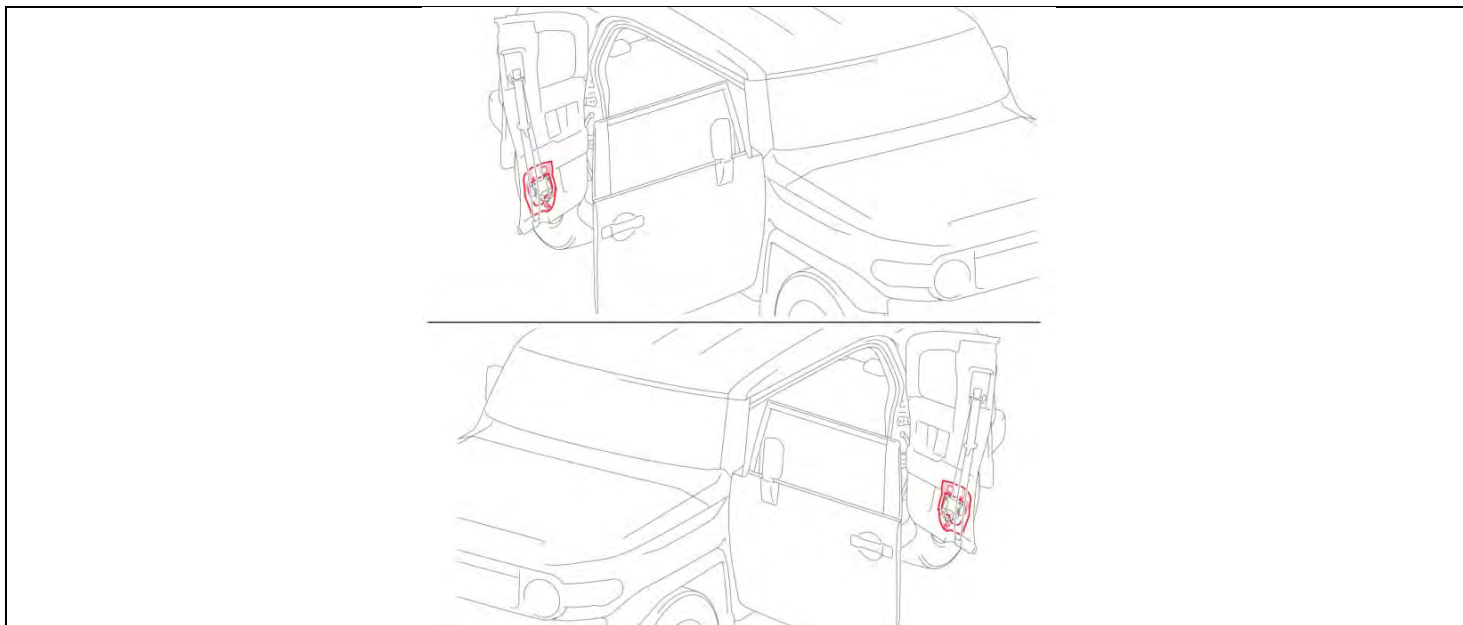
The retractors for the front driver and passenger seat belts are mounted in the access door panels of the vehicle. Due to insufficient strength of the access door panel, cracks may develop in the panel if the access door is repeatedly and forcefully closed over an extended period of time. If cracks occur in the panel around the lower retractor anchor, the seat belt retractor could become detached, which could increase the risk of injury to an occupant in the event of a crash.

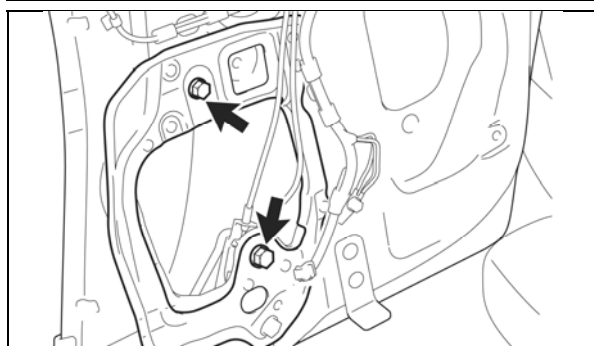
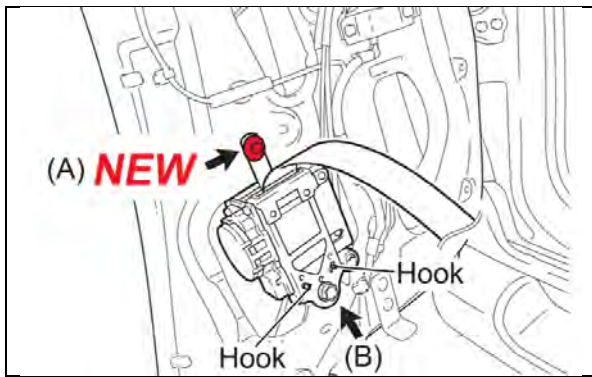
If the seat belt was identified as requiring replacement during the inspection steps, a new seatbelt **MUST** be installed at this time.

- a) Remove the 2 bolts and discard the upper bolt, a new upper bolt is provided in the kit.

- b) Position the seatbelt so that the hooks on the door panel engage with the holes on the seatbelt bracket and loosely install the bolts.
- c) Torque **NEW** bolt A.
Torque: 75in. lbf (8.5N-m)
- d) Torque bolt B.
Torque: 31ft. lbf (42N-m)
