TMS-NTC-13178 July 23, 2013

Re: Toyota Safety Recall 13V-235 Dealer Notification - Remedy

Subject: Safety Recall DLD - Remedy Available Certain 2010 Model Year HS 250h Vehicles Brake Booster Pump Assembly (Accumulator)

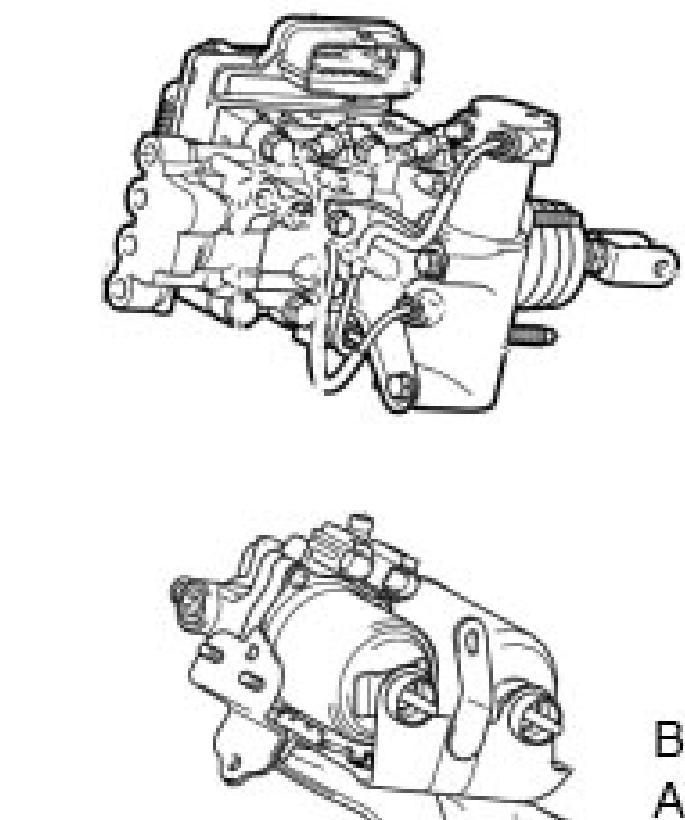
C1246 and/or C1256 was found during DTC inspection step.

The accumulator may have potentially leaked nitrogen gas into the brake booster assembly; therefore, the. Brake booster assembly must also be replaced.

C1246 AND C1256 WERE NOT found during DTC inspection step.

Replace the brake booster assembly as per the repair manual when replacing the accumulator. Proceed to **SECTION IX.**

ONLY accumulator replacement is required. Proceed to **SECTION IX.**
