TMS-NTC-14024
February 26, 2014

Re: Toyota Safety Recall 13V-442 Preliminary Dealer Notification Letter

Safety Recall D0T (D1T) *Preliminary Notification*
Certain 2012 – 2013 Model Year Avalon, Camry, Camry Hybrid, Venza, and
Certain 2013 Model Year Avalon Hybrid
HVAC Assembly

**TECHNICAL INSTRUCTIONS
FOR
SAFETY RECALL D0T
HVAC ASSEMBLY
CERTAIN 2012 – 2013 MODEL YEAR CAMRY & CAMRY HYBRID**

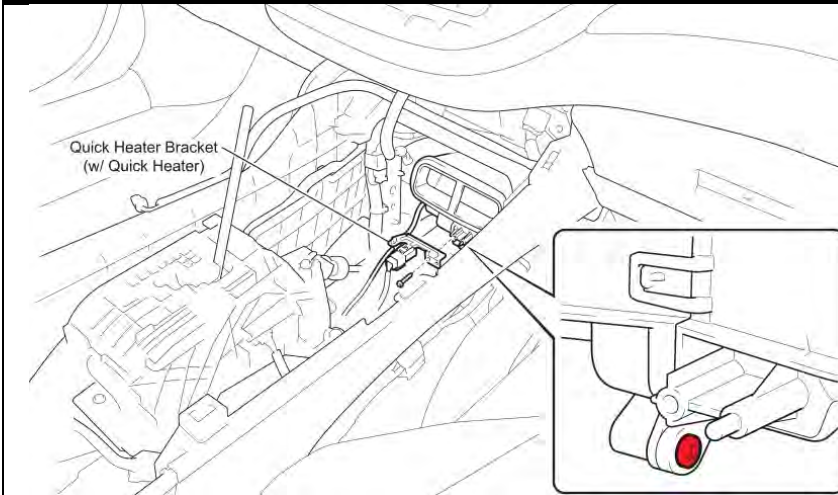
WITH SCREW DESIGN

This is the **OLD** case design. **Additional inspection is required. Proceed to STEP 3.**

This is the **NEW** case design. No further action required. Campaign Complete.

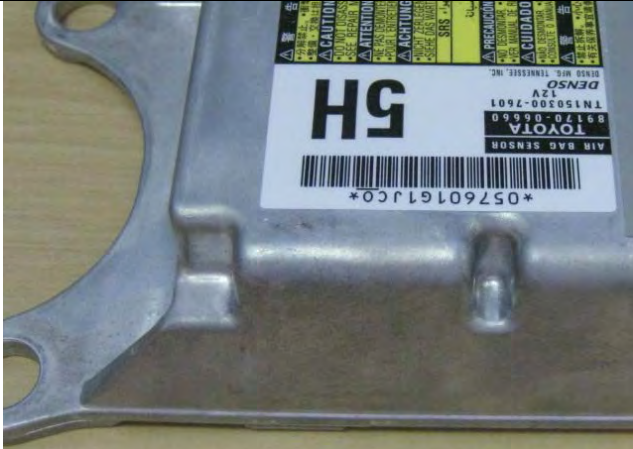
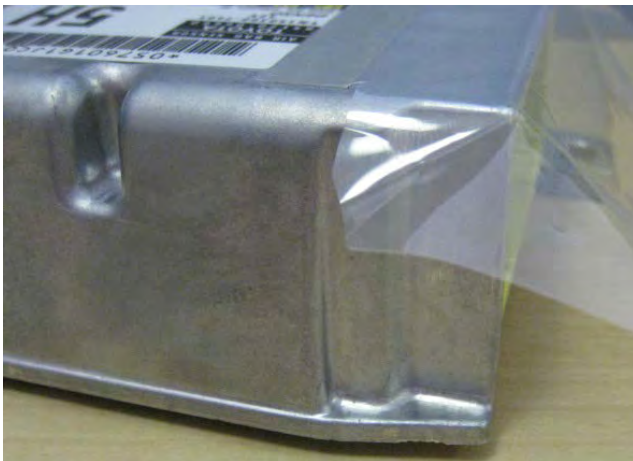
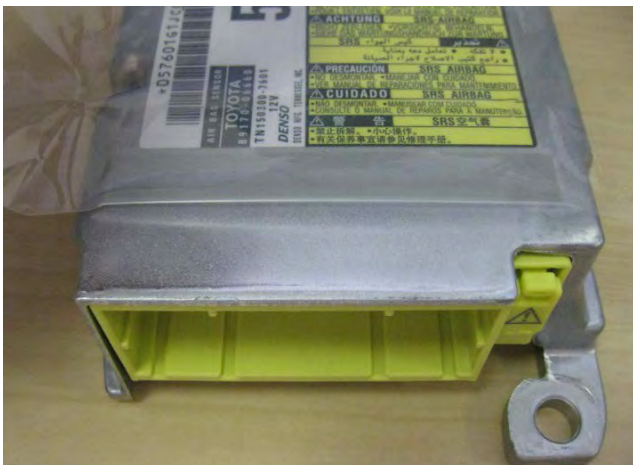
NO WETNESS FOUND

9. CHECK FOR EVIDENCE OF WETNESS ON THE CENTER AIRBAG SENSOR ASSEMBLY

- a) If not yet removed, remove the 3 bolts and the center airbag sensor assembly.
- b) Inspect visually for any water stains **ON** the center airbag sensor assembly.

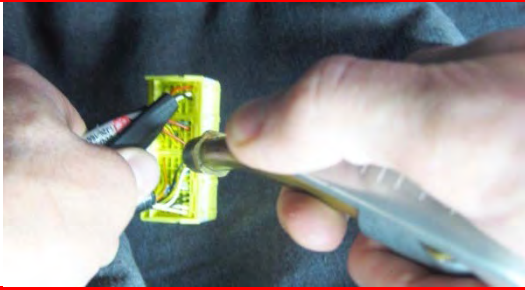
ONLY PERFORM THIS STEP IF WETNESS WAS FOUND ON THE CONNECTOR DURING THE INSPECTION ON THE PREVIOUS PAGE

1. USE COMPRESSED AIR TO DRY THE CONNECTOR

- Lightly blow compressed air **FROM THE BACK SIDE** of the connector to dry the connector.

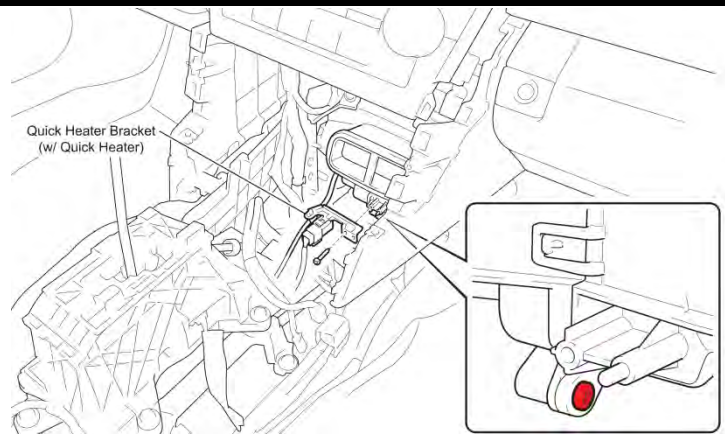
WITH SCREW DESIGN

This is the **OLD** case design. Additional inspection is required. Proceed to STEP 3.

This is the **NEW** case design. No further action required. Campaign Complete.

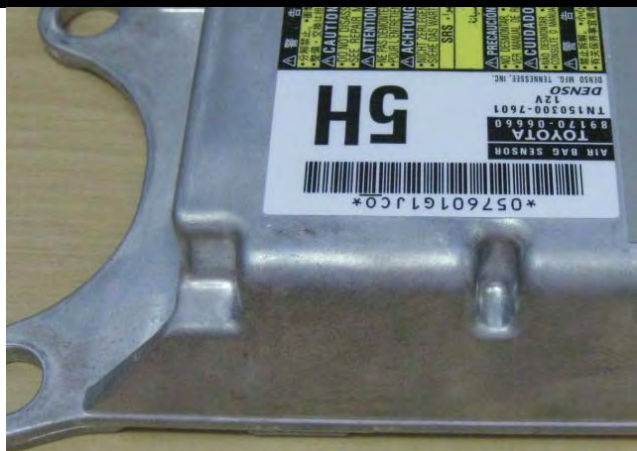
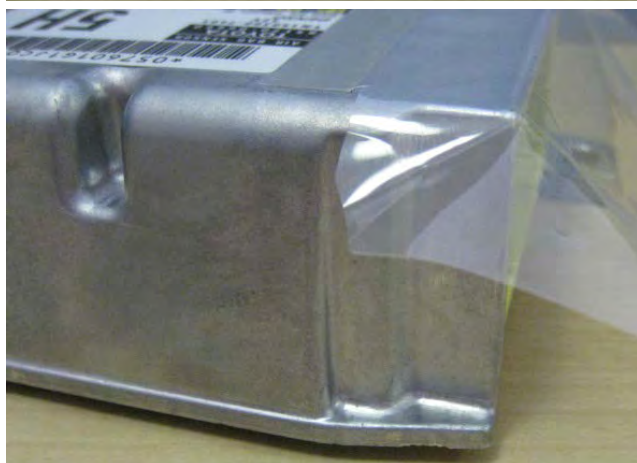
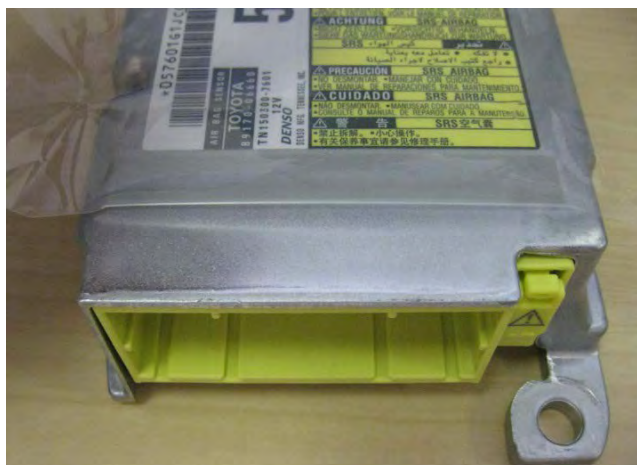
NO WETNESS FOUND

- a) If not yet removed, remove the 3 bolts and the center airbag sensor assembly.
- b) Inspect visually for any water stains **ON** the center airbag sensor assembly.

The center airbag sensor assembly **DOES NOT** require replacement. Proceed to **SECTION VI.** for instructions on seal tray installation.

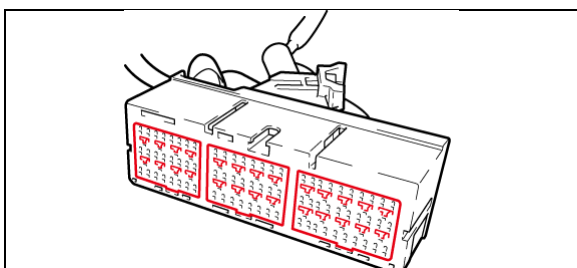
1. INSPECT THE TERMINALS OF THE CENTER AIRBAG ASSEMBLY HARNESS CONNECTOR

- Inspect the terminals for corrosion.
- Inspect the terminals for wetness.

CONDITION 1	ACTION REQUIRED
NO corrosion AND NO wetness found	The harness(s) DOES NOT require replacement. Proceed to SECTION VII. STEP 2-8 for center airbag sensor assembly replacement and vehicle reassembly.
CONDITION 2	ACTION REQUIRED
ONLY wetness found	The center airbag sensor must be replaced and the harness connector(s) must be dried, the harness(s) DO NOT require replacement. Proceed to SECTION VII. STEP 1-8 for connector drying procedure.
CONDITION 3	ACTION REQUIRED
Corrosion found	The harness(s) with corrosion MUST be replaced. Refer the SECTION IX. for additional information on harness replacement. The center airbag sensor must also be replaced, refer to SECTION VII. for center airbag sensor assembly replacement and vehicle reassembly.

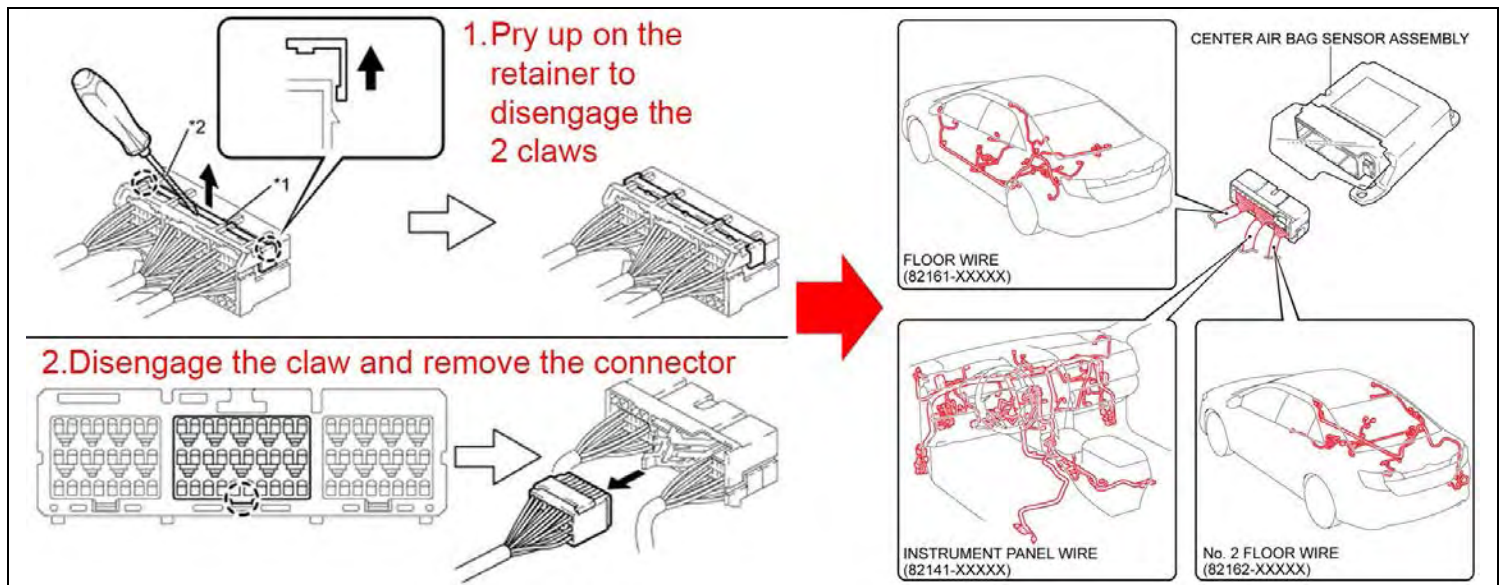
1. REPLACE THE HARNESS(S) WITH CORRODED TERMINALS

IF NO CORROSION IS FOUND ON THE TERMINALS, THE HARNESS DOES NOT REQUIRE REPLACEMENT

- Remove the affected harness(s) from the main center airbag sensor assembly connector.
- Replace the harness, refer to TIS for additional details.

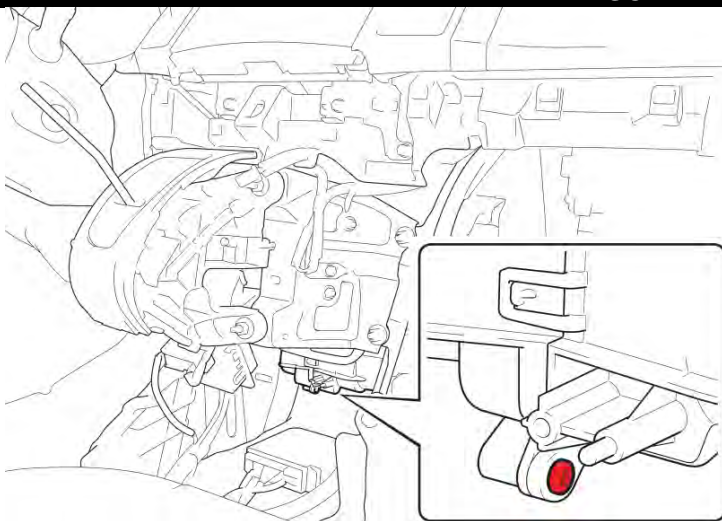
WITH SCREW DESIGN

This is the **NEW** case design. No further action required. Campaign Complete.

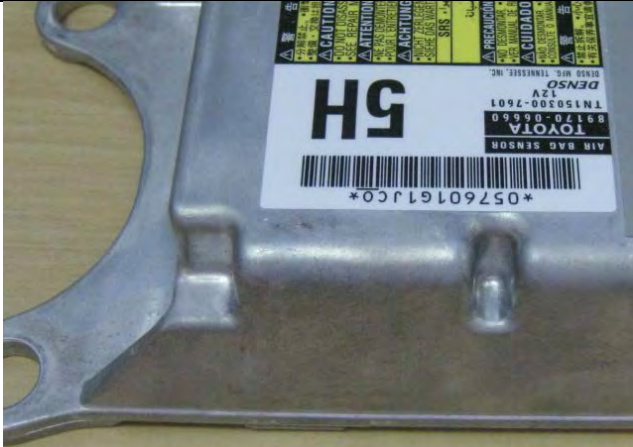
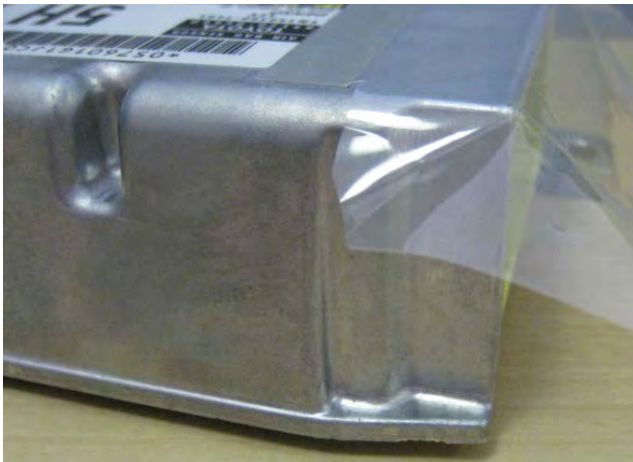
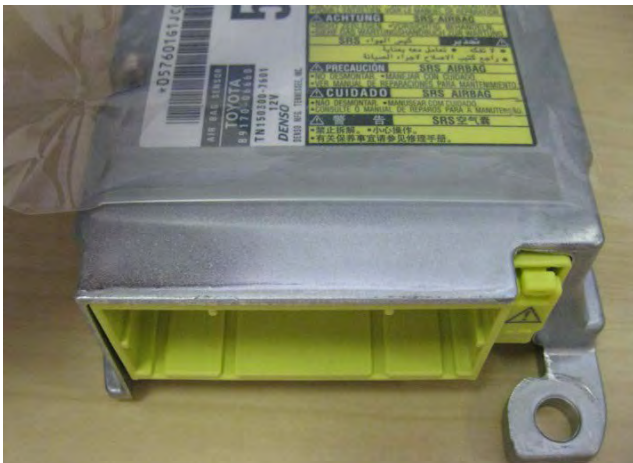
NO WETNESS FOUND

- a) If not yet removed, remove the 3 bolts and the center airbag sensor assembly.
- b) Inspect visually for any water stains **ON** the center airbag sensor assembly.

The center airbag sensor assembly **DOES NOT** require replacement. Proceed to **SECTION VI.** for instructions on seal tray installation.

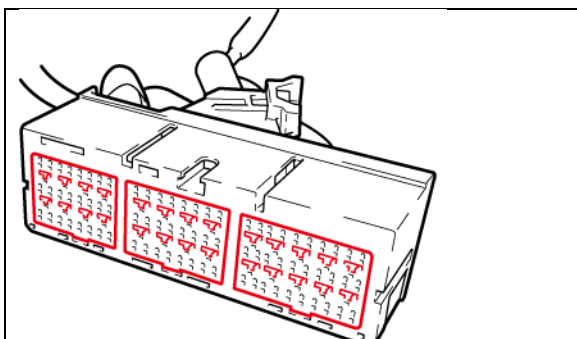
1. INSPECT THE TERMINALS OF THE CENTER AIRBAG ASSEMBLY HARNESS CONNECTOR

- Inspect the terminals for corrosion.
- Inspect the terminals for wetness.

CONDITION 1	ACTION REQUIRED
NO corrosion AND NO wetness found	The harness(s) DOES NOT require replacement. Proceed to SECTION VII. STEP 2-8 for center airbag sensor assembly replacement and vehicle reassembly.
CONDITION 2	ACTION REQUIRED
ONLY wetness found	The center airbag sensor must be replaced and the harness connector(s) must be dried, the harness(s) DO NOT require replacement. Proceed to SECTION VII. STEP 1-8 for connector drying procedure.
CONDITION 3	ACTION REQUIRED
Corrosion found	The harness(s) with corrosion MUST be replaced. Refer the SECTION IX. for additional information on harness replacement. The center airbag sensor must also be replaced, refer to SECTION VII. for center airbag sensor assembly replacement and vehicle reassembly.

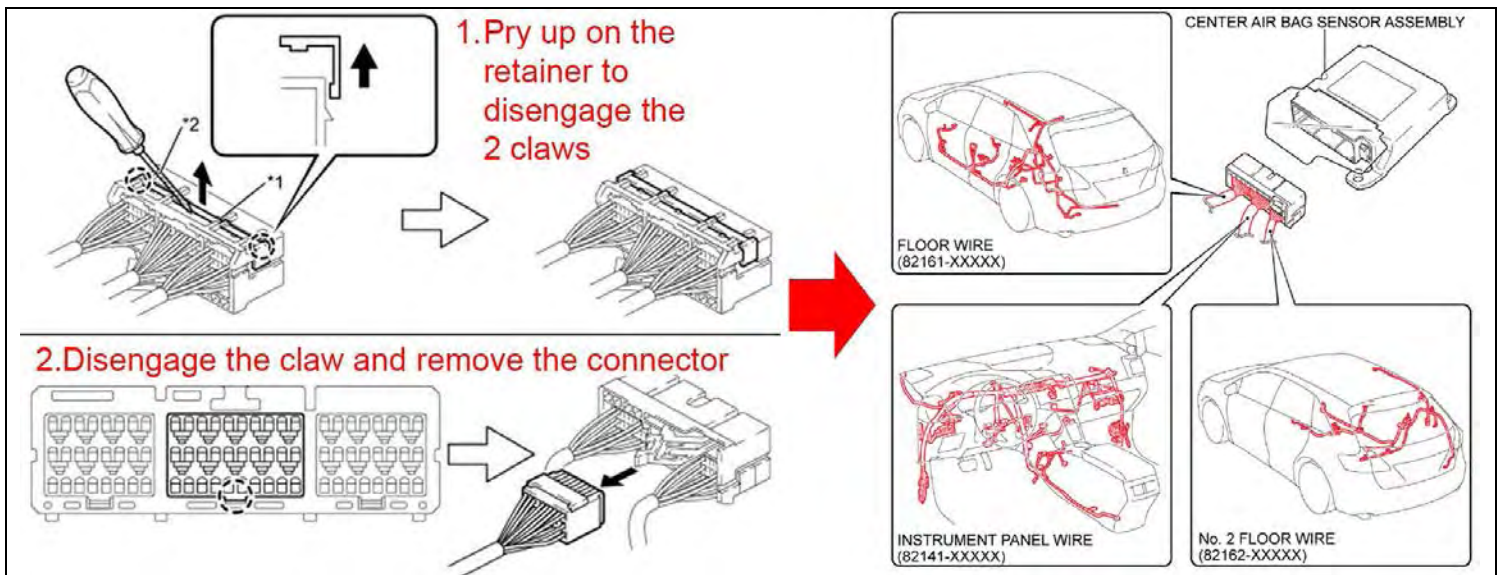
1. REPLACE THE HARNESS(S) WITH CORRODED TERMINAL

IF NO CORROSION IS FOUND ON THE TERMINALS, THE HARNESS DOES NOT REQUIRE REPLACEMENT

- Remove the affected harness(s) from the main center airbag sensor assembly connector.
- Replace the harness, refer to TIS for additional details.
