September 22, 2014

SUBJECT: STOP SALE / DEMONSTRATION / DELIVERY HOLD

Safety Recall 13S12 – Supplement #3

All 2013 Model Year Escape Vehicles Equipped with a 1.6L Engine
Risk of Localized Overheating of the Engine Cylinder Head that May Lead to Oil Leak
Fires

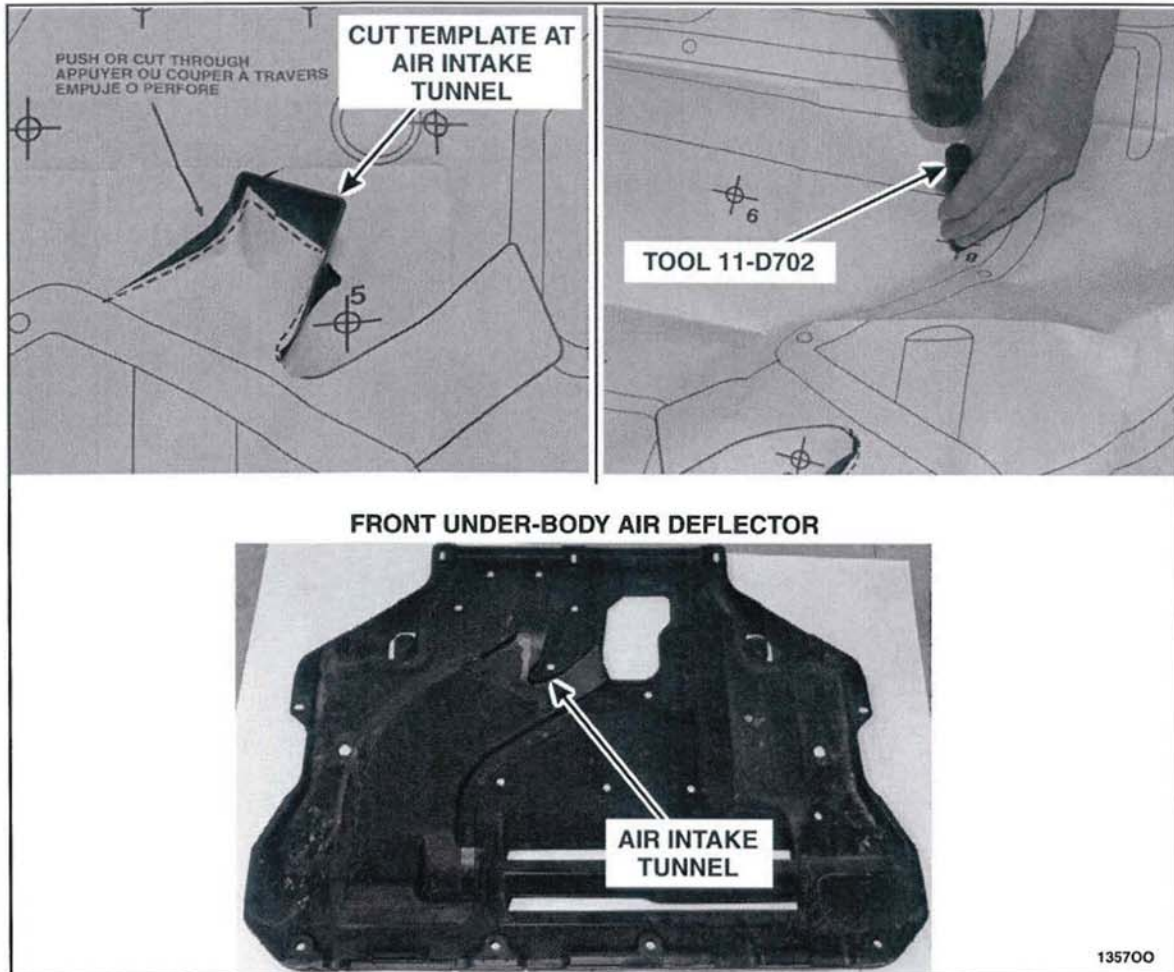
FIGURE K1

OVERVIEW: Holes are punched in the forward Under Body Air Deflector so that any fluid leaks that could occur would not be trapped on the top of the panel which could pose a risk for fire.

1. Place hole punch template included in the kit over the engine side of the front under-body air deflector. Align the two mounting holes identified on the template with the two corresponding holes on the air deflector. See Figure K1.

2. Cut or push through the area indicated on the template that aligns with the air intake tunnel, near punch location number 5, to allow the template to lay flat on the air deflector. See Figure K1.
3. Position a piece of scrap lumber below the area to be punched. Using a hammer and Hollow Material Punch (Tool 100-D702) provided in the dealer kit, punch out the 11 hole locations identified on the template. See Figure K1.
4. Set the front under-body air deflector aside for installation later.

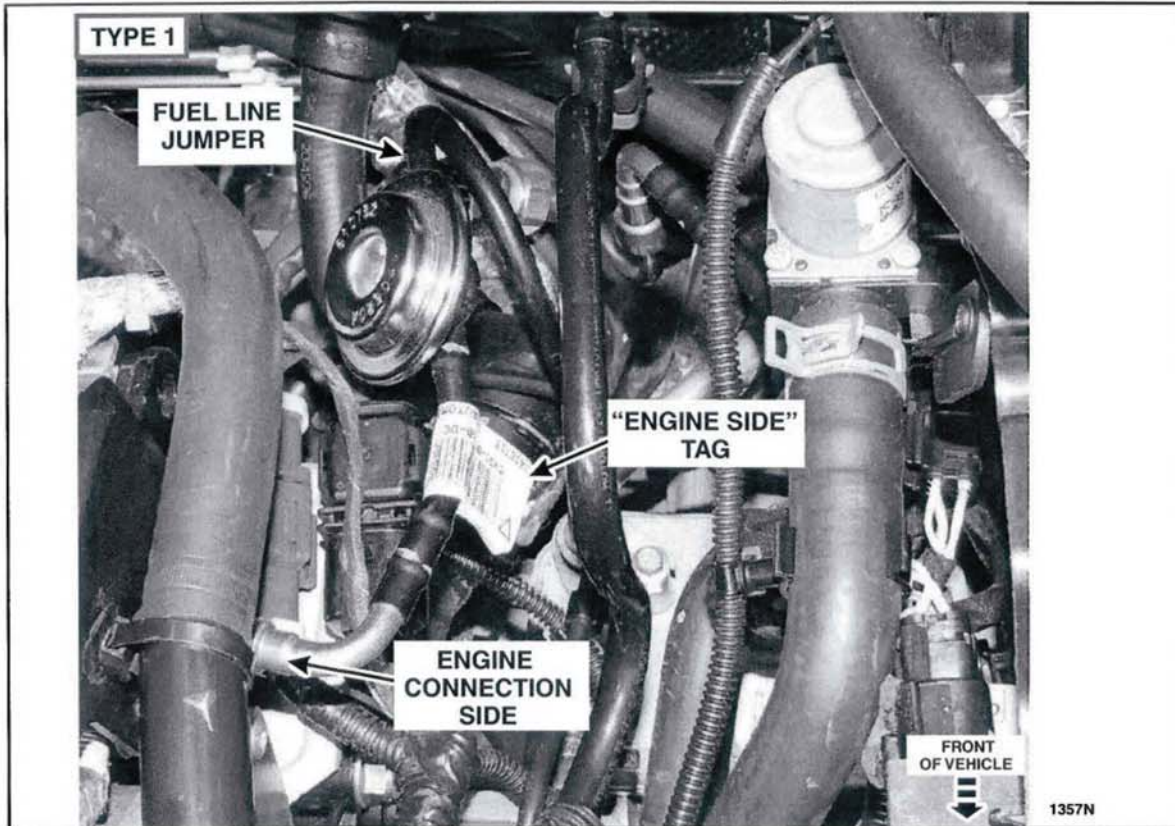
FIGURE 2

For all three of these line types, the correct installation is with the white "ENGINE SIDE" tag on the line closest to the engine connection side. See Figure 2, 3, and 4, for examples of correct installations.

- If the fuel line jumper **is** installed as shown, with the "ENGINE SIDE" tag located closest to the engine (front of vehicle), no further action is required. Reassemble the vehicle by reversing the removal procedure.
- If the fuel line jumper **is not** installed as shown, with the white "ENGINE SIDE" tag located closest to the engine (front of vehicle), proceed to "Fuel Line Jumper Replacement".

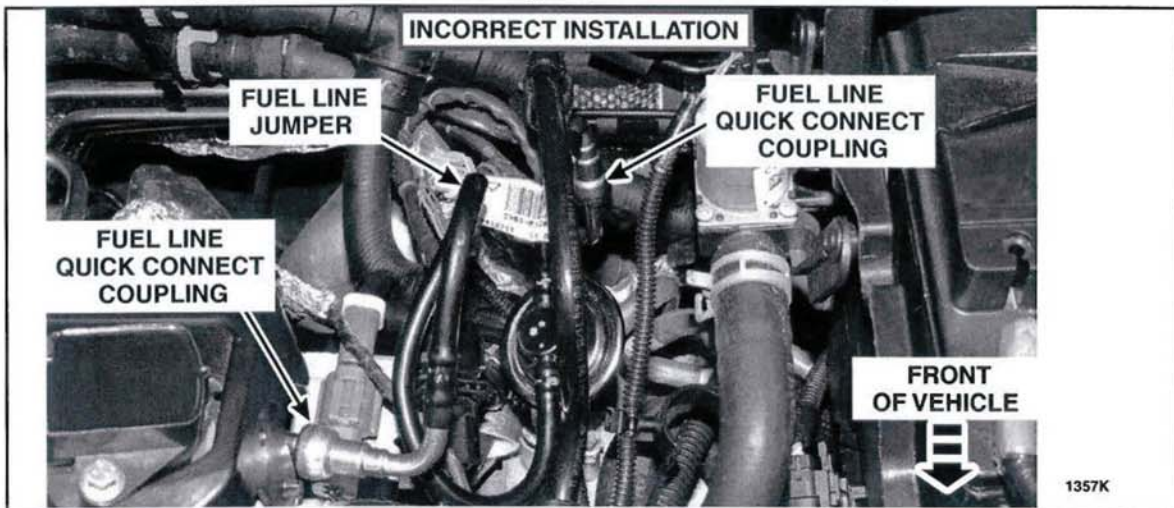
FIGURE 8

NOTE: The fuel line jumper shown is installed in the **incorrect orientation** with the "ENGINE SIDE" tag **not** located closest to the engine (further from front of vehicle).

8. Remove and discard the fuel line jumper. See Figure 8.

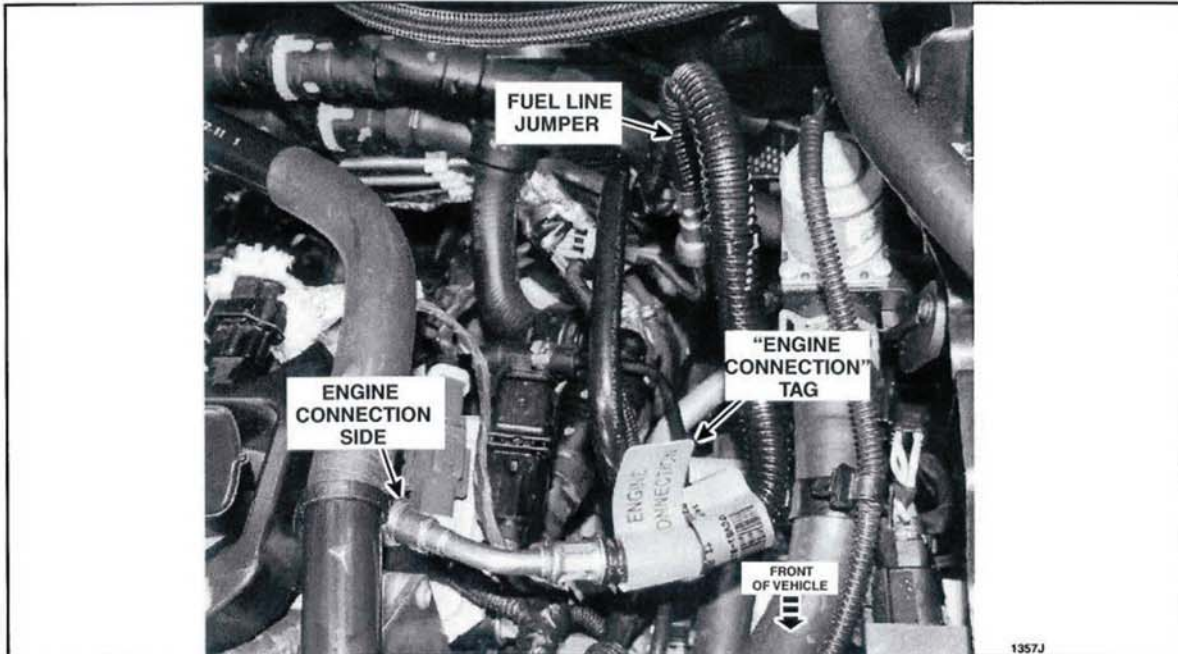
FIGURE 9

NOTE: Once the fuel line jumper is installed, the yellow "ENGINE CONNECTION" tag should be positioned closest to the engine (front of vehicle). See Figure 9.

- Be sure that the yellow "ENGINE CONNECTION" tag is positioned closest to the engine (front of vehicle) before attachment. See Figure 9.
- Connect the engine side of the fuel line jumper first.
- Push the fuel line jumper connectors onto the lines. Listen for a click, then pull on the connectors to verify proper attachment.
- After installation is complete, carry out a Key ON Engine OFF (KOEO) visual inspection for fuel leaks.
