**TO:** All Dealer Principals, Service Managers and Parts Managers

**Subject:** 2100 Plus Muncie CS10 & CS11 PTOs

**Number: SB 265B DATE: 12/04/2013**

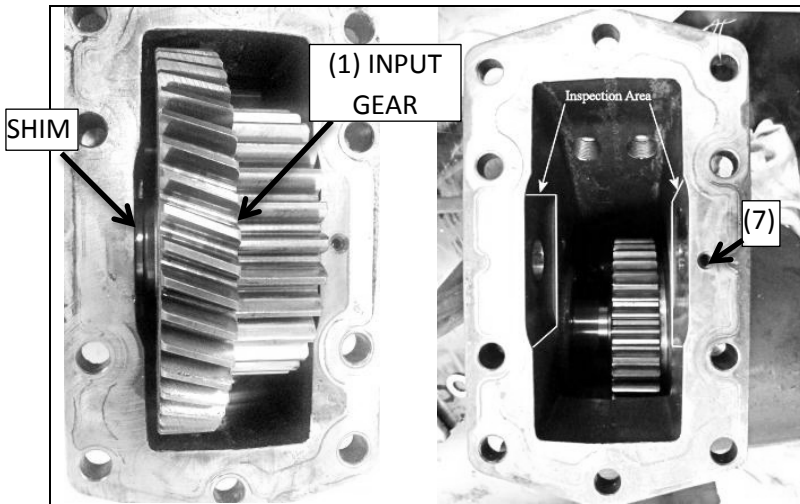
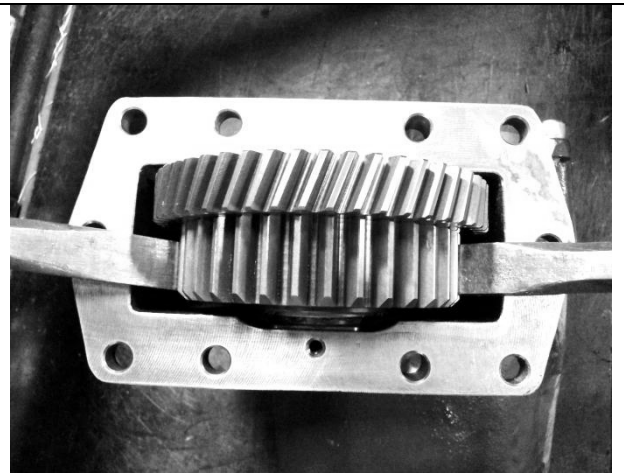
- A. Make a note of the position of the input gear within the housing and the bearing shim next to the gear. Remove the CS10/11 input gear (1) by removing the set screw (7) in the mounting pad and driving the idler shaft (4) from the housing.

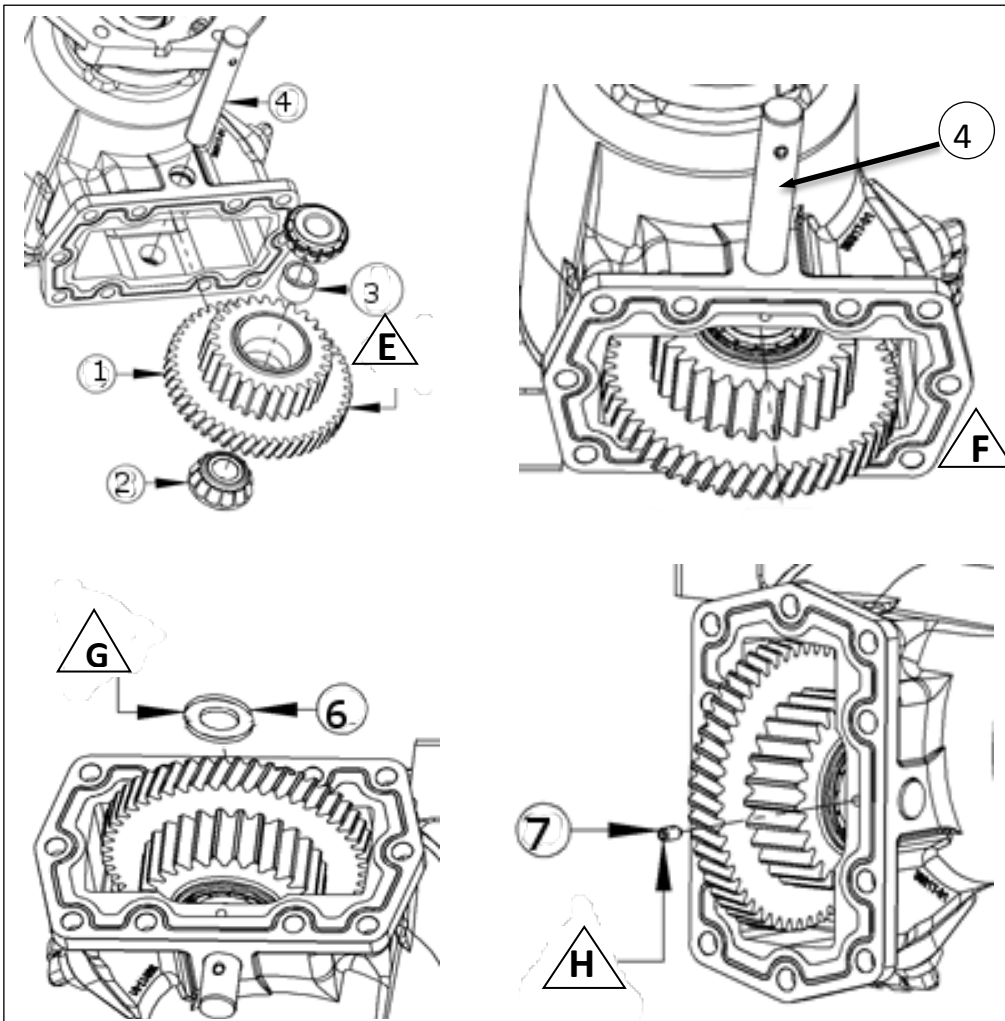
- B. Pry the input gear gently from housing using two pry bars.

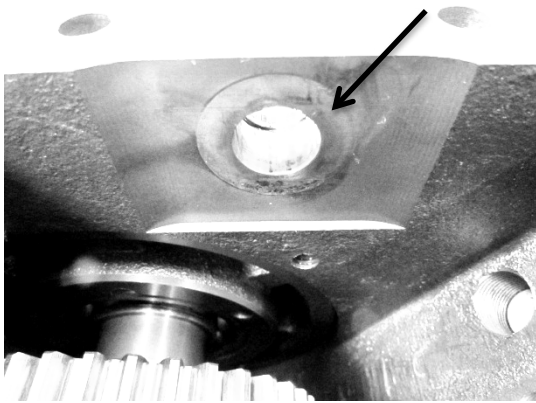
Inspection of the Housing. The area around the idler shaft shows little to no wear. This is an example of no wear.

If the Area around idler shafts shows wear, then the unit needs replacing.
