SIB 65 15 13

## Recall Campaign 13V-172: Passenger Front Air Bag Module

This Service Information Bulletin (Revision 8) replaces SI B65 15 13 **dated July 2020**.

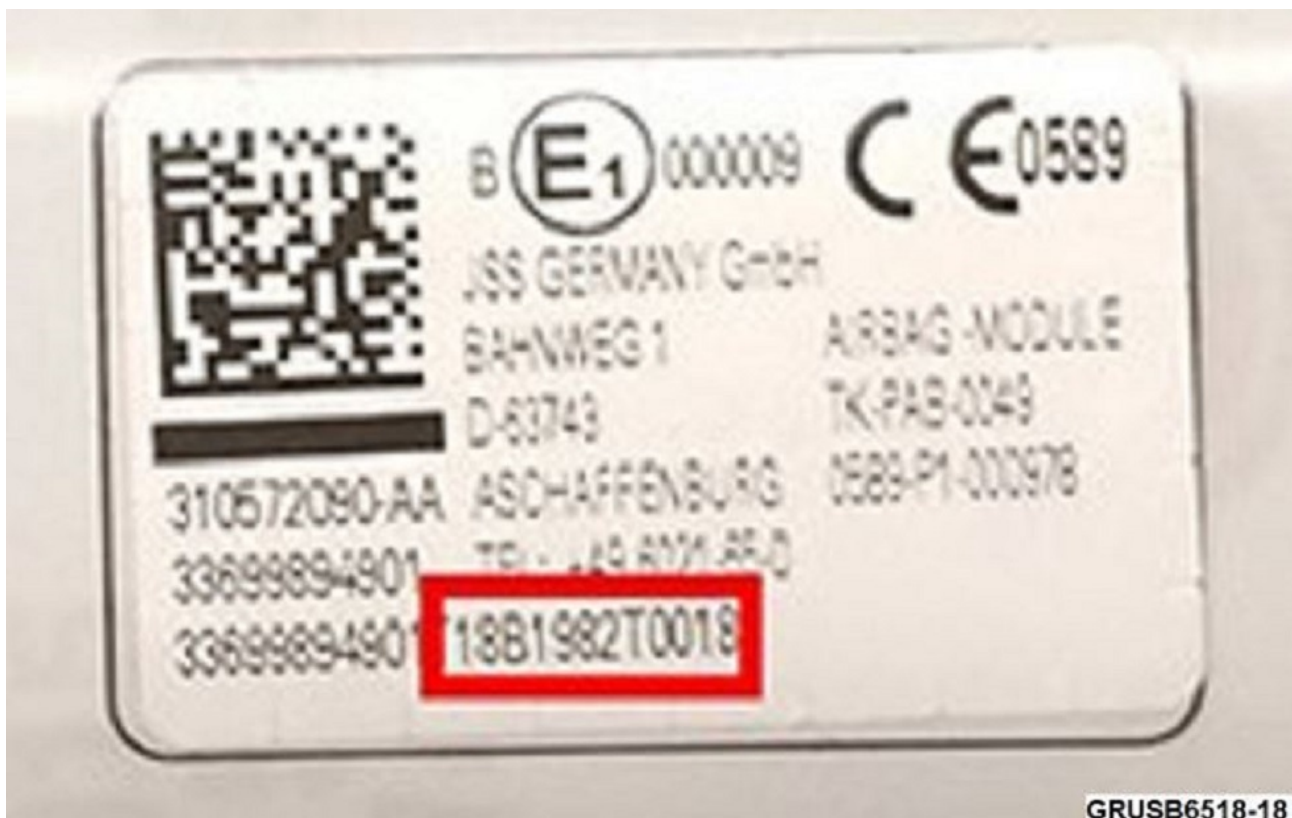
- The only parts allowed to be installed in this repair are the part numbers supplied in the PARTS INFORMATION section. Warranty will not pay for any other part numbers used.
- **The replacement air bag module's serial number (red circled below) must be documented on the repair order so it can also be entered into the claim's comment section.**

See Repair Instructions REP 72 12 000, "Remove and refit/replace the air bag unit" or follow the attached repair procedure.
