SIB 65 15 13

## Recall Campaign 13V-172: Passenger Front Air Bag Module

This Service Information Bulletin (Revision 9) replaces SI B65 15 13 **dated May 2025**

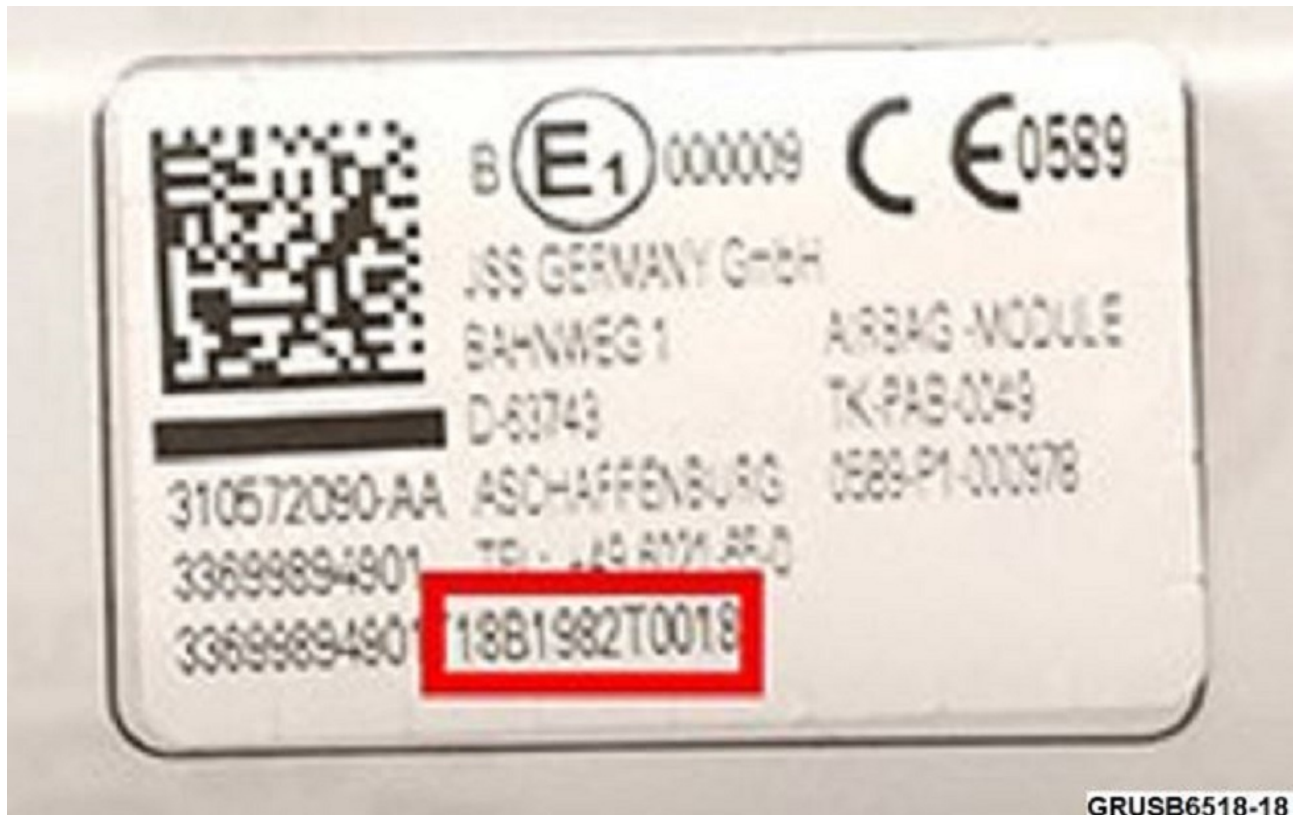
- The only parts allowed to be installed in this repair are the part numbers supplied in the PARTS INFORMATION section. Warranty will not pay for any other part numbers used.
- **The replacement air bag module's serial number (red circled below) must be documented on the repair order so it can also be entered into the claim's comment section.**

See Repair Instructions REP 72 12 000, "Remove and refit/replace the air bag unit" or follow the attached repair procedure.
