# Campaign Service

BULLETIN NUMBER:  
**SB13-04-S003**

### DRIVER DOOR SWITCH SHORT CIRCUIT #13V-248

- 2006-2007MY Isuzu Ascender Vehicles

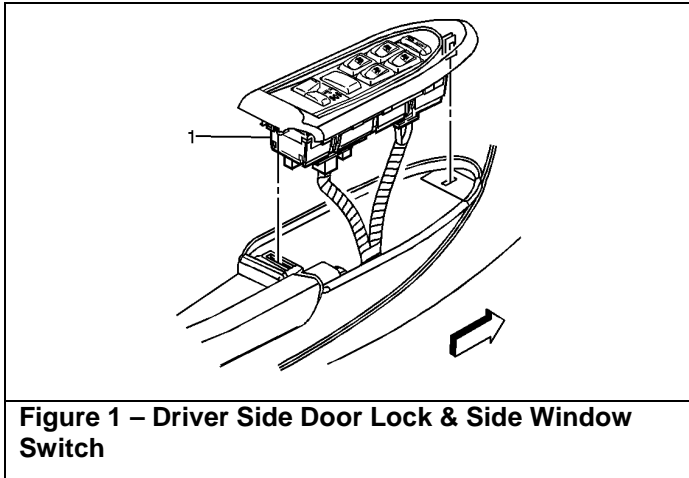
1. Perform a functional test on the driver side door lock and side window switch. Test all switch functions to ensure the driver side door lock and side window switch functions as designed.
  - a) If the driver side door lock and side window switch passes the functional test, proceed to Step 2.
  - b) If the driver side door lock and side window switch does NOT pass the functional test, replace the driver side door lock and side window switch. Refer to *Door Lock and Side Window Switch Replacement – Driver Side* in the service manual. After completing the replacement of the door lock and side window switch, proceed to Step 19 of this bulletin, “Applying the Campaign Label”.
