SAFETY RECALL BULLETIN

SUBJECT:			No: SR-13-007
2011 OUTLANDER SPORT/RVR PANORAMIC GLASS ROOF – SAFETY RECALL CAMPAIGN			DATE: July, 2013
			MODEL: 2011 Outlander Sport/RVR
CIRCULATE TO:	<input checked="" type="checkbox"/> GENERAL MANAGER	<input checked="" type="checkbox"/> PARTS MANAGER	<input checked="" type="checkbox"/> TECHNICIAN
<input checked="" type="checkbox"/> SERVICE ADVISOR	<input checked="" type="checkbox"/> SERVICE MANAGER	<input checked="" type="checkbox"/> WARRANTY PROCESSOR	<input checked="" type="checkbox"/> SALES MANAGER

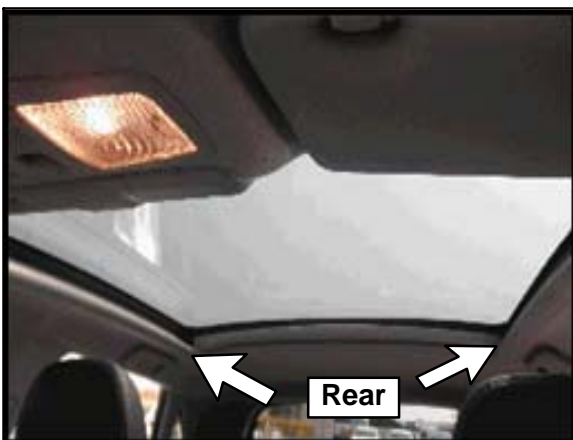
3. Completely cover the panoramic glass roof with a blanket or equivalent to block ambient lighting from entering the vehicle.

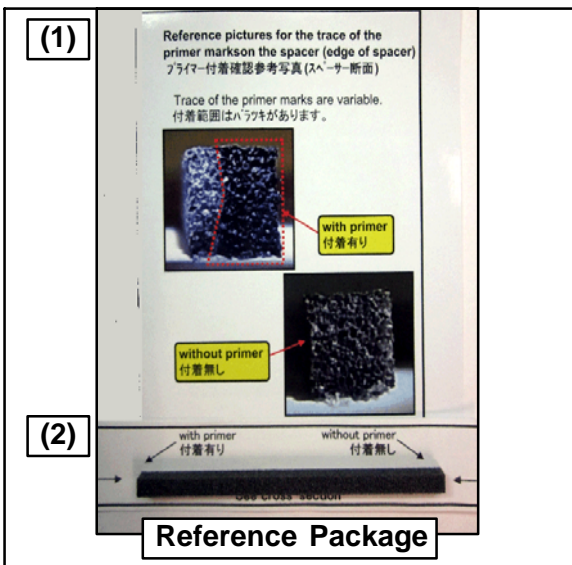
NOTE: Images of the window spacer have been enhanced to display the difference in color between spacers with primer and spacers without primer. The actual difference in color will not appear as pronounced as shown in the images.

NOTE: **If you do not see any primer marks, or have difficulty confirming if primer was applied, please contact Tech Line.**
