February 21, 2014

SUBJECT: **Safety Recall 13S08 – Supplement #2**
Certain 2005 Through 2011 Model Year Crown Victoria, Grand Marquis, and Town Car
Vehicles Originally Sold or Currently Registered in Corrosion States
Steering Column Shaft

Certain 2005 Through 2011 Model Year Crown Victoria, Grand Marquis, and Town Car Vehicles
Originally Sold or Currently Registered in Corrosion States
Steering Column Shaft

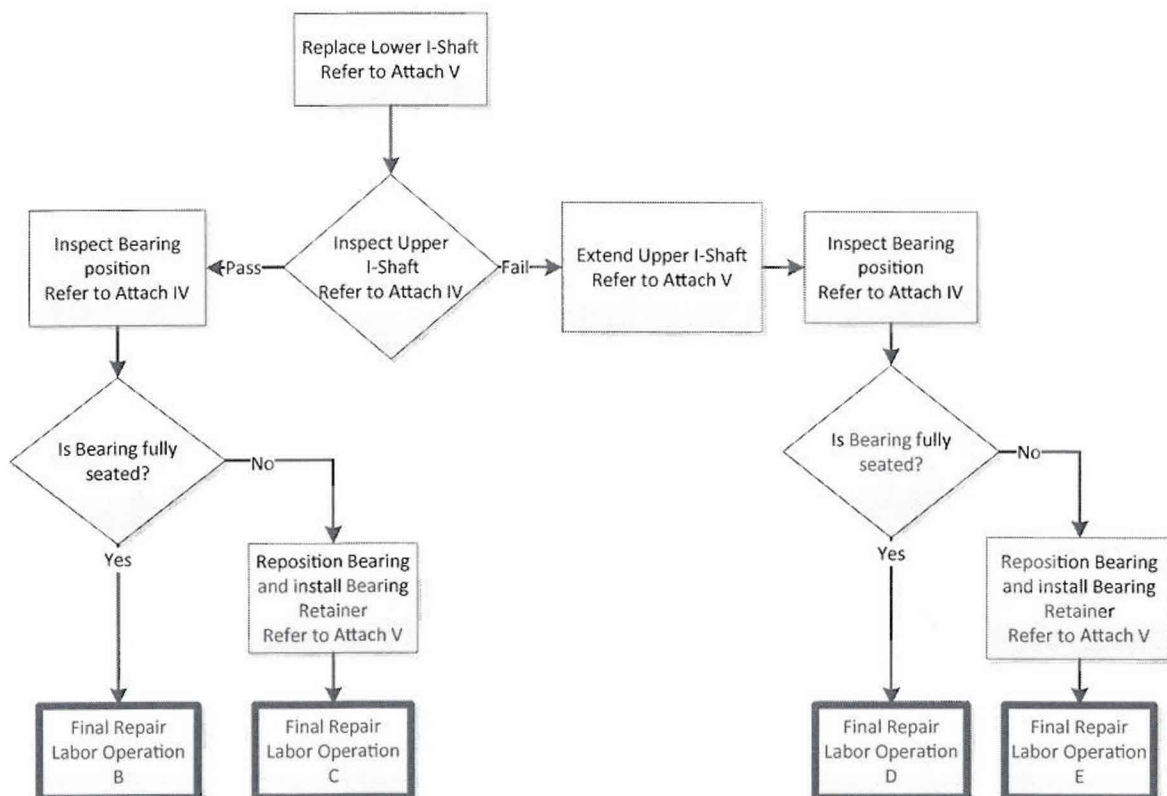
This service action requires replacement of the Lower Intermediate Steering Shaft (Lower I-Shaft), and inspection of other components to determine if additional repairs are required. Corrosion/seizure of the swing link joint on the Lower I-Shaft can affect other elements of the steering column system. Therefore, inspections of various components will be required before determining the appropriate repair action. Technicians should familiarize themselves with all aspects of the flowcharts prior to initiating repairs to avoid unnecessary disassembly/reassembly steps.

Refer to the following flow chart for inspection and repair criteria:

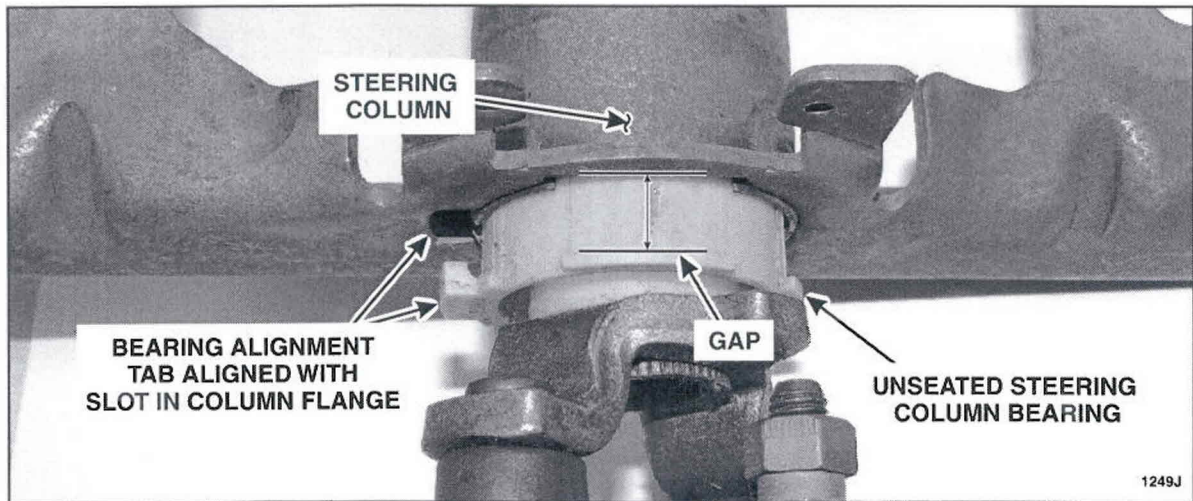
FIGURE 8

NOTE: In some instances the steering column bearing orientation tab may have broken off. If the tab has broken off, the bearing is still usable and can be seated within the steering column in any orientation.

2. Align the bearing alignment tab with the slot in the column flange. See Figure 8.
