SAFETY RECALL BULLETIN

SUBJECT: 2008–2013 LANCER EVOLUTION CLUTCH MASTER CYLINDER – SAFETY RECALL CAMPAIGN			No: SR-13-009
			DATE: November, 2013
			MODEL: 2008 – 2013 Lancer Evolution
CIRCULATE TO:	<input checked="" type="checkbox"/> GENERAL MANAGER	<input checked="" type="checkbox"/> PARTS MANAGER	<input checked="" type="checkbox"/> TECHNICIAN
<input checked="" type="checkbox"/> SERVICE ADVISOR	<input checked="" type="checkbox"/> SERVICE MANAGER	<input checked="" type="checkbox"/> WARRANTY PROCESSOR	<input checked="" type="checkbox"/> SALES MANAGER

PURPOSE

Due to the insufficient bonding strength of clutch master cylinder components on certain 2008 – 2013 Lancer Evolution vehicles, separation may occur, resulting in fluid leakage. This condition results in the inability to engage or disengage the clutch, limits the ability to shift the transmission into or out of a gear, and can create a no start condition once the vehicle comes to a stop.

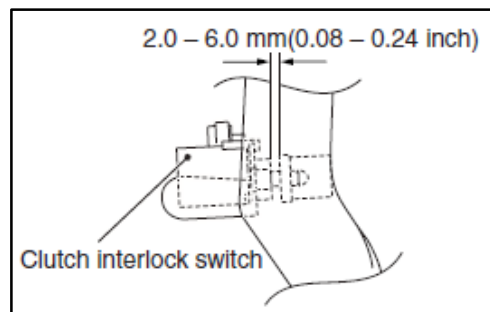
9. Check the switch components and ensure they are set to the following factory specifications:
- a. Clutch interlock switch, measured while the pedal is completely depressed. You may rotate the pedal stopper adjustment screw (as shown in Step 8b) to adjust the height of the clutch interlock switch when the pedal is completely depressed.

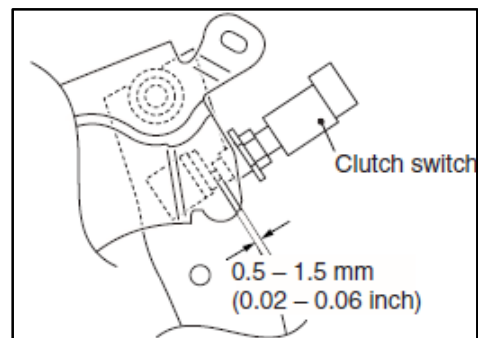
- b. Clutch switch, measured while the pedal is completely released. You may adjust the clutch switch by loosening the lock nut and rotating the body of the clutch switch.

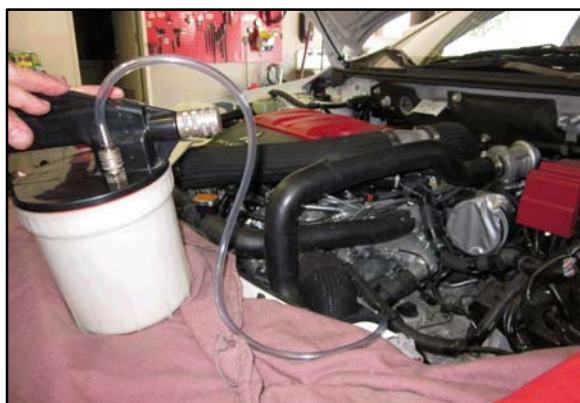
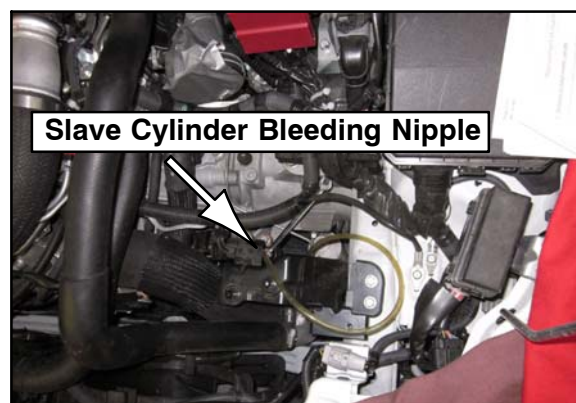
4. Attach the brake bleeder hose to the slave cylinder bleeding nipple. Loosen the nipple and start the brake bleeder. When air is completely removed from the slave cylinder, stop the brake bleeder, torque nipple to 8 ± 1 ft-lb (11 ± 1 N-m), and disconnect the brake bleeder hose.

Cover the surrounding area of the slave cylinder with shop rags to protect from brake fluid spillage. If spillage occurs, clean the area immediately with commercially available car wash shampoo, rinse with water, dry with shop rags and remove remaining residue with compressed air.

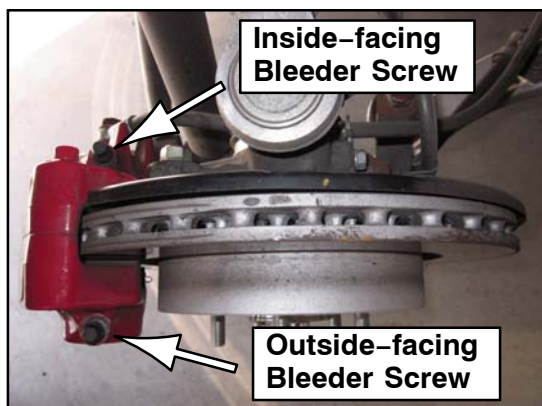
5. Use the remaining brake fluid to bleed the brakes and completely purge the old fluid. Starting with the right rear caliper, connect the brake bleeder hose to the outside-facing bleeder screw. Loosen the screw and start the brake bleeder. When air is completely removed from that brake line and caliper, stop the brake bleeder and remove the hose.

CAUTION Cover the surrounding area of the bleeder screw with shop rags to protect from brake fluid spillage. If spillage occurs, clean the area immediately with commercially available car wash shampoo, rinse with water, dry with shop rags and remove remaining residue with compressed air.

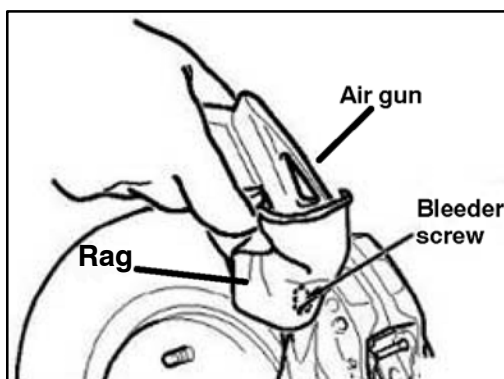
6. Blow air into the top of the bleeder screw to remove any remaining brake fluid from the bleeder screw hole. Air pressure should be regulated to a low setting to minimize splatter. Securely tighten the brake bleeder screw.

CAUTION Cover the surrounding area of the bleeder screw with shop rags to protect from brake fluid splatter. If splatter occurs, clean the area immediately with commercially available car wash shampoo, rinse with water, dry with shop rags and remove remaining residue with compressed air.

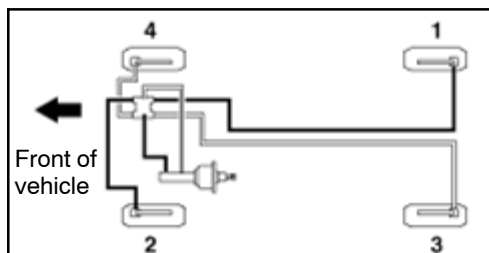
7. Repeat Steps 5 – 6 for the inside-facing bleeder screw.
8. Perform Steps 5 – 7 on the remaining calipers in the order shown below.

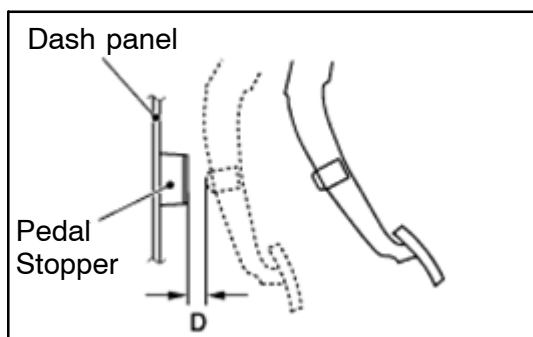
15. Complete one final check to the clutch pedal. Ensure the gap between the clutch pedal and pedal stopper at the point of clutch disengagement, measurement "D", is greater than 0.53 in. (13.5mm). If not within specification, diagnose per the applicable model year Lancer Evolution Service Manual – Group 21: Clutch > On-Vehicle Service > Clutch Pedal Check.
