# Safety Recall

Code: 97Z9

Subject: 2009-2011 MY Tiguan  
Fuse (Plug-In Position F16)

January 3, 2014

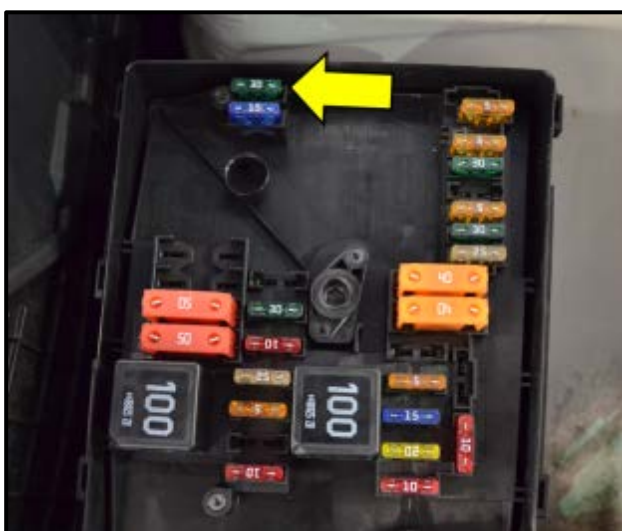
- Open the hood.
- ⇐ Disengage the two locking tabs <arrows> and remove cover from the SA/SB fuse panel.

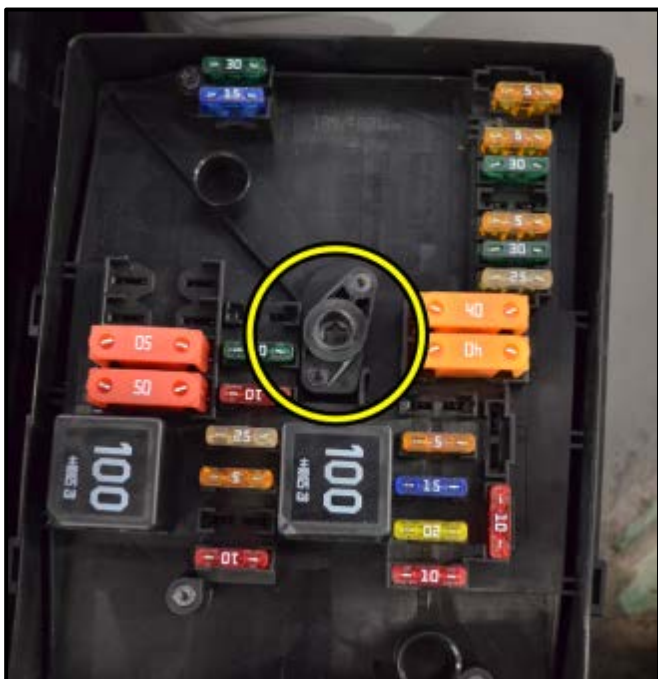
**Tip:** Note the location of all wires attached in this step prior to disassembly. Wire locations may vary based on model year and vehicle equipment.

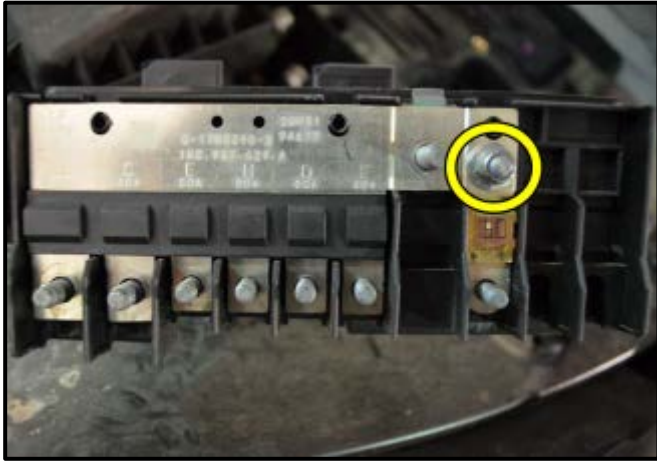
- ⇐ Remove the fuse panel mounting screw <circle>.
- Remove the upper SA/SB fuse panel from the vehicle.

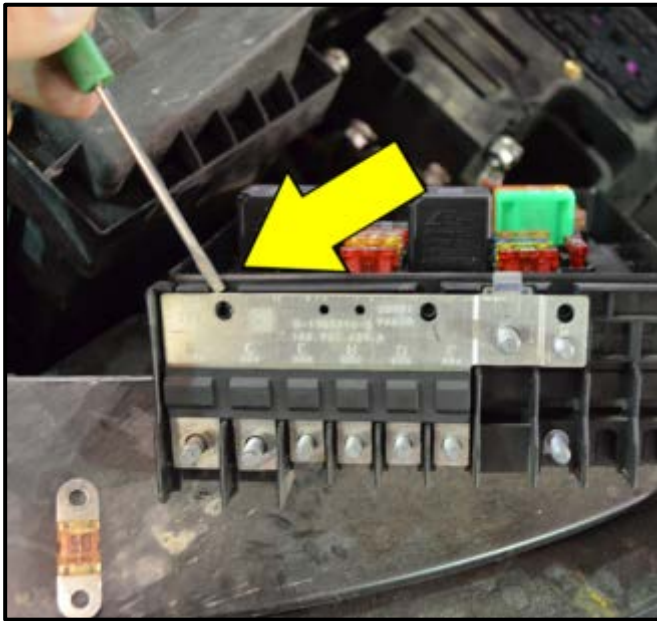
- The SA portion of the old fuse panel must be switched over to the replacement fuse panel.
- ⇐ Remove the hex nut <circle> and the remaining 50A fuse from the SA panel.
- Keep both the nut and the fuse – they will be installed onto the new panel.

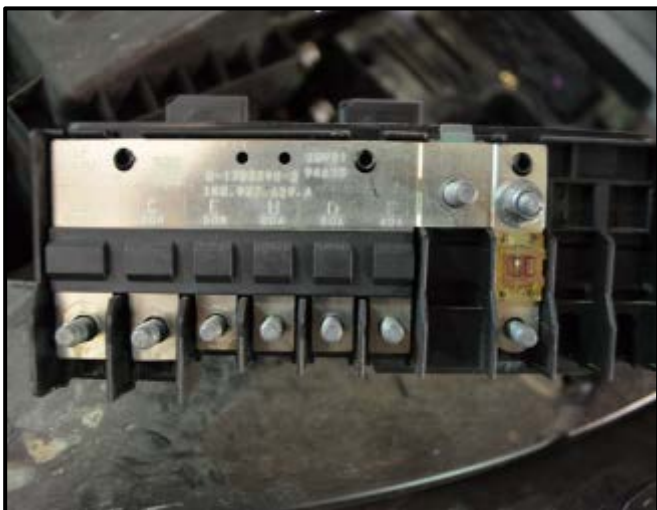
- ⇐ Using a pocket screwdriver, or equivalent, gently pry the SA portion of the fuse panel off the old fuse panel <arrow>.
