SUBJECT: 2001-2004 Tribute Front Subframe Corrosion - Safety Recall 7514D

2001-2004 TRIBUTE - FRONT SUBFRAME CROSSBRACE INSTALLATION

2001-2004 Tribute Subframe Corrosion - Safety Recall 7514D NHTSA Campaign No. 14V-174

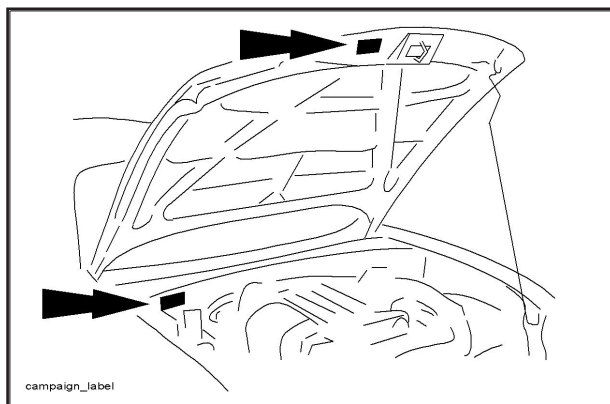
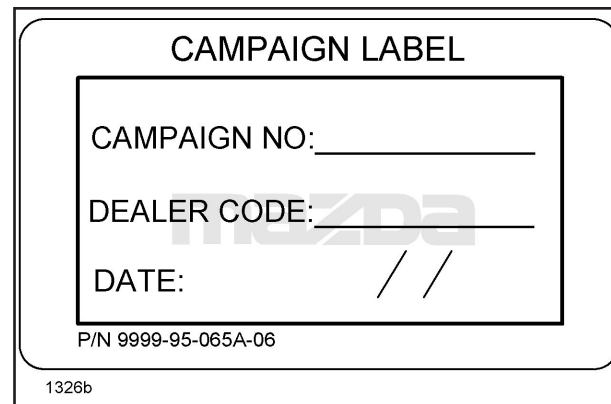
- If the vehicle is within one of the above year ranges, proceed to step 2.
 - If the vehicle is not within one of the above year ranges, return the vehicle to the customer or inventory.
2. Perform a Warranty Vehicle Inquiry using your eMDCS System and inspect vehicle for a Campaign Label 7514D attached to the vehicle's hood or bulkhead. Refer to eMDCS System - Warranty Vehicle Inquiry Results table below.

NOTE: Verify Recall number as the vehicle may have multiple Recalls.
