SUBJECT: 2008 Tribute Hybrid Motor Electronics Coolant Pump Replacement Safety Recall 7814I

2008 TRIBUTE HYBRID - MOTOR ELECTRONICS COOLANT PUMP REPLACEMENT

**2008 Tribute Hybrid Vehicles
Motor Electronics Coolant Pump Replacement - Recall 7814I
NHTSA Campaign No. 14V-552**

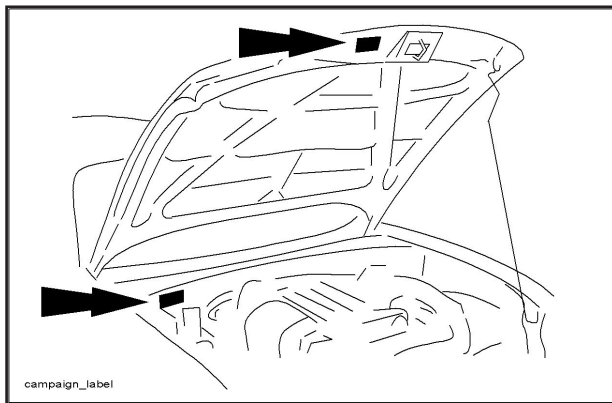
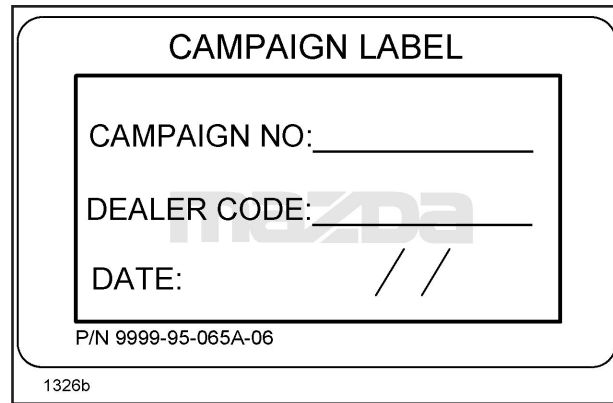
- If the vehicle is within one of the above year ranges, proceed to step 2.
 - If the vehicle is not within one of the above year ranges, return the vehicle to the customer or inventory.
2. Perform a Warranty Vehicle Inquiry using your eMDCS System and inspect vehicle for a Campaign Label 7814I attached to the vehicle's hood or bulkhead. Refer to eMDCS System - Warranty Vehicle Inquiry Results table below.

NOTE: Verify Recall number as the vehicle may have multiple Recalls.
