After-sales Retailer Support

2011-2015 Infiniti QX56/QX80 and 2011-2015 M56/Q70 Fuel Pressure Sensor Voluntary Safety Recall Campaign

Reference: R1417

Date: November 26, 2014

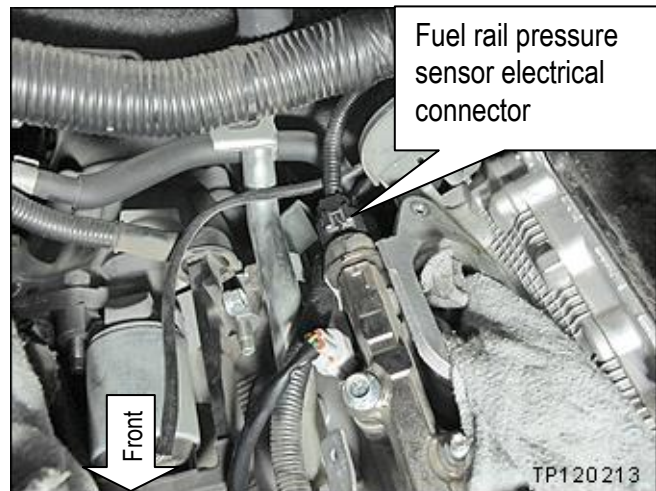
Figure 11

18. Disconnect the fuel rail pressure sensor electrical connector.

19. Torque the fuel rail pressure sensor as follows:

- a. Measure the length of your torque wrench between the center of the handle and the center of the square drive as shown in Figure 12.

- c. Attach special tool J-50991 to your torque wrench – use an extension if needed.
- d. Torque the sensor to the specified torque.

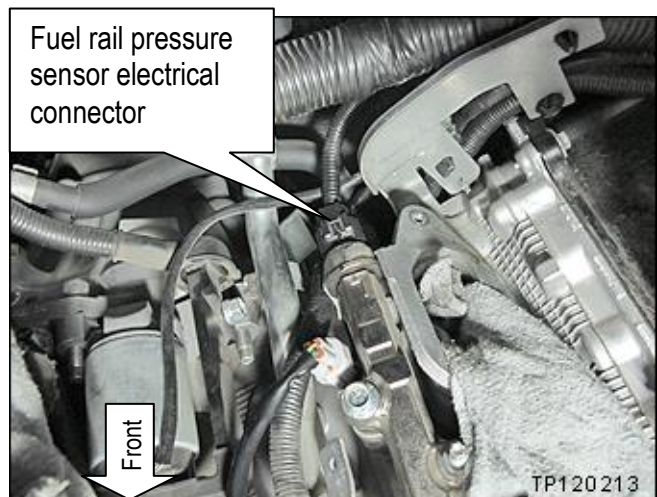
Figure 20m

25. Disconnect fuel rail pressure sensor electrical connector:

27. Torque the fuel rail pressure sensor as follows:

- a. Measure the length of your torque wrench between the center of the handle and the center of the square drive as shown in Figure 21m.

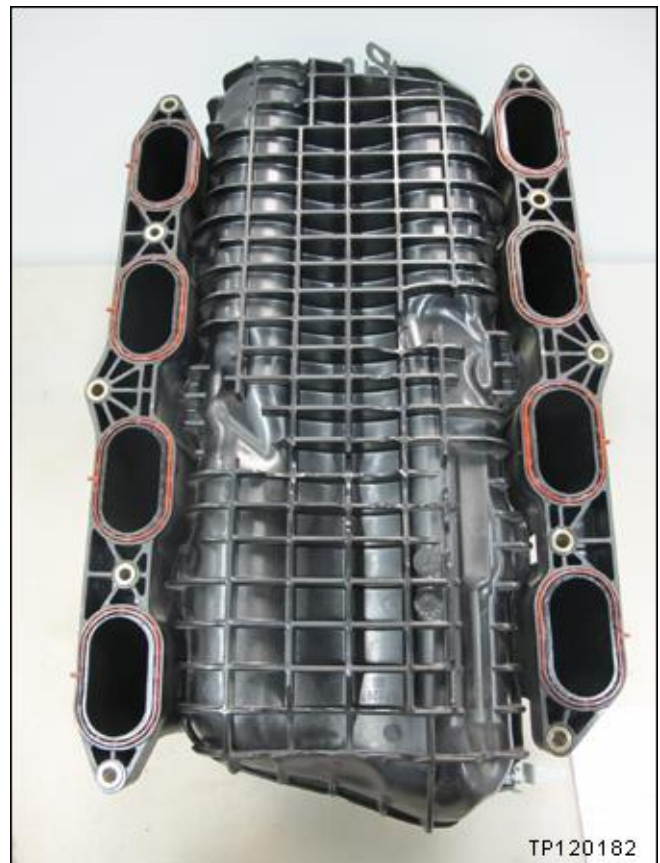
Figure 28m

NOTE:

- For vehicles in dealer inventory (less than 125 miles), new gaskets are not needed.
- Clean and inspect the old gaskets. Make sure gaskets are not torn or cut and they are installed properly.
