Delivery Stop: I12 Check Fuel Tank

I12 (i8)

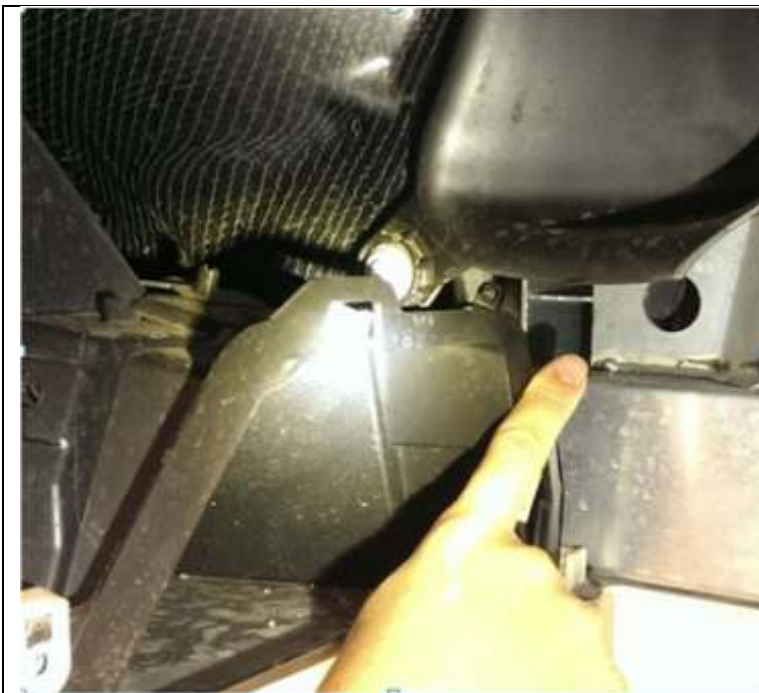
1. Remove the rear left wheel arch cover per Repair Instruction REP 51 71 041, "Removing and installing/replacing rear left or right wheel arch cover."
