Exhaust Catalyst Inlet Cummins ISL-G LEU

SC0376, Exhaust Catalyst Inlet

(April 2014)

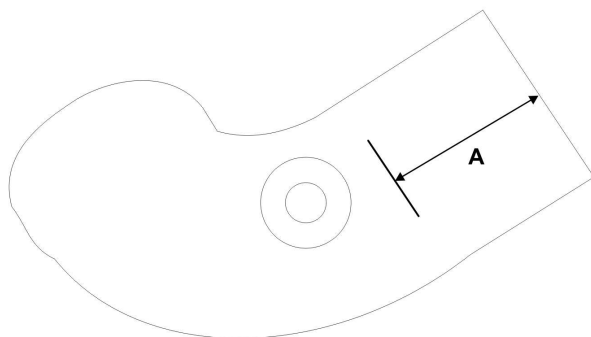
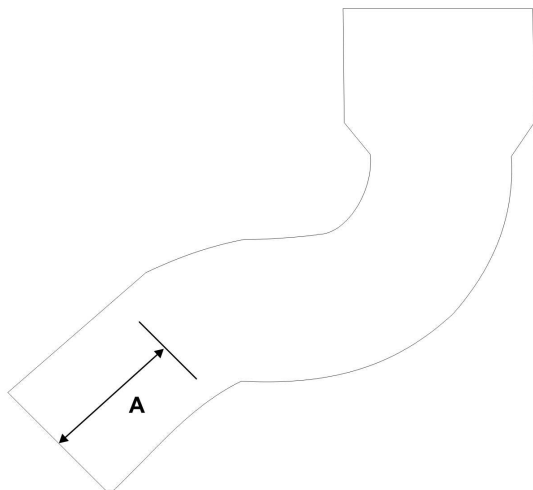
W2089516

A = 76 mm (3 in)

28 To determine insertion depth of piping into clamps, mark the turbocharger outlet pipe and the catalyst inlet pipe 76 mm (3 in) inward from the mating end to the flex pipe.

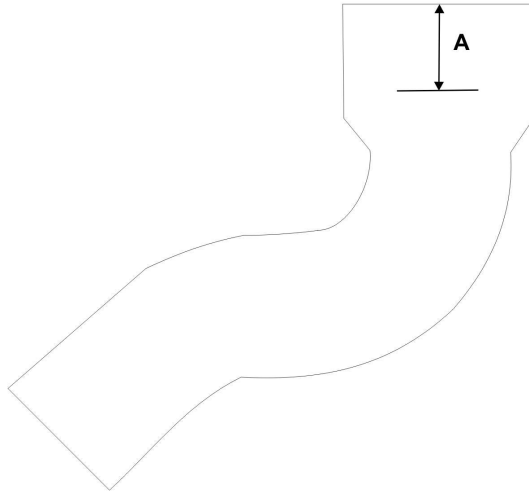
W2089517

A = 58 mm (2.25 in)

- 29 To determine insertion depth of the inlet pipe into catalyst inlet flange, mark 58 mm (2.25 in) from end of catalyst inlet pipe.
