# Recall Bulletin

## PRODUCT SAFETY RECALL

**SUBJECT:** Brake Booster Pump – Cavity Plug

**MODELS:** 2013 and some 2014 Cadillac XTS

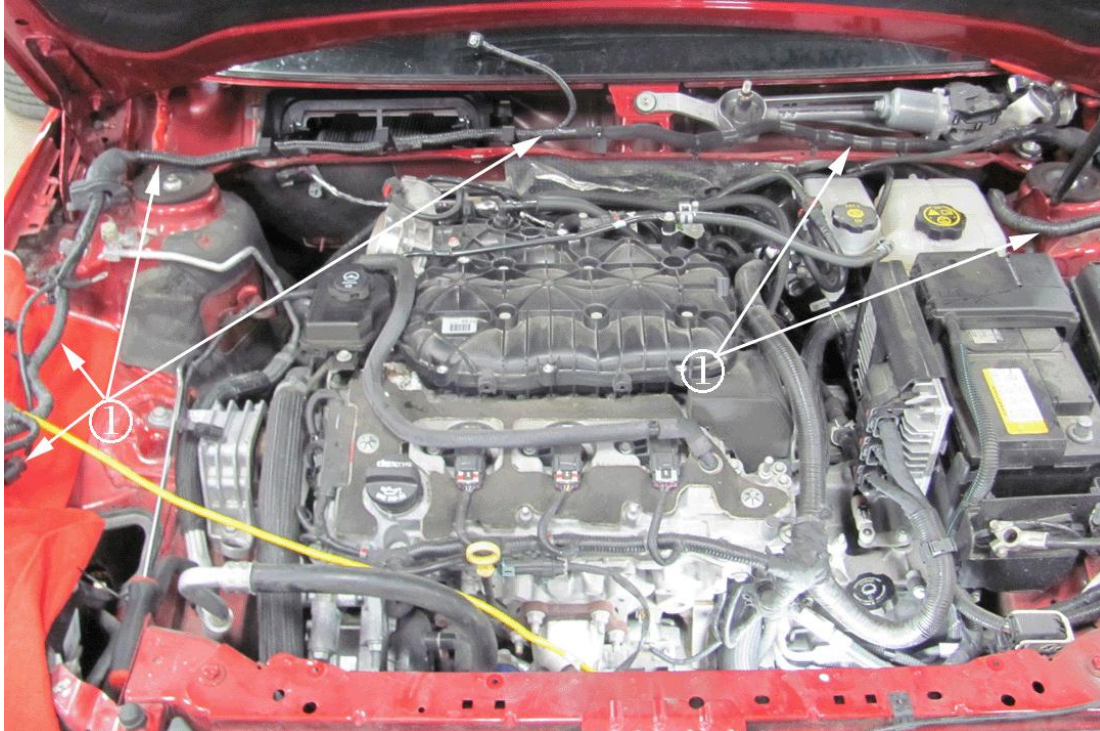
View of the forward lamp harness (1) with the required parts removed from the vehicle. Do NOT begin removing the harness until the required parts have been removed.

2. Install a new forward lamp harness into the vehicle.
3. Remove the power brake booster pump. Refer to *Power Brake Booster Pump Replacement* in SI.
4. Install a new power brake booster pump. Refer to *Power Brake Booster Pump Replacement* in SI
5. Perform steps 7-24 in the *Power Brake Booster Pump Electrical Connector Repair and Vent Hose Routing* section of the bulletin.
6. Start the vehicle and verify that the vehicle lights and accessories work.

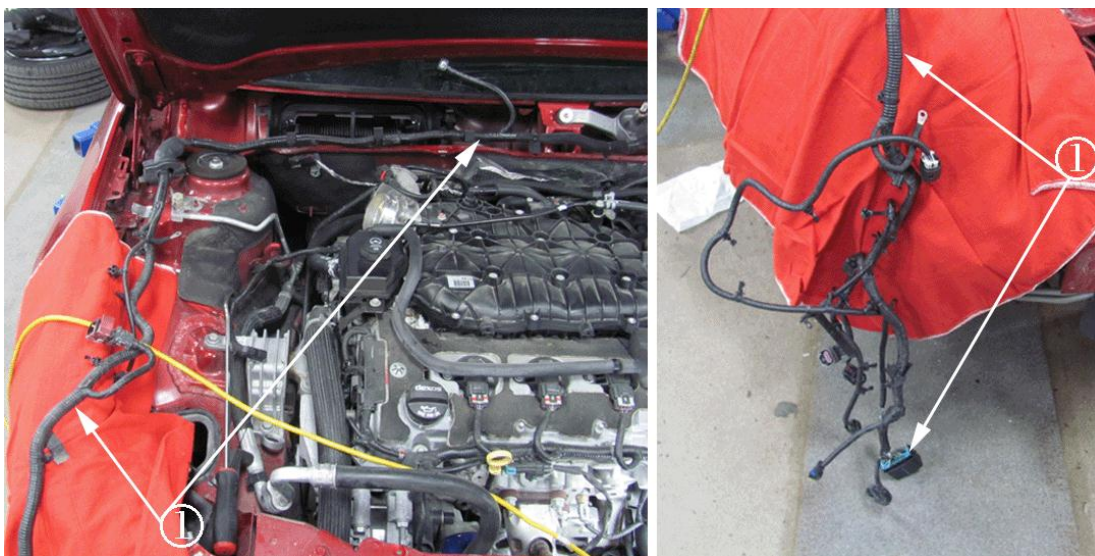
View of forward lamp harness (1) from the passenger side of vehicle with the required parts removed from the vehicle.
