ITB14-015

VOLUNTARY SAFETY RECALL CAMPAIGN OCCUPANT CLASSIFICATION SYSTEM MODULE REPROGRAMMING

CAMPAIGN ID #: R1404

APPLIED VEHICLES: 2013 JX35 (L50)
2014 QX60 (L50)
2014 QX60 Hybrid (L50)
2014 Q50 (V37)
2014 Q50 Hybrid (V37)

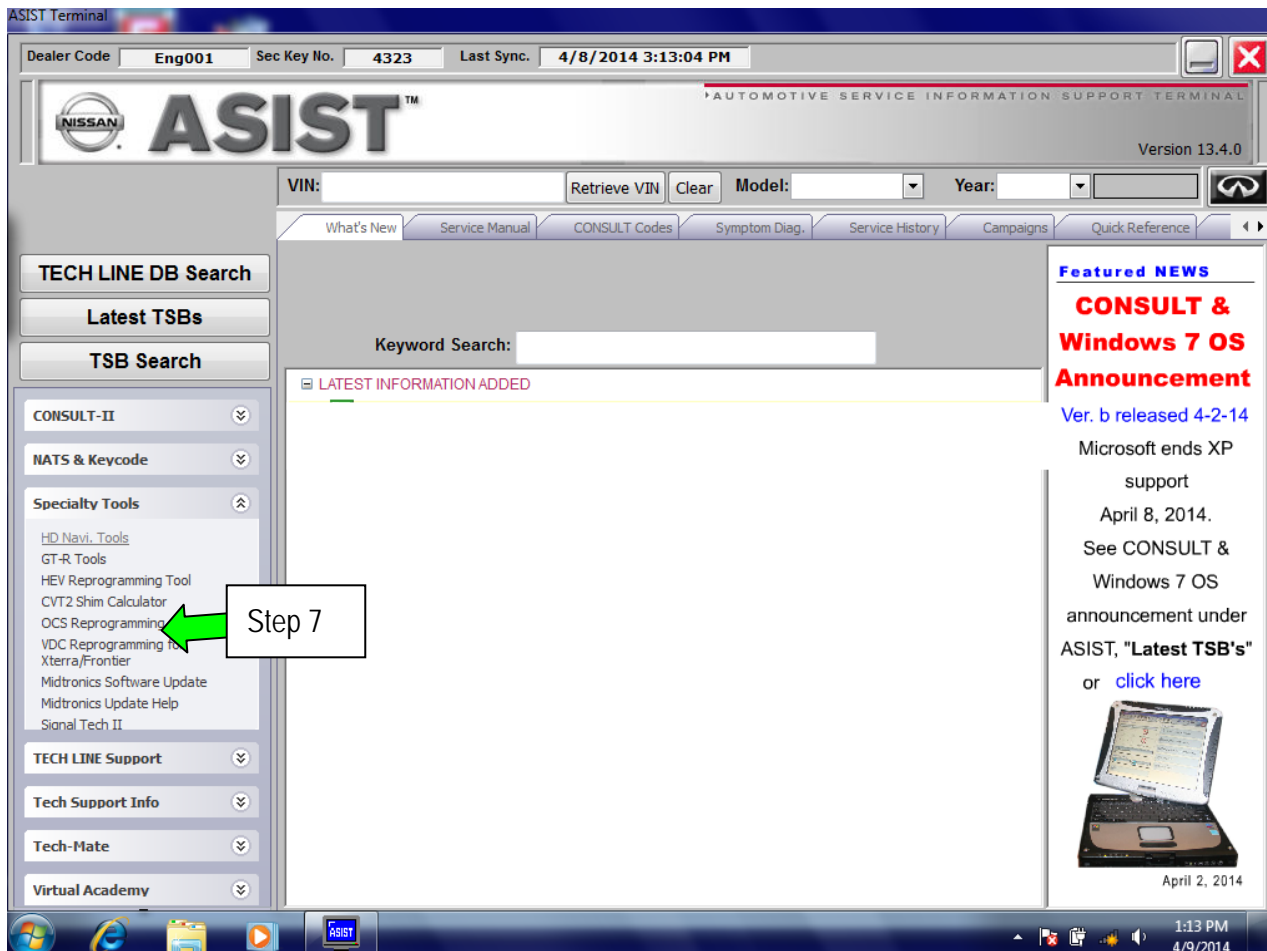
Figure 1

6. Open ASIST.
7. Select **Specialty Tools**, then **OCS Reprogramming**.

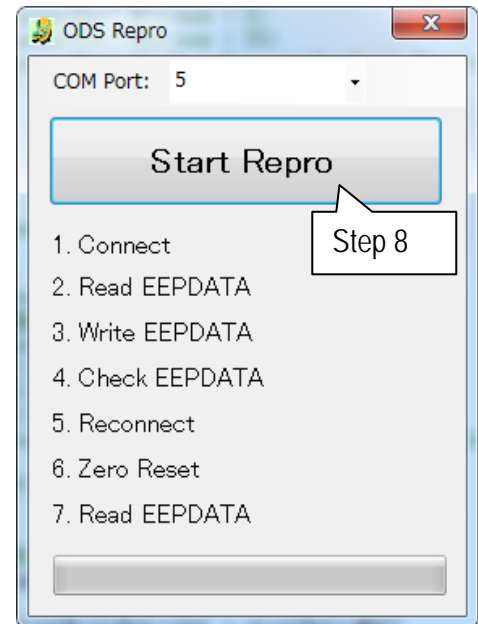
Figure 3

NOTE: If the error message “an error occurred on connection” displays:

- a. Disconnect the J-51594 OCS reprogramming cable, both ends.
- b. Reconnect the cable; make sure it is securely connected at both ends.

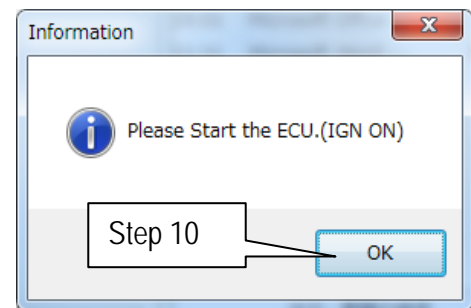
Figure 4

- After selecting OK in Figure 4, the OCS reprogramming will start.

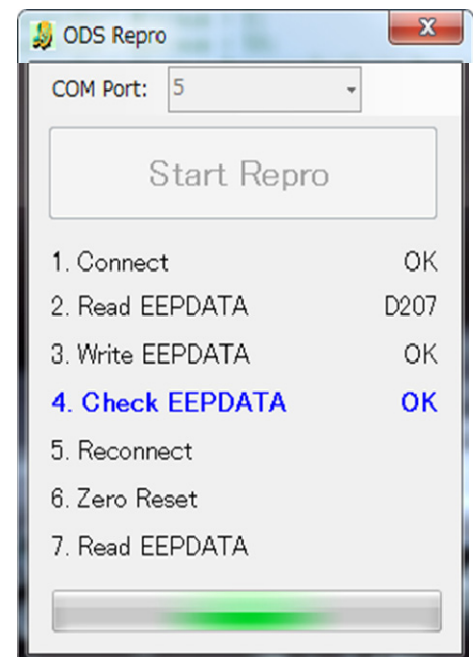
Figure 5

- Items 1 through 4 will likely complete quickly.
- If the OCS reprogramming stops (displays NG) at item 1,2,3 or 4, refer to Figures 10 through 13 on pages 8 and 9.

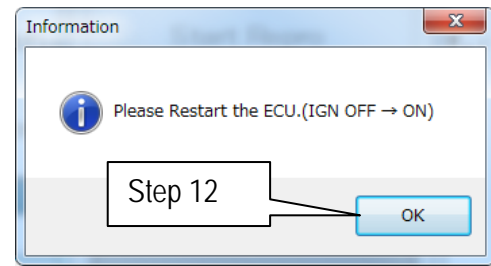
Figure 6

- After selecting OK in Figure 6, the OCS reprogramming will likely complete items 5 through 7 quickly (see "Complete" screen, Figure 8 below).
- If the OCS reprogramming stops (displays NG) at item 5, 6 or 7, refer to Figures 13 through 15 on pages 10 and 11.

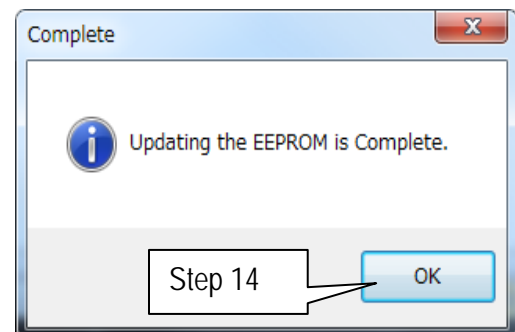
Figure 8

13 When this screen displays (Figure 8), OCS reprogramming is complete.
