This Service Information bulletin supersedes SI B11 07 14 **dated September 2014.**

Recall Campaign 14V-176: N51, N52K and N52T Engine – Replace VANOS Gear Bolts

REPAIR PROCEDURE

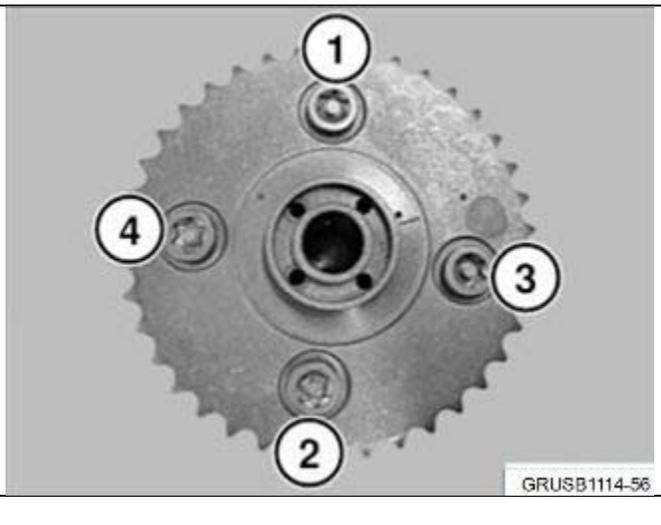
<p>3. Evaluation of bolt:</p> <p>If any of the bolts were loose or broken during this procedure, the VANOS assembly will need to be replaced. Refer to step 14.</p> <p>VANOS bolt is tight (1)</p> <p>VANOS bolt is loose (2)</p> <p>VANOS bolt heads have sheared off (3)</p> <p>Note: VANOS gear assembly removed from engine for clarity. Do not remove VANOS Gear Assembly</p>
<p>Intake VANOS Adjustment Unit:</p>

<p>4. Replace and torque the aluminum bolts (1-4) one at a time.</p> <p>Note: 1-4 is not a sequence; they can be replaced in any sequence.</p> <p>IMPORTANT: Never loosen more than one VANOS assembly bolt (1-4) at a time to avoid losing the sealing and alignment of gear assembly.</p>

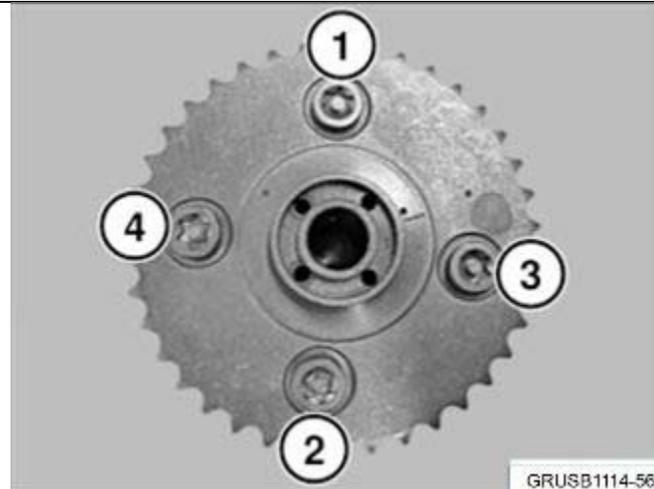
<p>10. Evaluation of bolt:</p> <p>If any of the bolts were loose or broken during this procedure, the VANOS assembly will need to be replaced. Refer to step 16.</p> <p>VANOS bolt is tight (1)</p> <p>VANOS bolt is loose (2)</p> <p>VANOS bolt heads have sheared off (3)</p> <p>Note: VANOS gear assembly removed from engine for clarity. Do not remove VANOS Gear Assembly</p>

11. Replace and torque the aluminum bolts (1-4) one at a time.

IMPORTANT: Never loosen more than one VANOS assembly bolt (1-4) at a time to avoid losing the sealing and alignment of gear assembly.
