This Service Information bulletin supersedes SI B11 08 14 **dated September 2014.**

Recall Campaign 14V-176: N55 Engine – Replace VANOS Gear Bolts

The VANOS adjustment units may develop an internal oil leakage that will no longer allow the VANOS to adjust quickly enough. Due to this leakage, the vehicle's engine emergency mode and engine malfunction is permanently active.

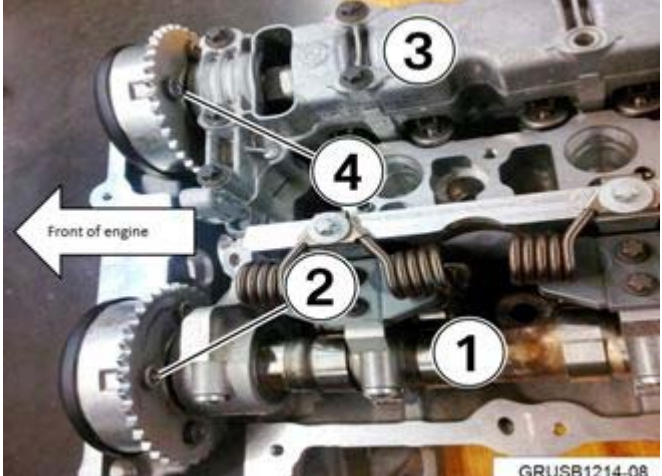
<p>Front of engine</p> <p>GRUSB1214-08</p>	<p>Overview of components:</p> <p>Intake camshaft (1)</p> <p>Intake VANOS gear assembly bolts (2)</p> <p>Exhaust camshaft (3)</p> <p>Exhaust VANOS gear assembly bolts (4)</p>

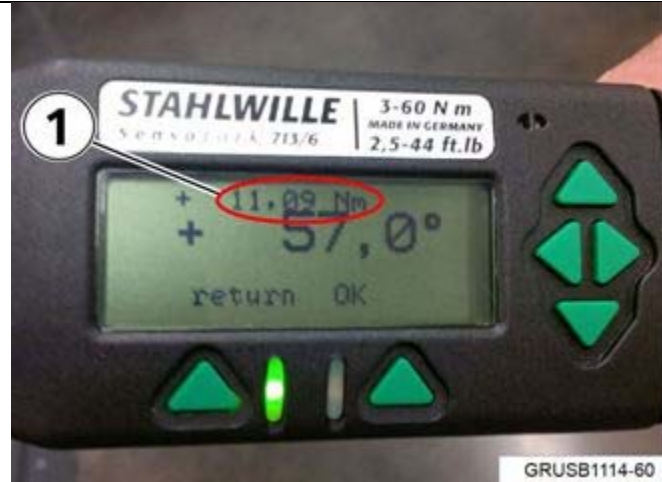
8. While performing the angle torque, the digital screen on the torque wrench will display the current Nm meter value. This value should be between **8 Nm-14 Nm**.

If the displayed value is not within the specification, the bolt will need to be removed and replaced with a new bolt again. Repeat as necessary.

9. If any of the bolts were loose or broken during this procedure, the VANOS assembly will need to be replaced. Refer to step 16.

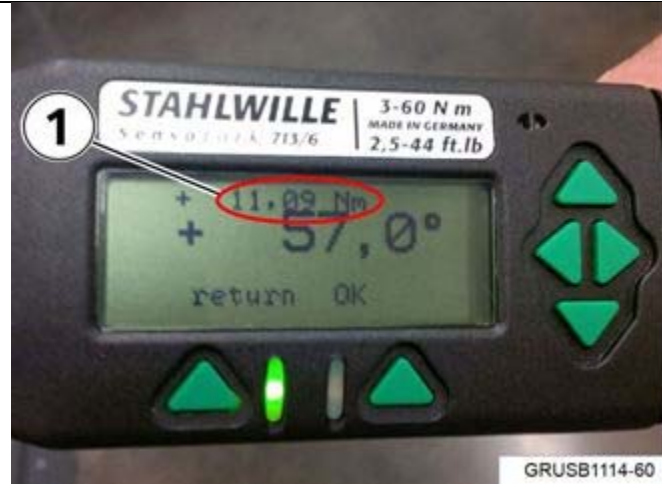
15. While performing the angle torque, the digital screen on the torque wrench will display the current Nm meter value. This value should be between **8 Nm-14 Nm**.

If the displayed value is not within the specification, the bolt will need to be removed and replaced with a new bolt again. Repeat as necessary.

16. If any of the bolts were found loose or broken during this procedure, the affected VANOS assembly will need to be replaced. Refer to step 17.

17. If any of the VANOS bolts were found loose or broken, that VANOS unit will need to be replaced. Refer to Repair Instruction 11 36 046, “Removing and installing or replacing intake and exhaust camshaft adjusters.”
