star bulletin

Date: June
Order No.: P-B-82.10/704
Group: 82

**SUBJECT: Model 204, Model Years 2008 - 2011
Check Right and Left Tail Lamp Bulb Carrier, Replace if Necessary**

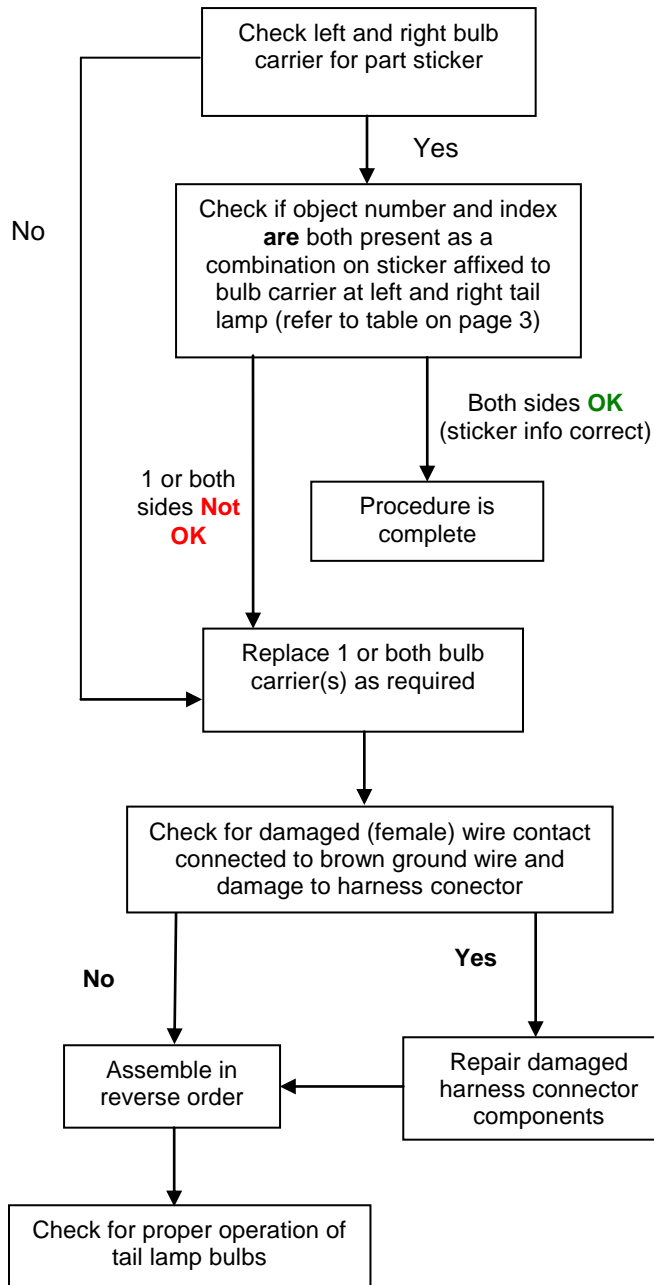
Work process flow chart and component illustrations

The object number and index on each bulb carrier will be verified and the carrier(s) will be replaced if necessary. Both tail lamp connectors and wire contacts will be inspected for evidence of oxidation and the connector(s) and affected wire contact(s) will be replaced if necessary. Customers who previously paid for this repair can request reimbursement with appropriate documentation.

Please note, this flow chart does **not** include **all** the steps for this procedure. **Please be sure to read all steps included in the Procedure starting on the following page:**

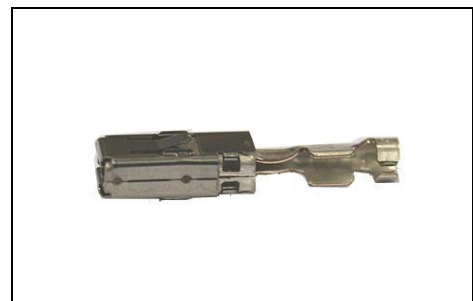
Harness connector

Female wire contact connected to wire on wiring harness

Check (female) wire contact in position 1 (B, Figure 5) on brown ground wire (1, Figure 4) with associated harness connector (2, Figure 4) for damage: Replace defective components refer to WIS:
 - AR00.19-P-0120-07A - Remove contacts from Junior Power Timer coupling.
 - AR00.19-P-0100-03A - Repair wiring harness by crimping.
