Campaign No. 2014050001, August 2014

SUBJECT: **Model 204, Model Years 2008 - 2011**  
**Check Tail Lamp Carrier, Replace as Necessary**

**IMPORTANT SAFETY RECALL 2014050001**

**This notice applies to your vehicle, Insert VIN here  
Rear Tail Lamp Bulb Carrier  
NHTSA Recall # 14V-177**

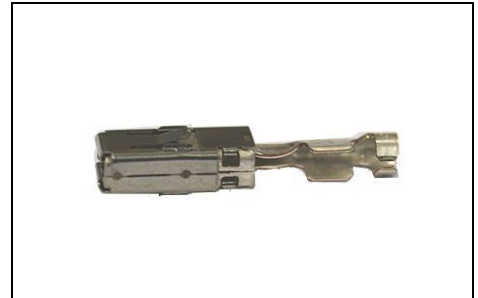
Harness connector

Female wire contact connected to wire on wiring harness

Check (female) wire contact in position 1 (B, Figure 5) on brown ground wire (1, Figure 4) with associated harness connector (2, Figure 4) for damage: Replace defective components refer to WIS:
  - AR00.19-P-0120-07A - Remove contacts from Junior Power Timer coupling.
  - AR00.19-P-0100-03A - Repair wiring harness by crimping.
