Mercedes-Benz

Campaign No. 2014050001, August 2014

SUBJECT: **Model 204, Model Years 2008 - 2011**
Check Tail Lamp Carrier, Replace as Necessary

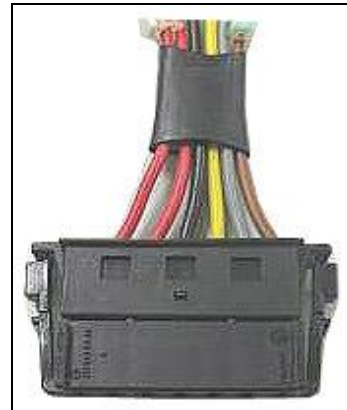
Bulb carrier

Check (female) wire contact in position 1 (B, Figure 5) on brown ground wire (1, Figure 4) with associated harness connector (2, Figure 4) for damage: Replace defective components refer to WIS:
 - AR00.19-P-0120-07A - Remove contacts from Junior Power Timer coupling.
 - AR00.19-P-0100-03A - Repair wiring harness by crimping.

Replace rear tail lamp bulb carrier:
 -
