# Safety Recall

Code: 38B9

**Subject: 2014 MY Jetta, Beetle, Beetle Convertible and Passat Vehicles with 1.8T Engine and Torque-Converter Automatic Transmission Transmission Oil Cooler**

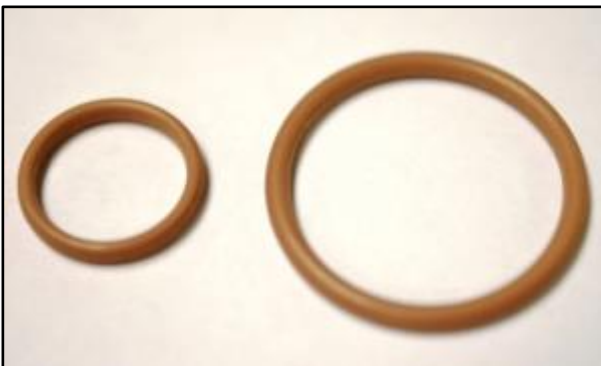
- 09G 321 181 – Large O-Ring
- 09G 321 181A – Small O-Ring

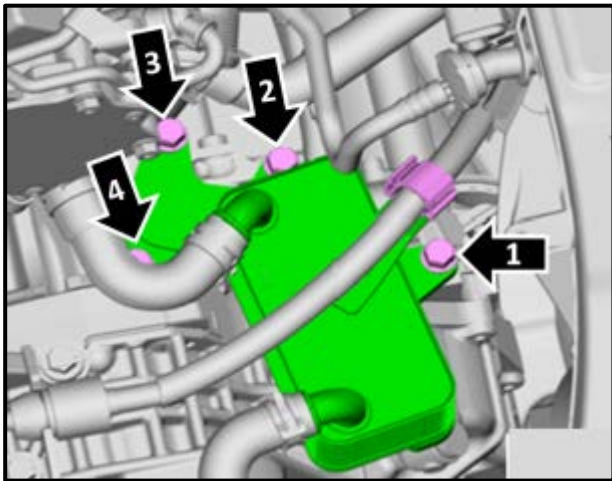
⇐ Remove the retaining bolts <arrows 1 through 4> from the ATF cooler.

**i** Tip: You will need to gently reposition the metal coolant lines enough to allow access to bolts <arrows 2 and 3>.

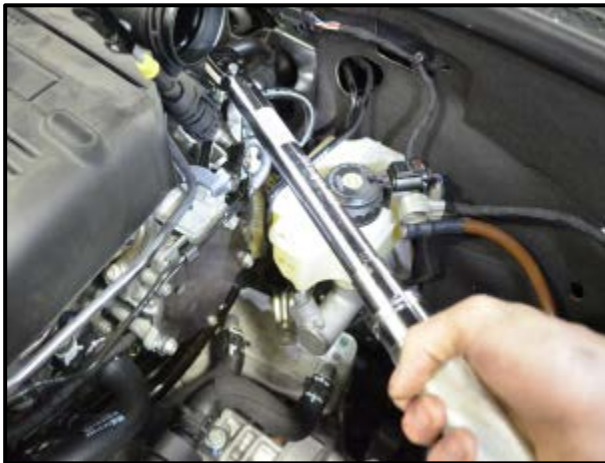
**Tip:** It is possible to properly torque the ATF cooler bolts <as shown> using a long extension and swivel type socket above each bolt. The metal coolant lines can be repositioned gently by hand to allow access to each ATF cooler mounting bolt.

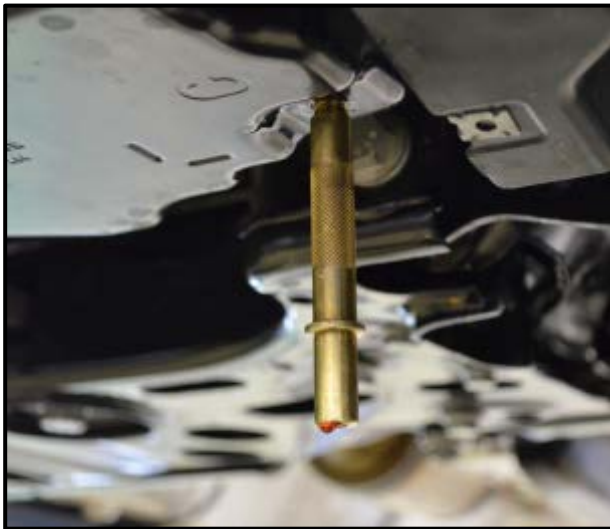
**Note:** This seal ring can be reused one time for this campaign only
