Campaign Service BULLETIN

BULLETIN NUMBER:
CB14-N-001

INOPERATIVE HORN – 14V-203

(Transport Canada #2014-143)

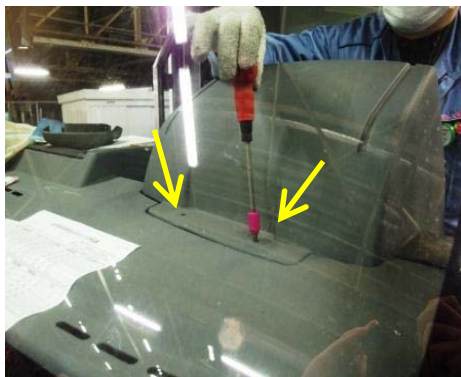
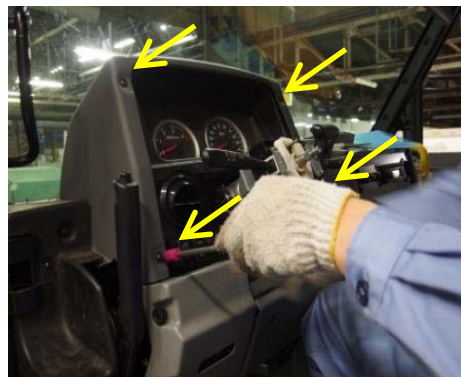
Figure 10 – Back of Meter Hood

Figure 11 – Front of Meter Hood

5. Remove the meter hood at the six (6) screw locations (save for reuse).
