Technical Service Bulletin

14-01-020

TUCSON (LM)

SUBJECT: DRIVER FRONT AIRBAG MODULE BOLT INSPECTION
(RECALL CAMPAIGN 118)

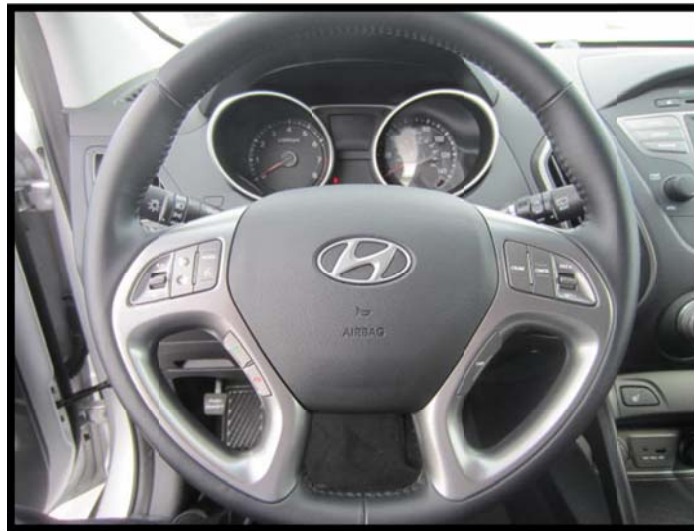
Description: This bulletin describes the service procedure to verify the torque of the two driver front airbag module assembly bolts.
