Automotive Technical Service Bulletin

October 24, 2014 Bulletin No. TS 15 10244

SUBJECT: Pigtail Installation for DRL Module and/or Signal Switch

MODEL(S): Forenza (RQ420)

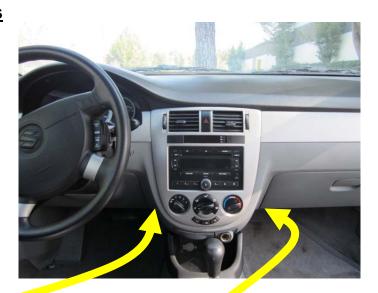
IMPORTANT: If the DRL Module, the DRL Module Wiring, or the DRL Connector show evidence of any heat related damage, in addition to the wiring repair please perform the following Ground G203 check.

1. Disconnect the left and right side HVAC Control cables at the Temperature control lever and the Blend Door lever.
