Recall Bulletin

SUBJECT: Driver Front Airbag Inflator Failure

MODELS: 2013-2014 Chevrolet Cruze

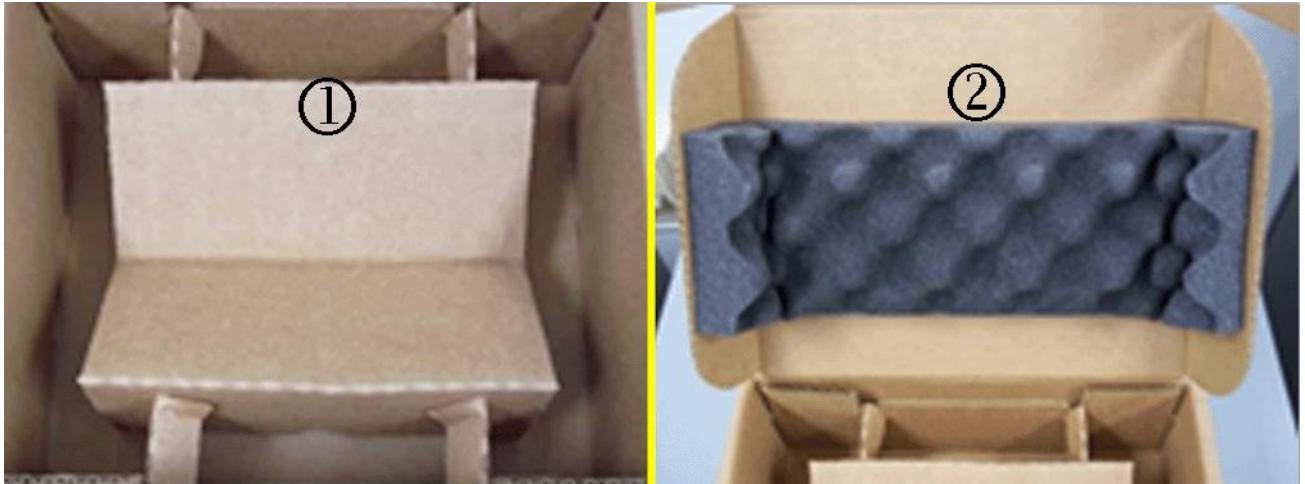
3961570

1. **DO NOT DEPLOY the AIRBAG.** Ensure that the box the replacement airbag arrived in is not damaged and place the steering wheel airbag in the box. Also, make sure to include a copy of the repair order in the box.
