Technical Service Bulletin

GROUP	NUMBER
CAMPAIGN	14-01-044
DATE	MODEL(S)
NOVEMBER 2014	VERACRUZ (EN)

CYLINDER HEAD COVER OIL LEAK REPAIR (RECALL CAMPAIGN 121)

Applicable Vehicles: Veracruz (EN) vehicles built from January 13, 2006 to July 24, 2012

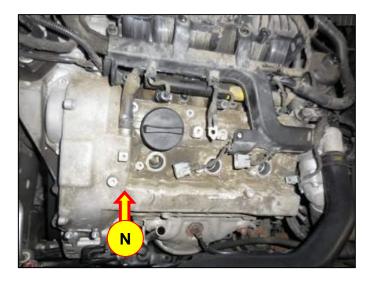
10. Remove the bank 2 (LH) cylinder head cover (N).

Tightening torque specification: 8.0 lb-ft (96 lb-in, 10.8 Nm)

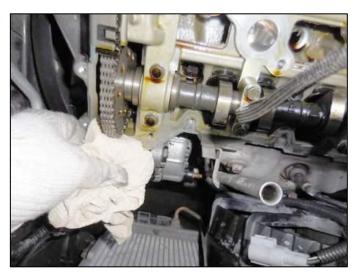
- Be careful not to damage the surface of the cylinder head cover.
- The removed liquid gasket residue should not fall into the engine.
- 12. Clean the cylinder head and cover with a clean lint-free shop towel referring to the picture of the cleaning area below (highlighted in red).

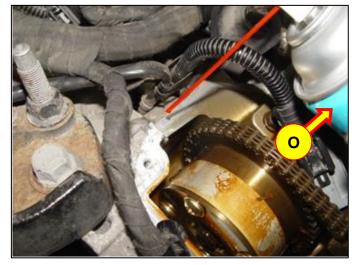
13. With a degreaser/cleaner (O), clean off any of the remaining dirt and oil from the cylinder head and cover and then wipe dry with a clean lint-free shop towel.

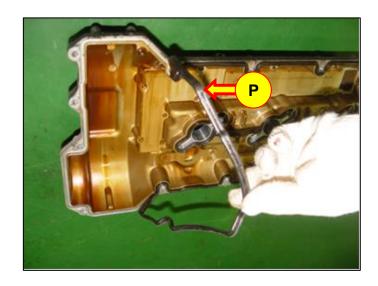
14. Remove the cylinder head cover gasket (P).

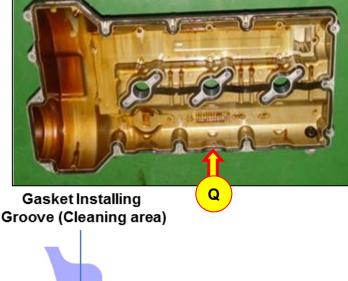
15. Install the new cylinder head cover gasket (Q).

Before installing the new gasket (Q), clean the gasket installing groove with a degreaser/cleaner and a clean lint-free shop towel.

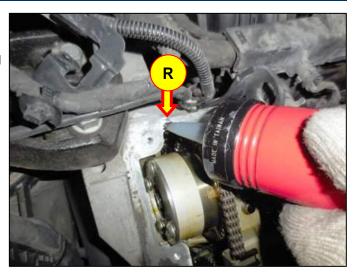
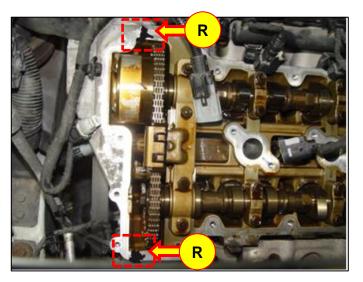
16. Apply liquid RTV gasket onto the "T" joints (R), which is the mating points where the front timing chain cover and the cylinder head meet.

When applying the liquid RTV gasket, the applied bead on the surface should be approximately 3/16th in (4.5 mm) wide as shown in the picture below.

Carefully reinstall the cylinder head cover within the next several minutes before the liquid RTV gasket begins to harden.

Tightening torque specification: 8.0 lb-ft (96 lb-in, 10.8 Nm)

When reinstalling the cylinder head cover, tighten the bolts in the order as shown in the picture at right.

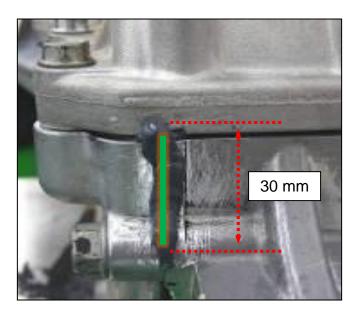
- Apply liquid RTV gasket onto the outer surface of the "T" joints (S) of the cylinder head and cover.
 - Apply the liquid RTV gasket in a line at least 30 mm long, following the green bold line as shown in the picture on the right and below.

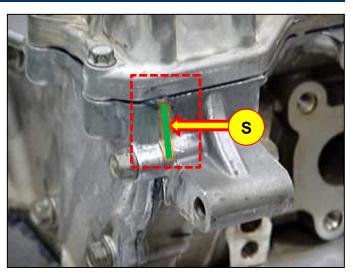
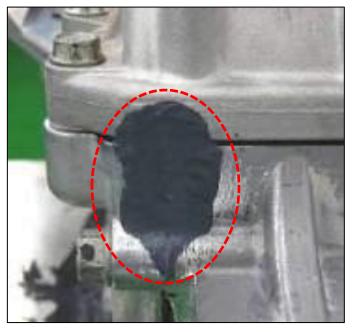
Within several minutes before the liquid RTV gasket begins to harden, spread the gasket evenly as shown in the picture on the right.

Allow at least one hour for the liquid RTV gasket to cure before starting the engine.
