SIB 65 17 14

RECALL CAMPAIGN 14V-428: REPLACE PASSENGER'S FRONT AIR BAG MODULE:

This Service Information bulletin (Revision 7) supersedes SI B65 17 14 dated **December 2022**.

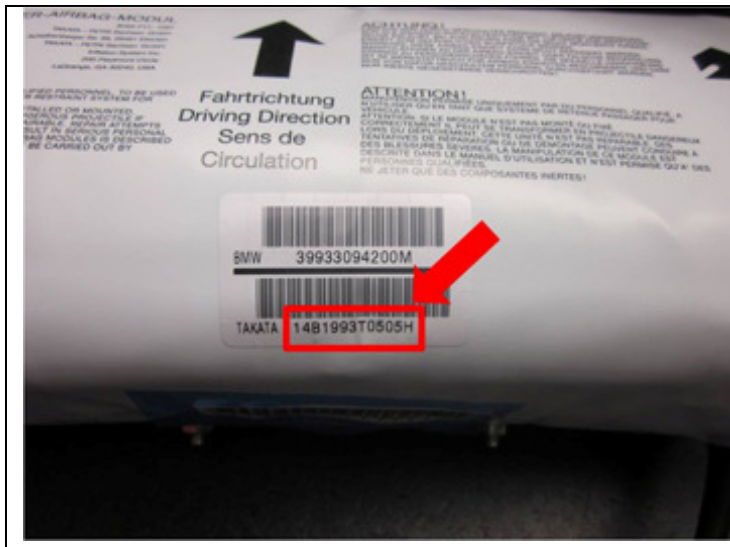
- We cannot rule out that the retaining straps of the airbag lid have been damaged by airbag deployment. Note before repair if there is any damage.
- We cannot guarantee correct function of the retaining straps when reusing a possibly damaged airbag lid. Inspect the lid before repair.

Make a note of the new airbag module serial number prior to installation. The serial number for the new airbag module must be entered in the comment box in the warranty application. Ensure that you enter the serial number without any blank spaces. Otherwise, it is not possible to uniquely assign the number.
