RECALL CAMPAIGN 14V-428: REPLACE PASSENGER'S FRONT AIR BAG MODULE:

This Service Information bulletin supersedes SI B65 17 14 **dated November 2018**

MODEL

Model Year from 2000 to 2006

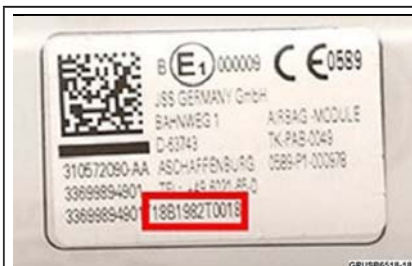
Please make sure to document the serial number before installation.

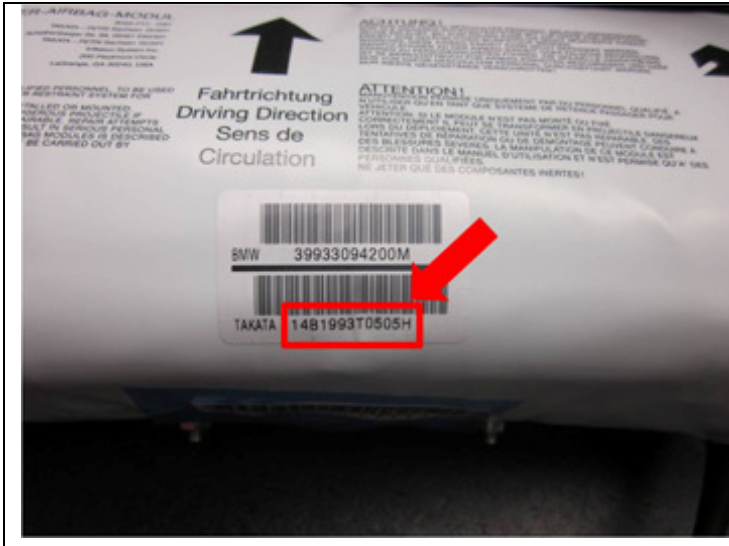
Make a note of the new airbag module serial number prior to installation. The serial number for the new airbag module must be entered in the comment box in the warranty application. Ensure that you enter the serial number without any blank spaces. Otherwise, it is not possible to uniquely assign the number.
