Technical Service Bulletin

14-01-032-1

2011 SONATA (YF)

SUBJECT: SONATA (YF) BRAKE TUBE REPLACEMENT
(RECALL CAMPAIGN 122)

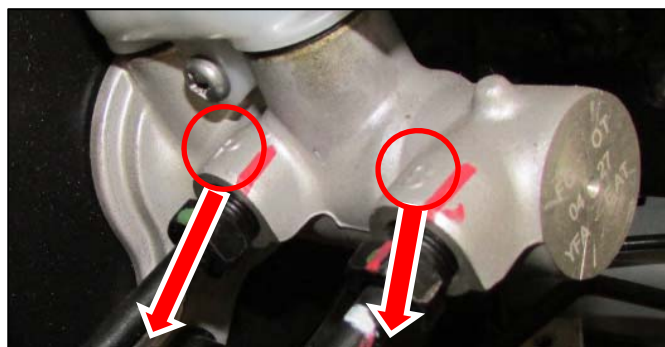
5. Note on the master cylinder the **PRIMARY** port is marked with a “P.” At the HECU module, the **PRIMARY** circuit port is marked with an “MC1.”

“P” - Primary

“S” - Secondary

Tightening torque:
10.1 ~ 12.3 lb-ft (1.4 ~ 1.7 kgf.m,
13.7 ~ 16.7 Nm)

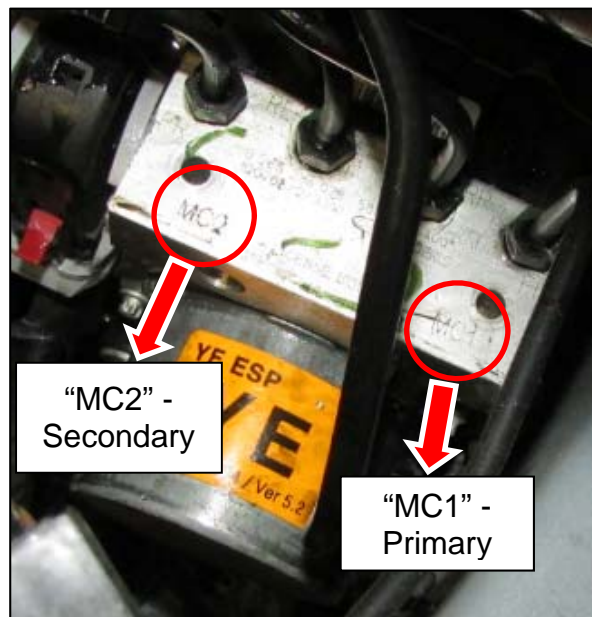
“MC2” -
Secondary

“MC1” -
Primary
