Recall Bulletin

F/CMVSS NONCOMPLIANCE RECALL

SUBJECT: Console Storage Compartment Latch

MODELS: 2014-2015 Chevrolet Impala LT and LTZ

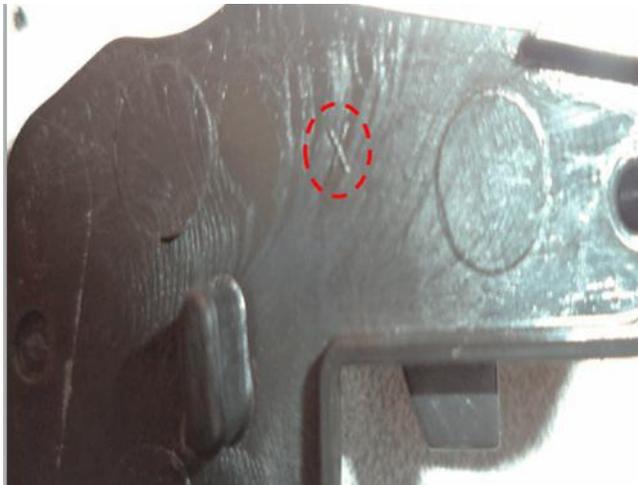
3971111

Note: The new inertia latch with spring installed will have an "X" located on the outer surface, as shown in the graphic above.
