SAFETY RECALL BULLETIN

SUBJECT: 2011 OUTLANDER SPORT/RVR BRAKE BOOSTER – SAFETY RECALL CAMPAIGN		No: SR-14-008
		DATE: October, 2014
		MODEL: 2011 Outlander Sport/RVR
CIRCULATE TO:	<input checked="" type="checkbox"/> GENERAL MANAGER	<input checked="" type="checkbox"/> PARTS MANAGER
<input checked="" type="checkbox"/> SERVICE ADVISOR	<input checked="" type="checkbox"/> SERVICE MANAGER	<input checked="" type="checkbox"/> WARRANTY PROCESSOR
		<input checked="" type="checkbox"/> TECHNICIAN
		<input checked="" type="checkbox"/> SALES MANAGER

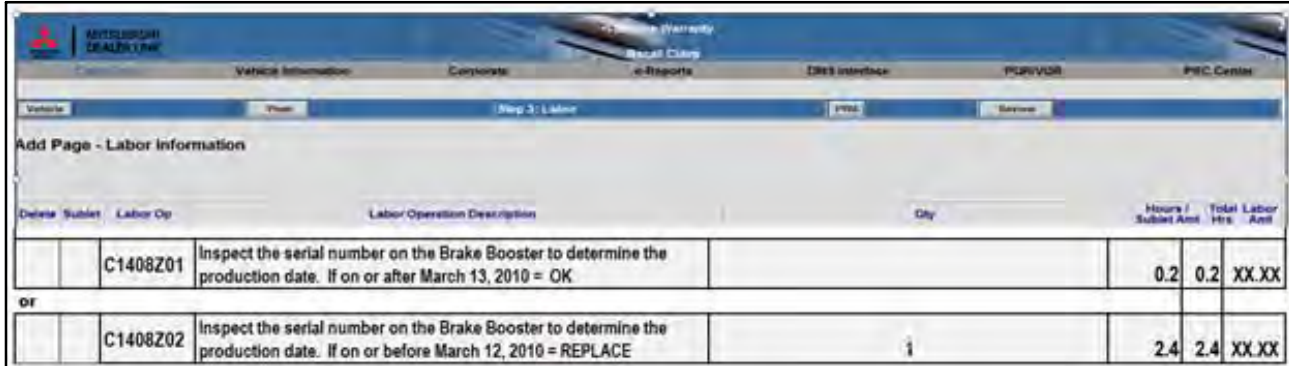
The full campaign labor operation number of either #1) C1408Z01 or #2)C1408Z02 and the allowed labor time of either .2 hours for scenario #1, 2.4 hours for scenario #2 will be automatically entered as a result of the 'Repair Performed' selected from the "Vehicle" page.
