Recall Campaign 14V-627: N20 and N26 Engine - Check Intake Camshaft

SITUATION

A defect in the intake camshaft can reduce engine oil lubrication to the engine vacuum pump, which may result in the pump's failure. Failure of the engine vacuum pump can lead to subsequent loss of power-assisted braking.

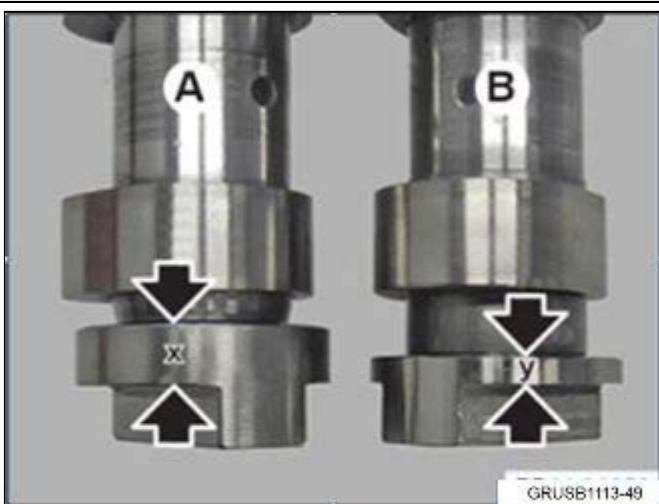
2. The width of the camshaft material near the vacuum pump drive lug must be identified. In the example, the thickness of the material is highlighted between the arrows.

Camshaft A: X = approximately 8 mm
Camshaft B: Y = approximately 4 mm

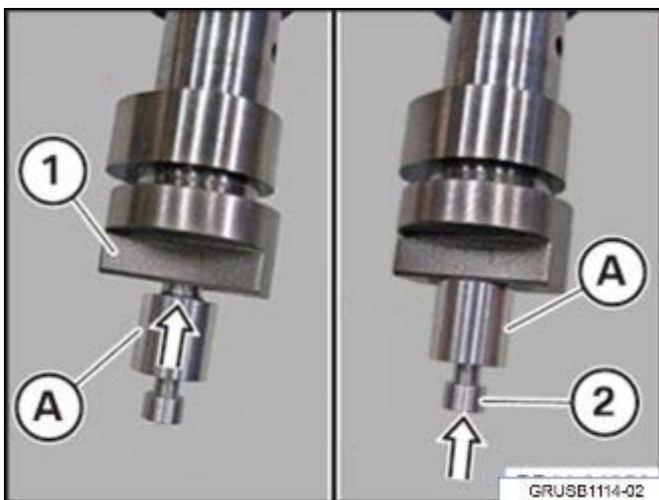
5. Insert the test sleeve (A) into the intake camshaft vacuum pump drive flange (1).

Push the test pin (2) in the direction of the arrow until it stops. Determine the position of the test pin (2).
