# Safety Recall – Interim Inspection

Code: 42G7

**Subject: 2011-2013 MY Jetta and 2012-2013 MY Beetle  
Rear Axle Safety Inspection**

December 02, 2014

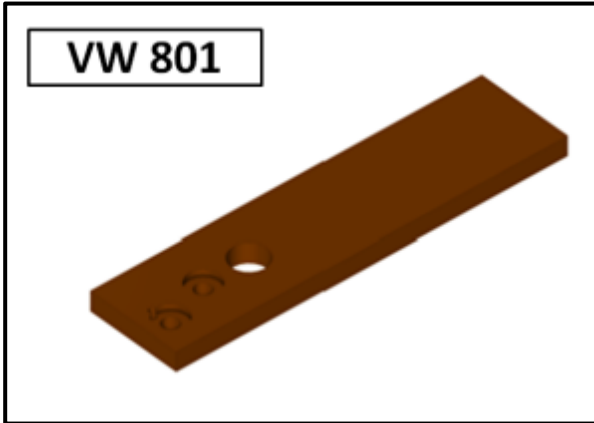
- VW 801 – Crankshaft holding fixture (or equivalent)

**i** Tip: The tool VW 801 serves as a “straight-edge” for the purpose of measuring the straightness of the trailing arms. An equivalent straight edge tool can also be used but must measure between 11.8 to 12.5 inches (~300mm) in length.

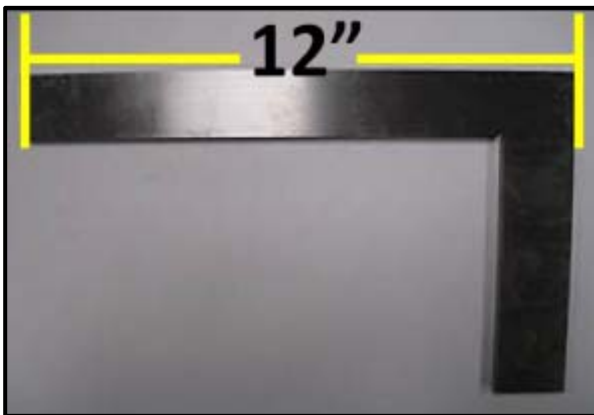
**i** Tip: Example of equivalent tool: Carpenter square measuring 12 inches (~300mm) in length.
