Safety Recall **REVISION**

Code: 42G8

**Subject: 2011-2013 MY Jetta and 2012-2013 MY Beetle
Rear Axle Trailing Arm Inlay Installation**

April 08, 2015

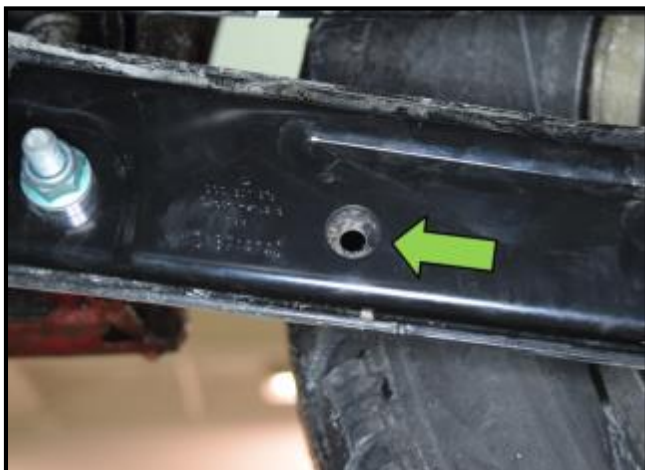
⇐ Prior to tightening the mounting bolts, inspect the alignment of the inlay where shown <arrow>. The hole for the parking brake cable bracket should appear centered as shown.

- If the holes do not line up properly, inspect the installation of the bushings in the trailing arm and adjust them as necessary.
