Test Report No. 1000

Ice House Shackle Mount Testing

Test Date: October 24, 2014

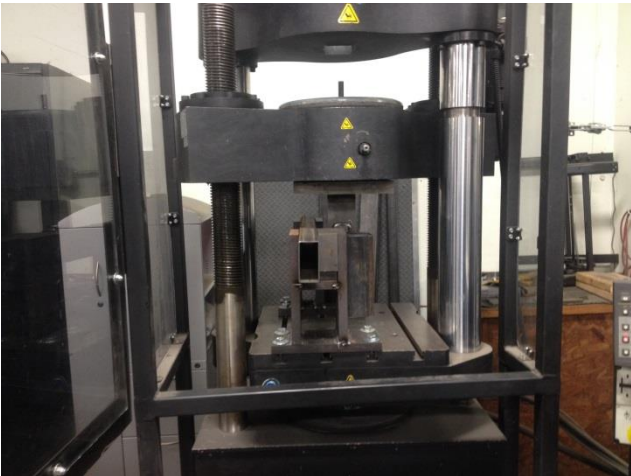
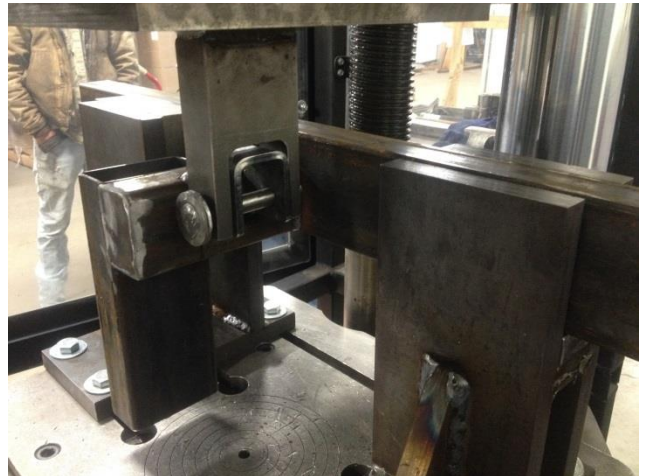
The force applied to the shackle mount resulted in the weld starting to separate from the mount. The tube that the shackle mount is located on began pulling the frame rail and bending it at the location in question. The deformation continued until the jack mount contacted the Instron table ending the test.

Figure 3: Current shackle mount #1 prior to testing

Figure 4: Current shackle mount #1 prior to testing

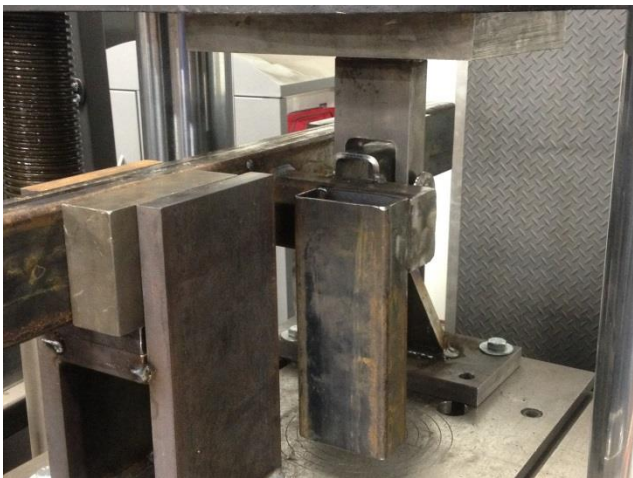
The results for this sample closely mimic those from the first sample. A couple of the welds began to separate from the steel under the pressure of the load and the steel frame began to twist.

Figure 9: Current shackle mount #2 prior to testing

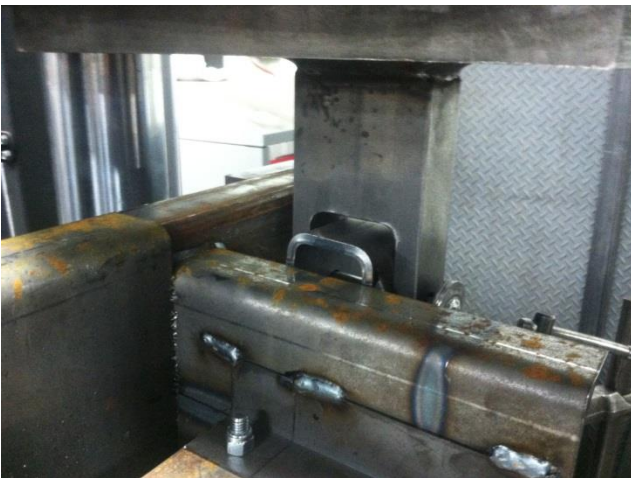
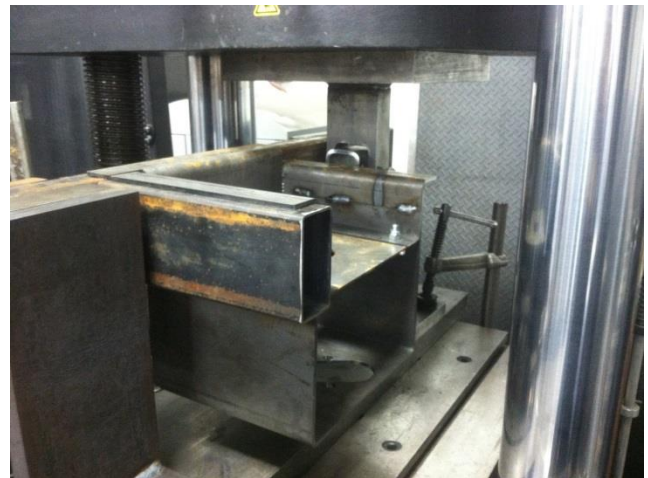
The welds at the material in question and the shackle mount began to separate. The entire "box" on this sample twisted under the pressure of the load, which is visible in Figure 27.

Figure 23: Past design #1 prior to testing

Figure 24: Past design #1 prior to testing

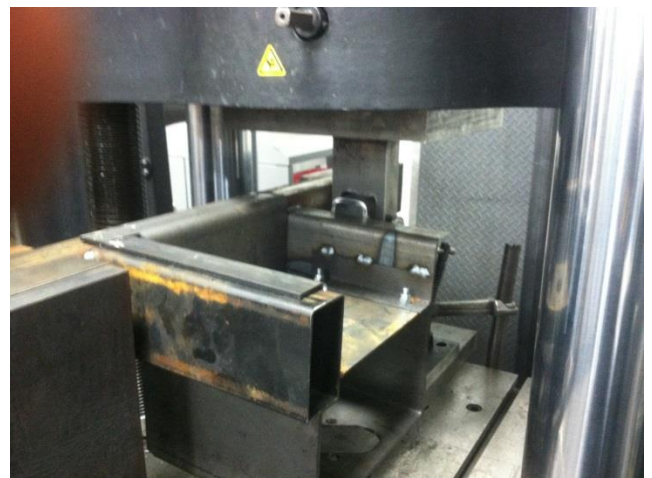
The weld to the material in question began to separate from the steel, same as in the last sample. Additionally, the twist in the "box" and in the frame is very prevalent as seen in Figure 30.

Figure 28: Past design #2 prior to testing

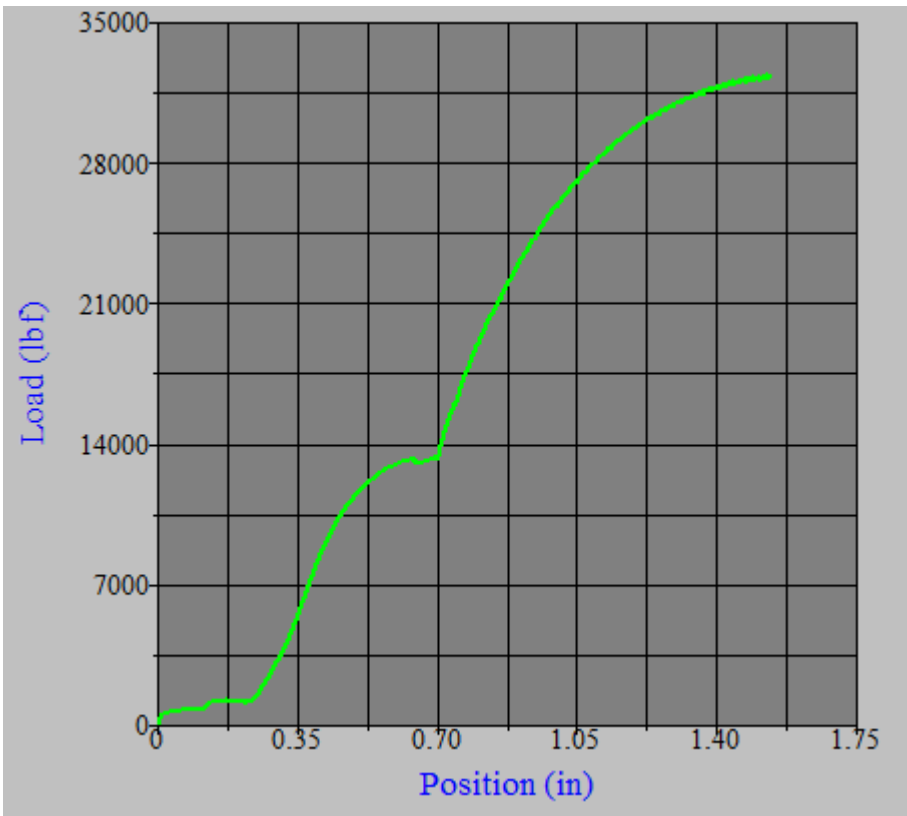
Figure 33: Proposed repair #1

The reinforced frame on this sample proved beneficial. The total load increased by 13,001 pounds, while the deflection decreased by approximately half an inch. The shackle mount was damaged by the load, and bent into the side of the frame. The material in question held together, no flaws.
