TECHNICAL BULLETIN

J047NAS1
10 NOV 2014

Safety Recall: Seatbelt Tension Sensor Connector Wiring

F-TYPE (X152)

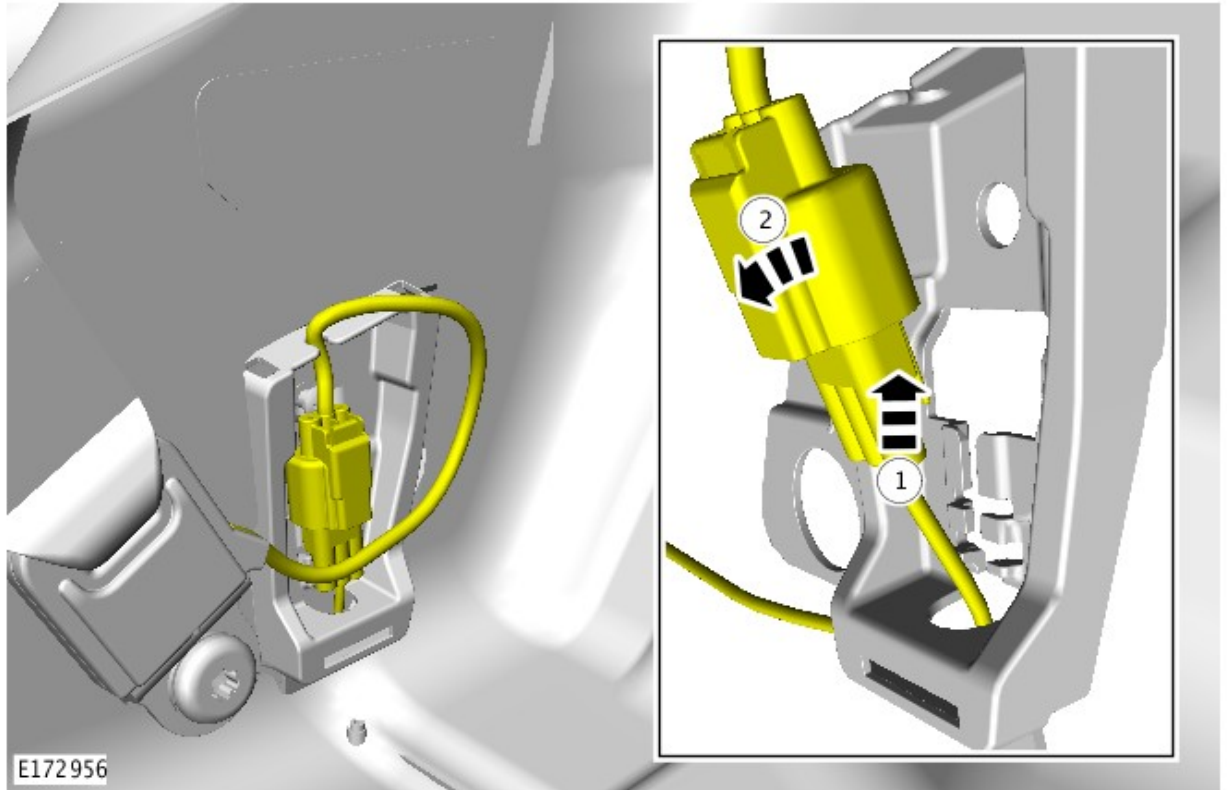
4. At the Seatbelt Tension Sensor side of connector C3R210, check that the electrical connector wires are positioned in the correct pin location as shown.

- If the wires are in the correct position, reverse steps 1-3 and release the vehicle.
- If the wires are not in the correct position, proceed to step 5.
